**AIRPROX REPORT No 2025247**

Date: 10 Dec 2025 Time: 1411Z Position: 5142N 00209W Location: ivo Aston Down gliding site

**PART A: SUMMARY OF INFORMATION REPORTED TO UKAB**

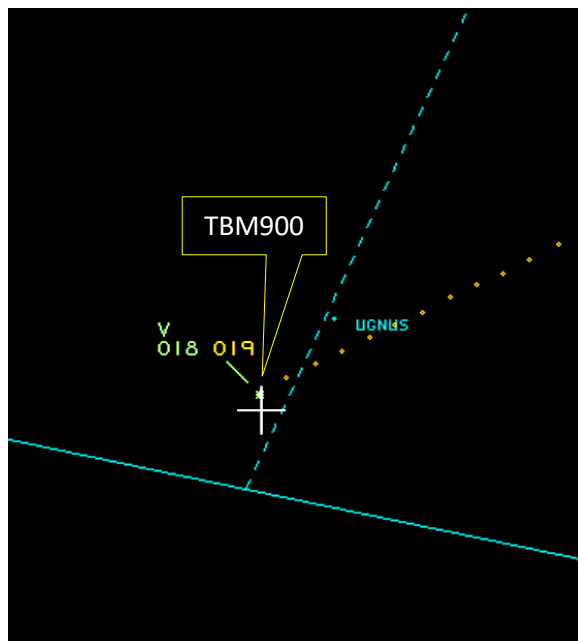
Figure 1 – 1410:51

An analysis of the NATS replay was undertaken and the TBM900 was seen passing Aston Down at the reported time of the Airprox. There was no primary or secondary radar trace on the ASK21.

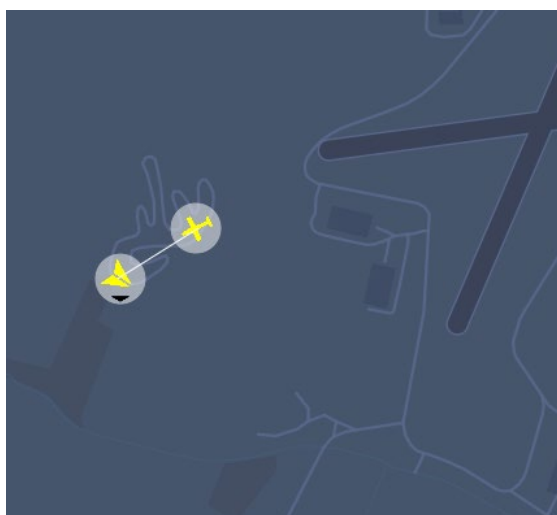
Figure 2 -Time 1410:38

An analysis of third-party tracking software was undertaken, and the TBM900 was detected using ADS-B data sources, while the ASK21 glider was detected using FLARM data (Figure 2).

The pilot of the ASK21 provided their navigation data file. Using combined radar and GPS data, the CPA was assessed to have occurred at 1410:44 with approximately 150ft vertical and less than 0.1NM lateral separation.

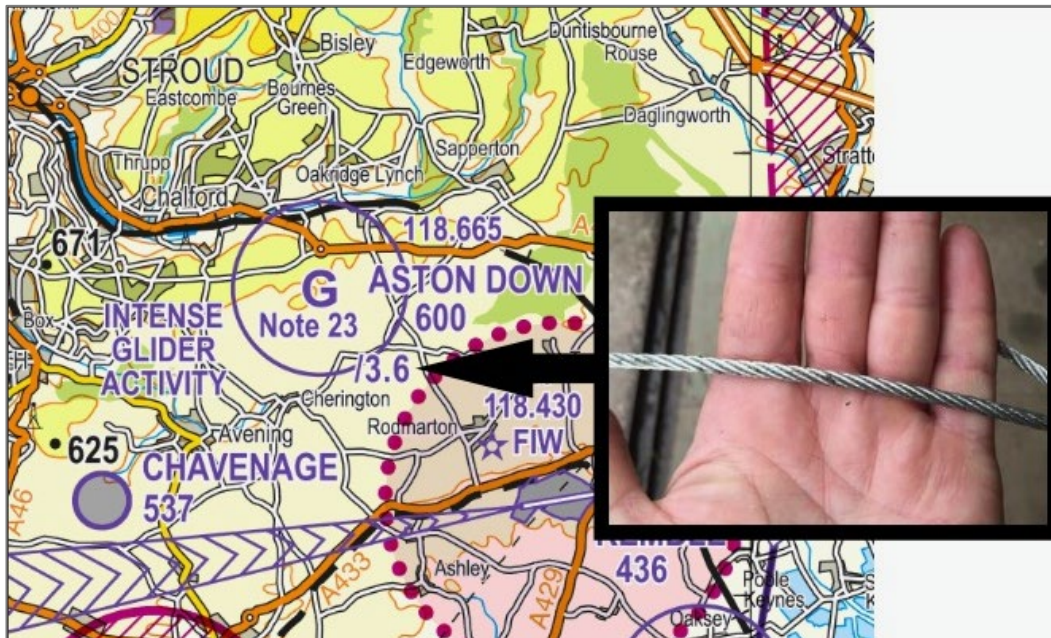
Figure 3 Depiction of the winch cable and winch launch altitude

UK gliders launch sites are listed in UK AIP ENR 5.5 and typically labelled on CAA VFR charts with a 'G in a circle' symbol (See Airprox depiction above and Figure 3). A greater density of gliders may be expected nearby at any time during daylight hours, and at any altitude up to cloudbase. More active sites are accompanied by an "Intense Gliding Activity" caption.

Where winch launching is used, the maximum winch launch altitude is listed in the AIP and marked on the chart; this is 3600ft AMSL at Aston Down, as indicated by the black arrow in Figure 3. A glider being winch-launched achieves a climb angle of 45° and an initial climb rate in excess of 4000ft/min
