AIRPROX REPORT No 2025253

Date: 31 Dec 2025 Time: 1241Z Position: 5620N 00335W Location: 5NM southwest of Perth

PART A: SUMMARY OF INFORMATION REPORTED TO UKAB

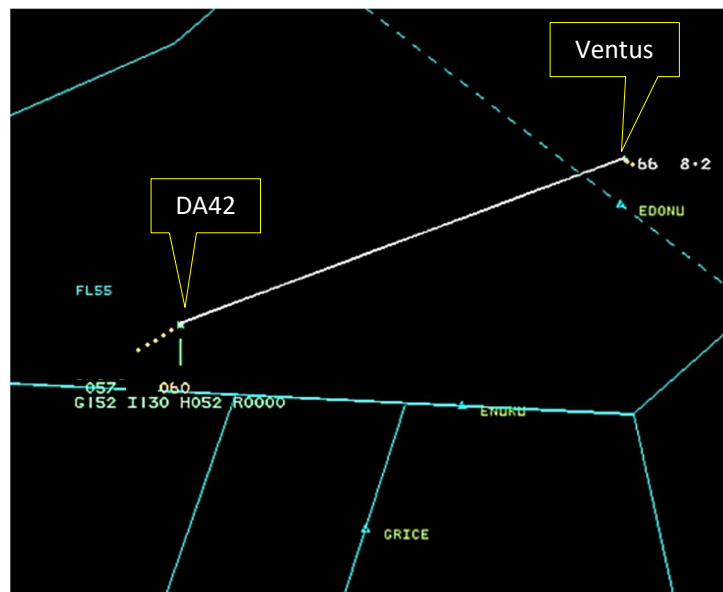
Figure 1 shows the relative locations and trajectories of both [the DA42] and the primary target at this time, when they were 8.2NM from each other.

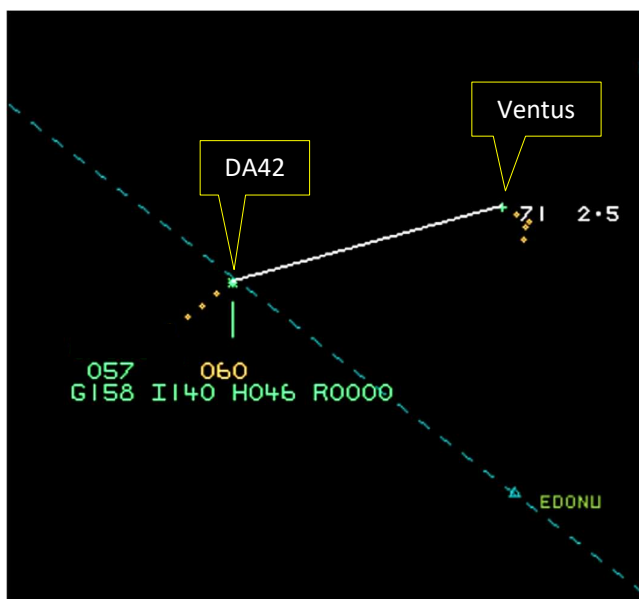
Figure 2

The controller updated this Traffic Information at 1239:02 "Previously mentioned primary, in your one o'clock at about, just appeared back on the radar, about four miles, if anything tracking northbound but no height information". The pilot responded that the traffic was "...not sighted". The aircraft were 4.8NM apart at this time and the primary-only target had turned onto a more northerly track and continued to occasionally drop from the radar picture and then reappear. At 1240:02 the controller provided a further update to the pilot, "...previously mentioned return is just in your twelve, well one o'clock to twelve o'clock, er range of about two miles, no height information. If anything tracking northwesterly. Just going into your twelve o'clock in the next ten seconds or so". There was no response from the pilot. The relative locations of each aircraft involved at this time are shown in Figure 2.

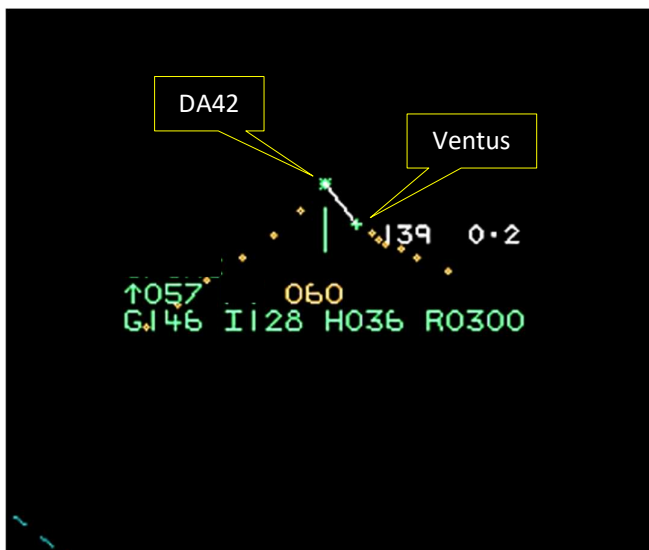
Figure 3 – Time 1240:48

In their Airprox report, the pilot of [the DA42] stated, ‘*...my two students noticed the contact, and then so did I. I took control and climbed above the contact, only by a few hundred feet. According to our relative directions, the other traffic had right of way, although we were so close when I saw the traffic, I couldn’t go behind and just flew above. My student in the front had an instrument flying hood on, although there was a student in the back who could look out. We were not in controlled airspace at this time*’. The pilot concluded their report, ‘*On reflection, I consider that there was a high chance of collision*’. The pilot of [the DA42] described the other aircraft as a white, low wing, single engine motor glider and the UK Airprox Board believes this to have been [Ventus C/S]. The closest point of approach between [the DA42] and the primary target occurred at 1240:48 and was measured on NODE radar at 0.2NM, as shown in Figure 3, with the primary target passing behind [the DA42].
