AIRPROX REPORT No 2026002

Date: 07 Jan 2026 Time: ~1155Z Position: 5424N 00622W Location: 3NM east of Portadown

PART A: SUMMARY OF INFORMATION REPORTED TO UKAB

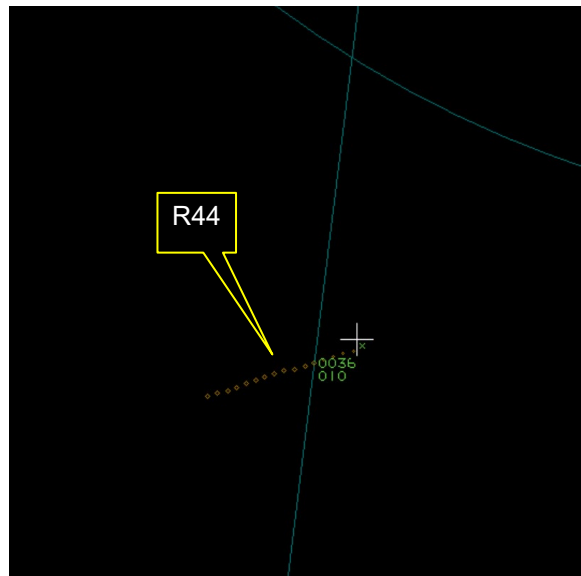
The R44 was tracked by radar and identified through Mode S data. The microlight did not appear on radar or any of the tracking tools available to the UKAB Secretariat.

Figure 1: R44 approach track to position of reported Airprox

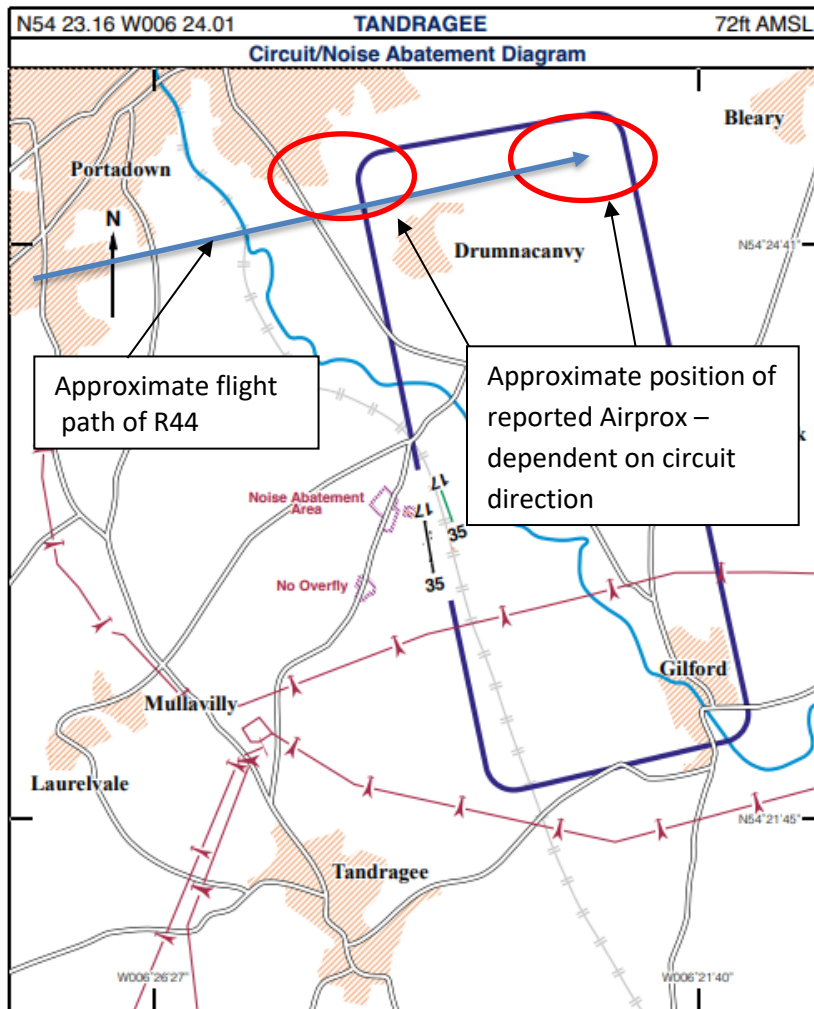
Figure 2: Tandragee (Kernan) circuit diagram (reproduced from Pooley's Flight Guide)

The R44 and untraced microlight pilots shared an equal responsibility for collision avoidance and not to operate in such proximity to other aircraft as to create a collision hazard.¹ An aircraft operated on or in the vicinity of an aerodrome shall conform with or avoid the pattern of traffic formed by other aircraft in operation.²

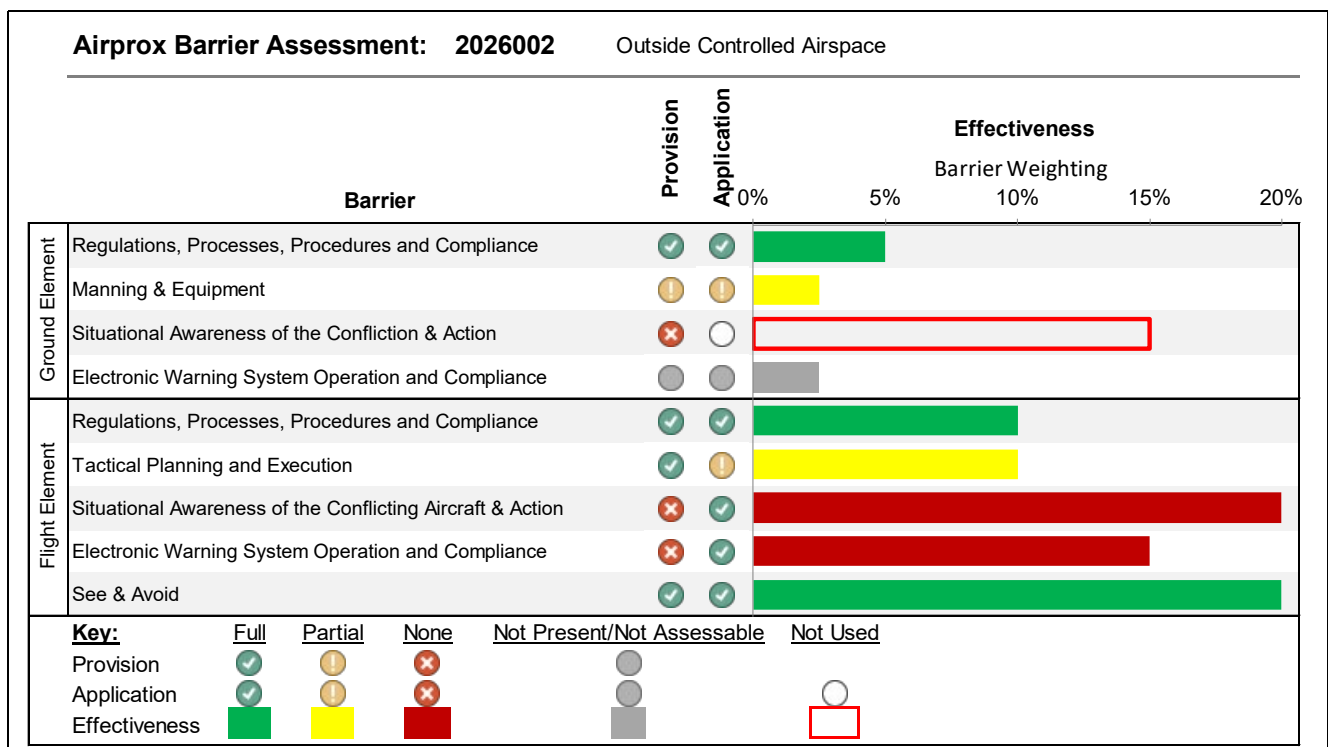
In assessing the effectiveness of the safety barriers associated with this incident, the Board concluded that the key factors had been that:

Manning and Equipment were assessed as **partially effective** because there had been no primary radar available to the Aldergrove Radar controller.

Situational Awareness of the Confliction and Action were assessed as **not used** because there had been no requirement for the Aldergrove Radar controller to monitor the R44 under the terms of a Basic Service.

Tactical Planning and Execution was assessed as **partially effective** because the R44 pilot could have considered adjusting their operating altitude as they had passed through the area or made an RT information call on the Kernan airfield frequency.

Situational Awareness of the Conflicting Aircraft and Action were assessed as **ineffective** because the R44 pilot had only generic situational awareness of other aircraft activity in the area.

Electronic Warning System Operation and Compliance were assessed as **ineffective** because the equipment carried by the R44 had not registered any electronic emissions from the untraced microlight.
