**AIRPROX REPORT No 2026007**

Date: 17 Jan 2026 Time: ~1351Z Position: 5423N 00737W Location: ivo Enniskillen Airport

**PART A: SUMMARY OF INFORMATION REPORTED TO UKAB**

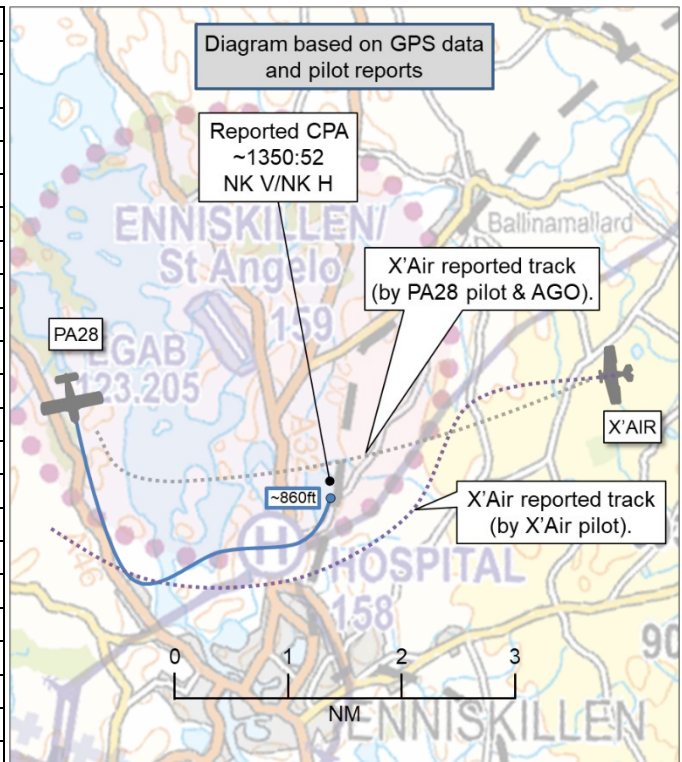
frequency (CF1). The Board then discussed the actual routing of the X'Air, but was unable to determine where the X'Air pilot had flown their aircraft due to the differing reports between the X'Air pilot and those of the PA28 pilot and AGO. [UKAB note: hence the two tracks depicted on the diagram at the top of this report.] The Board felt that it had been a pity that the X'Air pilot had been unable to provide a GPS track from their EC device to help clarify the situation, but was satisfied that the X'Air had remained sufficiently close to the circuit for members to conclude that the pilot had not sufficiently avoided the circuit pattern formed by the PA28 (CF2), which members also found surprising, given that the pilot had had generic situational awareness of circuit activity based on their reported familiarity with the Enniskillen circuit (CF3). The Board noted that the X'Air pilot's passenger had been carrying an EC device that had been capable of detecting the PA28, but that no alert had been reported as having been received (CF5), and that this had contributed to the pilot's reduced situational awareness. The Board further noted that the pilot had reported that they *'were visual with an aircraft way out in their 10 o'clock [position], which was miles from them, heading in the direction of Omagh'*. The Board surmised that the PA28 may have been pointing towards Omagh during the turn onto the final approach, but did not qualify as being *'miles from them'* and members agreed, therefore, that the X'Air pilot had seen a distant aircraft and not the PA28 in the Enniskillen circuit (CF6).
