**AIRPROX REPORT No 2026005**

Date: 16 Jan 2026 Time: 1301Z Position: 5155N 00210W Location: Gloucester Airport

**PART A: SUMMARY OF INFORMATION REPORTED TO UKAB**

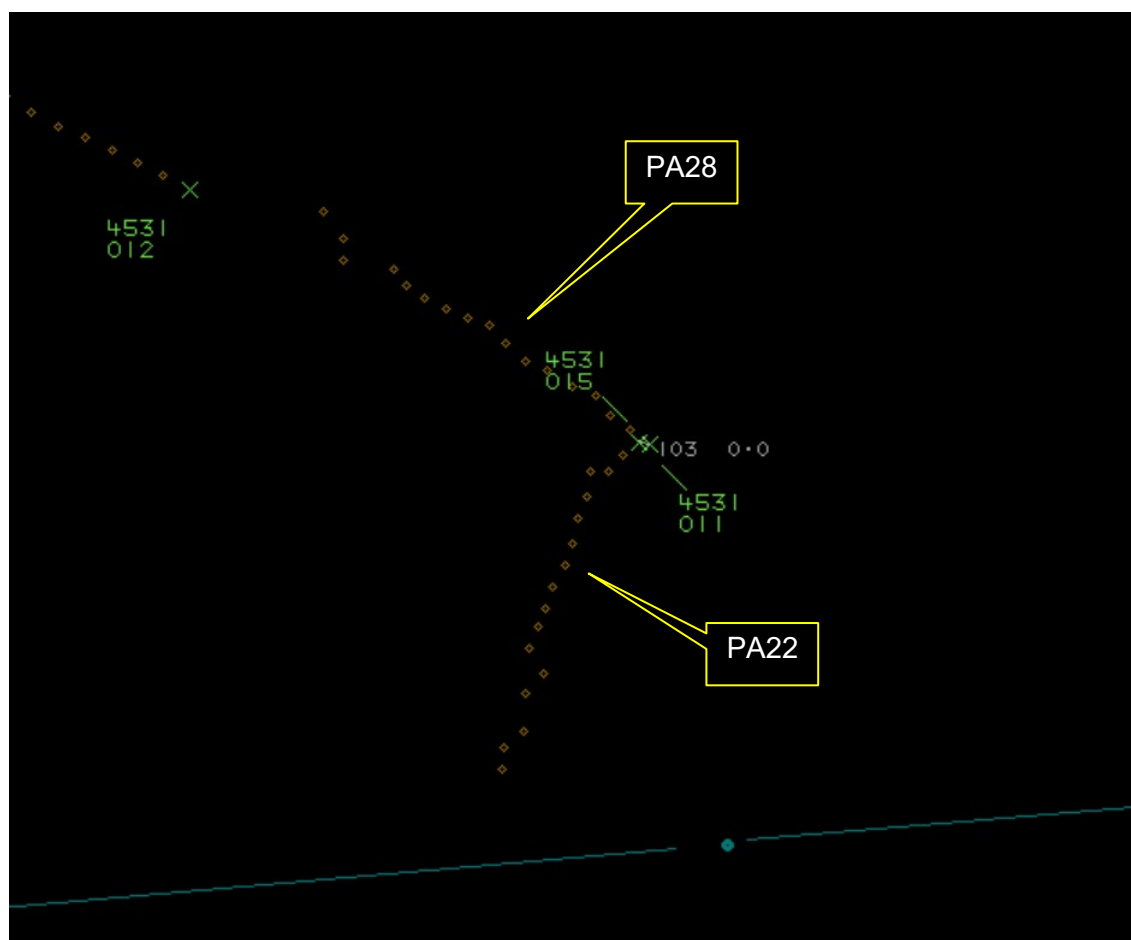
CPA at 1300:32

Figure 1: CPA (1330:32) 400ft V/ <0.1NM H

Both aircraft were tracked by radar and identified through Mode S data.
