**AIRPROX REPORT No 2026085**

Date: 21 May 2026 Time: 1321Z Position: 5121N 00106W Location: 5NM N Basingstoke

An Airprox was reported when an AW139 and a PA17 flew into proximity 5NM north of Basingstoke at 1321Z on Thursday 21<sup>st</sup> May 2026. The AW139 pilot was operating under VFR in VMC, in receipt of a Traffic Service from Southern Mil. The PA17 pilot was operating under VFR in VMC, not in receipt of a FIS.

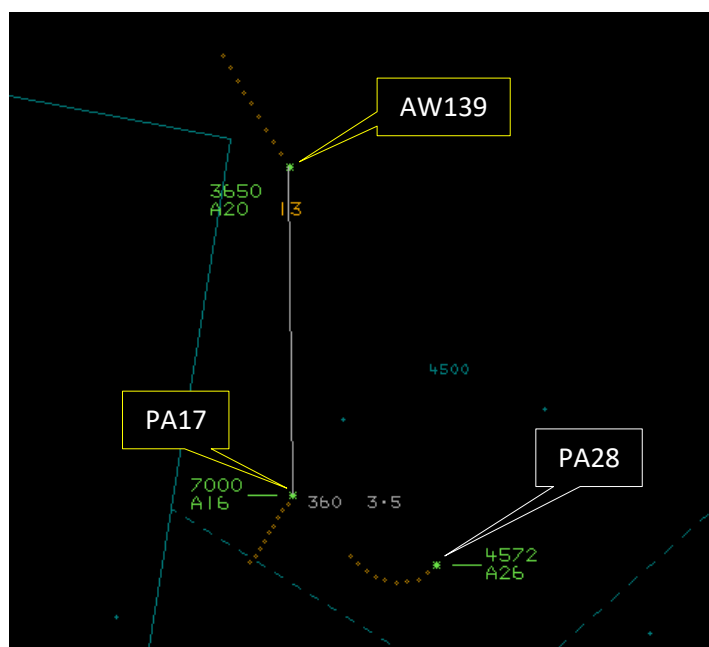
Figure 1 – Aircraft positions at 1320:19

An analysis of the NATS radar replay was undertaken and the AW139, PA17 and PA28 were positively identified from Mode S data (Figure 1). All three aircraft were observed by reference to ADS-B data sources. The pilot of the AW139 kindly supplied GPS track data for their flight.

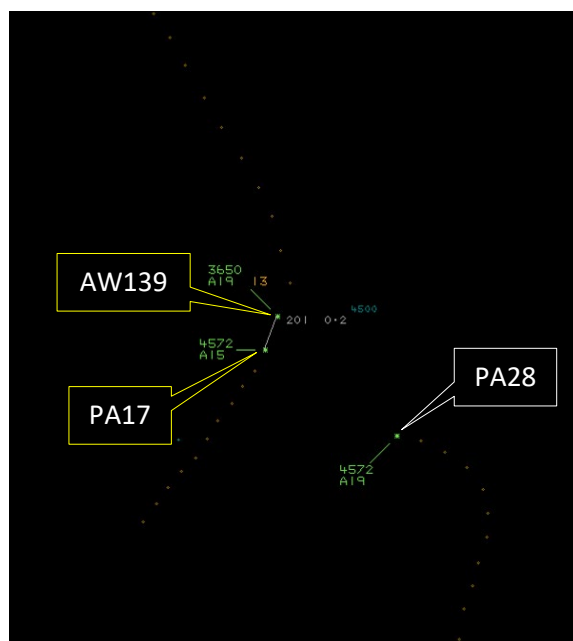
Figure 4 – 1321:22 (2sec before CPA)

The diagram was constructed and the separation determined by combining the data sources. The moment of CPA was assessed to have occurred between the radar sweeps at 1321:22 and 1321:26 (Figures 4 and 5). The altitude of the PA17 has been shown as an estimate as it had been at 1500ft 2sec before CPA and 1600ft 2sec after CPA.
