UK AIRPROX BOARD

Analysis of Airprox in UK Airspace

**Report Number 13
July 2004 - December 2004**

Thirteenth Report by the UK Airprox Board:

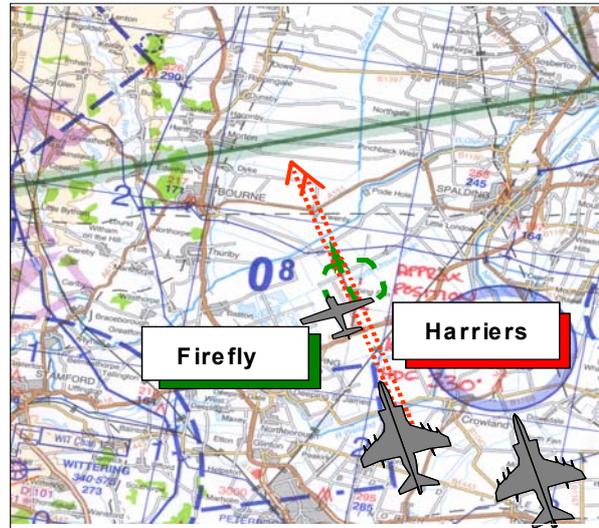
Date/Time: 5 Jul 1005
Position: 5243N 00015W (5nm SE Bourne)
Airspace: UKDLFS LFA6 (Class: G)
Reporting Ac Reported Ac
Type: Firefly T67M Harrier
Operator: HQ PTC HQ STC
Alt/FL: 200ft agl 2000ft
RPS 1013 (QFE)
Weather VMC CLBC VMC HAZE
Visibility: >10km 6km
Reported Separation:
50-100f tv/O H Not seen
Recorded Separation:
400ft V/O H

Members noted that not having seen the Firefly or apparently been aware of its position, the Harrier pilot's report related to the position of the pair a few minutes after the actual incident. The Board commented that this might account for the substantially differing perceptions of the weather by the pilots involved. While accepting that

observed visibilities can differ depending on the view point, had it been as low as the 5km reported by the Harrier pilot then perhaps calling Cottesmore APR earlier would have been a wise precaution. His actions would then have been in accord with the requirements of the Cottesmore Flying Order Book and would have revealed the presence of the Firefly thus allowing the Harrier pair to avoid it. Notwithstanding, Members felt that neither the weather nor the position of the Sun were factors in this incident.

Cause: Non-sighting of the Firefly by the pilots of the overtaking Harriers.

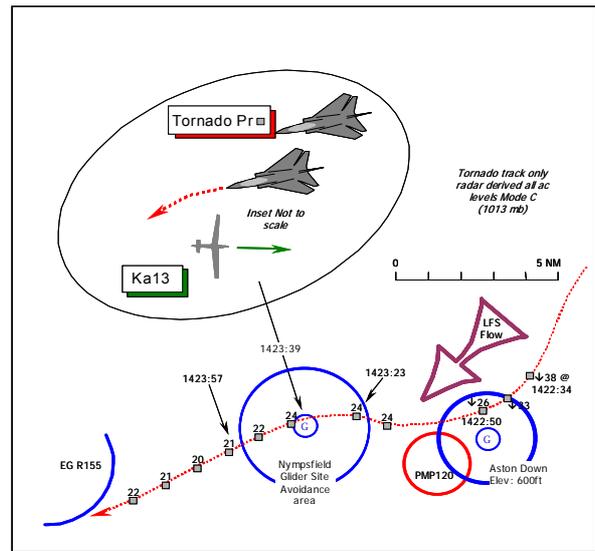
Date/Time: 12 Jul 1423
Position: 5142N 00217W
 (Nympsfield Glider site - elev 700ft)
Airspace: FIR/UKDLFS - LFA 2 (Class: G)
Reporting Ac Reported Ac
Type: Ka13 Glider Tornado GR4 pr
Operator: Civ Club HQ STC
Alt/FL: 1700ft 2260ft
 (aal) RPS (1012mb)
Weather VMC CLBC VMC CLBC
Visibility: 20nm 20km
Reported Separation:
 200ft V/100ft H 500ft V/200m H
Recorded Separation:
 Not recorded

THE TORNADO GR4 PILOT’S STATION comments that although the sortie was correctly briefed and authorised it would appear that the crew did infringe the Nympsfield Glider Site. However, a descent into the LFS in the area of the Bristol Channel is fraught with hazards: airways, glider sites and nuclear power stations, to name but a few.

HQ STC comments that the Tornado GR4 crew should have noted the 3000ft marking on the UK Low Flying Chart, which denoted that in addition to the standard glider-site avoid, Nympsfield was promulgated for winch launching and aerotows to 3000ft agl. This would have been apparent in the planning stage. The fact that they had not allowed for the elevation of the field and had even encroached the standard glider site avoid margin of 2000ft agl was indicative of their poor preparation. Fortunately, they were aware of the glider's presence from a reported distance of 1km, and were in a position to avoid it if required, however, their chosen flightpath was too close and obviously caused the glider pilot concern.

Cause: The Tornado GR4 formation flew through the Nympsfield Glider Site Avoidance Area and close enough to cause concern to the glider pilot.
