UK AIRPROX BOARD

Analysis of Airprox in UK Airspace

**Report Number 19
July 2007 - December 2007**

Nineteenth Report by the UK Airprox Board:

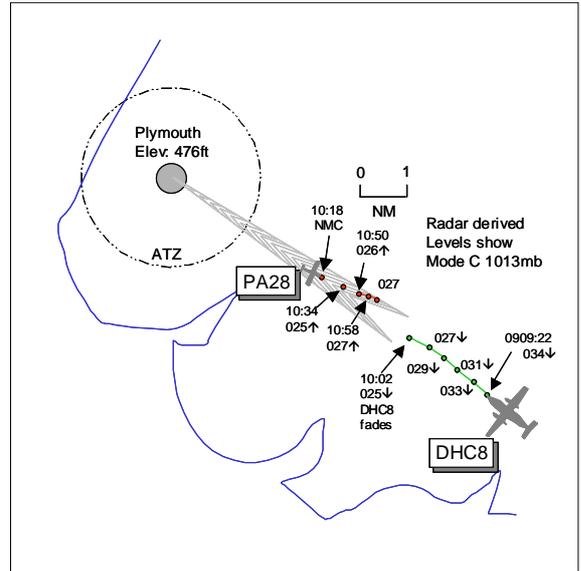
Date/Time: 7 Jul 0911 (Saturday)
Position: 5023N 00400W (5nm FIN APP RW31
Plymouth - elev 476ft)
Airspace: LFIR (Class: G)
Reporting Ac Reported Ac
Type: DHC8 PA28
Operator: CAT Civ Club
Alt/FL: 2300ft↓ 1000ft↑
(QNH 1018mb) (QNH)
Weather VMC CLOC VMC CLBC
Visibility: >10km >10km
Reported Separation:
150-250ft V Not seen
Recorded Separation:
NR

THE DHC8 PILOT reports heading 305° at 160kt fully established on the ILS RW31 at range 5nm and receiving an ATS from Plymouth on 133.55MHz squawking with Mode C. During the approach 2 TCAS contacts were observed flying in the opposite direction, 1 directly ahead [the subject PA28] showing 00, the same level, and 1 to the R of the ILS C/L showing -05. A TCAS RA 'monitor v/s' was received and the guidance was followed and as the visibility was >10km in VMC the other ac, a light coloured single-engined type, possibly an Arrow, was seen to overfly directly O/H with vertical separation of between 150-250ft. He assessed the risk as medium.

Cause: The PA28 pilot did not follow his stated route and, contrary to ATC instructions, flew onto the ILS FAT and into conflict with the DHC8 which he did not see.

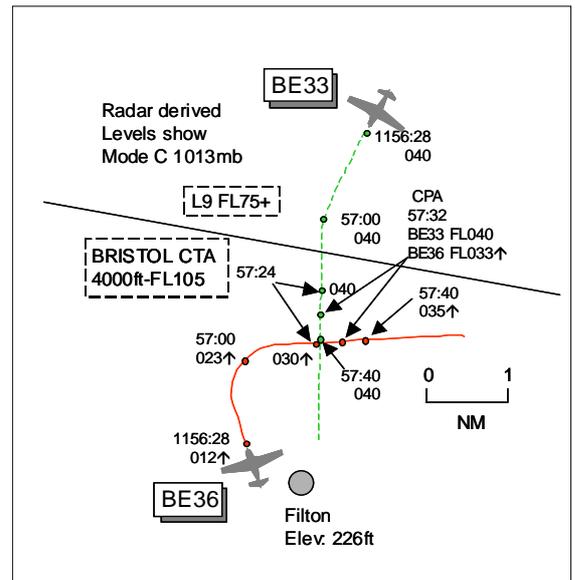
Date/Time: 12 Jul 1158
Position: 5133N 00235W (2nm N Filton)
Airspace: Bristol CTA/LFIR (Class: D/G)
Reporter: Bristol International RAD1
First Ac Second Ac
Type: BE33 BE36
Operator: Civ Pte Civ Pte
Alt/FL: 4000ft ↑4000ft
(QNH) (QNH)
Weather IMC NR IMC NR
Visibility:
Reported Separation:
Not seen Not seen
Recorded Separation:
700ft V/O-4nm H

THE BRISTOL INTERNATIONAL RAD1 reports acting as an OJTI to a trainee who was working a BE33 transiting the base of CAS at altitude 4000ft. Filton had coordinated a departure routeing towards CPT VOR at altitude 3000ft which was observed departing RW27. The SSR labels merged and on separation the Filton ac was seen to be at 3700ft. No avoiding action or TI was passed as the targets had already passed each other and separation was increasing.

Cause: Following an undetected read back error, an undetected assigned altitude report and an undetected Mode C readout, Filton ATC allowed the BE36 pilot to climb into conflict with the BE33.

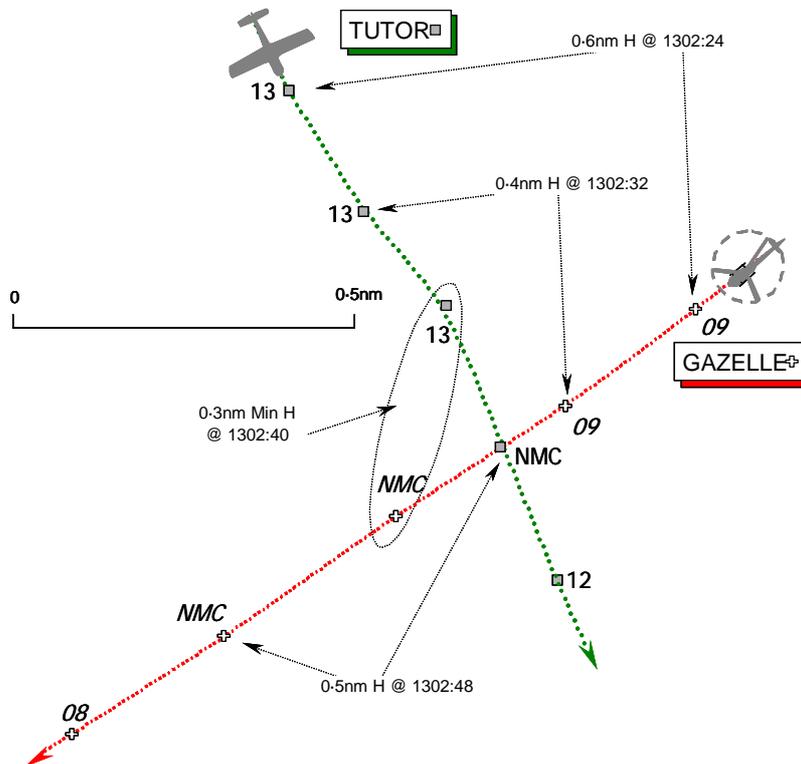
UKAB Note (1): The Claxby radar recording shows the Grob Tutor inbound to Church Fenton FINALS for RW16 at 1302:24, indicating 1300ft (1013mb) – broadly 1180ft QFE (1009mb), with the Gazelle maintaining a steady SW’ly course indicating 900ft (1013mb) – about 780ft QFE (1009mb). The Gazelle appears to be broadly following the track of the A64 road and a course perpendicular to the FAT for RW16. Just before the Gazelle crosses ahead of the Grob Tutor in between radar sweeps the helicopter is shown at a minimum of 400ft unverified Mode C beneath the Grob Tutor maintaining 1300ft Mode C in conformity with the instructions issued by TD. Minimum horizontal separation occurs on the next sweep at 1302:40, when the Gazelle is shown at a range of 0.3nm as the Grob starts to draw astern of the helicopter; NMC is shown thereafter by both ac.

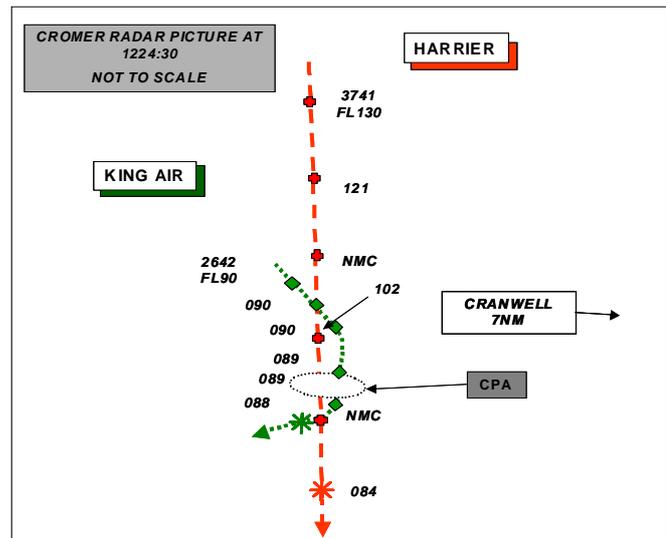
500ft V/<0.1nm (interpolation) H

(This is at the minimum horizontal separation. The ac are co-alt as the Harrier descends through the King Air's level but by this time the horizontal separation is increasing)
