UK AIRPROX BOARD

Analysis of Airprox in UK Airspace

Report Number 24 January 2010 – June 2010

Twenty-Fourth Report by the UK Airprox Board:

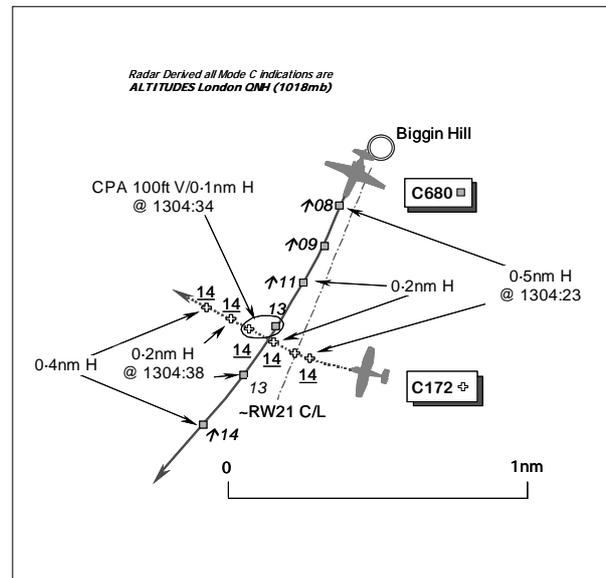
Date/Time: 17 Jan 2010 1304Z (Sunday)
Position: 5119N 00001E
(Biggin Hill A/D - elev 599ft)
Airspace: Biggin Hill ATZ (Class: G)
Reporting Ac Reporting Ac
Type: C172 C680
Operator: Civ Club Civ Comm
Alt/FL: 1000ft 1000ft
QFE (999mb) QNH (1018mb)
Weather: VMC N/R VMC N/R
Visibility: 10km +10km
Reported Separation:
<500ftV/<500ftH 100ftV/100mH
Recorded Separation:
100ft V @ 0.1nm H [-200yd]

The ADC mentor commented later that he had observed that the C172 was slightly lower than expected. This was confirmed on the ATM, where the Mode C of the C172 pilot displayed an altitude of 1400ft, rather than 1600ft as expected. Accordingly, the pilot was asked to, *“check your level you should be a thousand feet on the Q-F-E 9-9-9”*. The pilot immediately confirmed he was complying with the level instructions at 1303:50: *“[C/S] at 1 thousand feet on 9-9-9 millibars”*.

The mentor remarked that he and the trainee observed that the C680 commenced rolling quickly and became airborne earlier than expected about half way down the runway. He added that it then appeared to climb quite steeply. Concerned about the relative positions of the subject ac, the C680 crew was asked, *“[C/S] do you have the Cessna in sight”*. The mentor said that as he was about to issue a warning to the C680 crew, the trainee transmitted the information. He commented that the information message was shorter than ideal but in the circumstances, due to the close proximity of the traffic, there was no time to pass a full traffic information call. He believed that the C680 was passing about 600/700ft at about the time the information message was initiated. In any case, both the mentor and trainee believed that the pilot of the C680, by now, would have seen the C172. The C680 crew responded, *“negative [C/S] oh affirm [C/S]”* [before uttering *“whoaaa”* at 1304:30 and then asking, *“what were you doing there sir?”*]. The mentor then commented on the frequency that the C172 should have been at 1600ft on the QNH and the pilot of the C680 stated *“he came straight through our departure”*. The C172 pilot reported, *“just turning downwind at 1 thousand feet on 9-9-9 millibars continuing approach as instructed”*. The mentor commented that, despite being operational at Biggin Hill for a number of years, he had not experienced the type of departure carried out by the C680 crew.

Accordingly, TWR should have passed appropriate instructions/information to the pilots of the subject ac that would have assisted in preventing any conflict between the two ac. On this occasion, neither pilot was informed about the details of the other flight. If, for example, the C680 crew had been informed about the presence of the C172 prior to departure, it would have allowed them to take appropriate action to avoid the C172. Although the trainee had cleared the C680 crew for take off, the mentor was responsible for the operating position. However, a number of unexpected factors caused the situation to develop. Namely, the C680 crew rolled quicker than anticipated, which meant that it arrived in the vicinity of the upwind end of RW21 before the C172 pilot had cleared the climb-out path. Additionally, the C680 crew rotated earlier than predicted and this was followed by a higher than anticipated ROC.

Cause: The ADC cleared the C680 for take off without giving appropriate TI and it flew into conflict with the C172 joining the circuit.

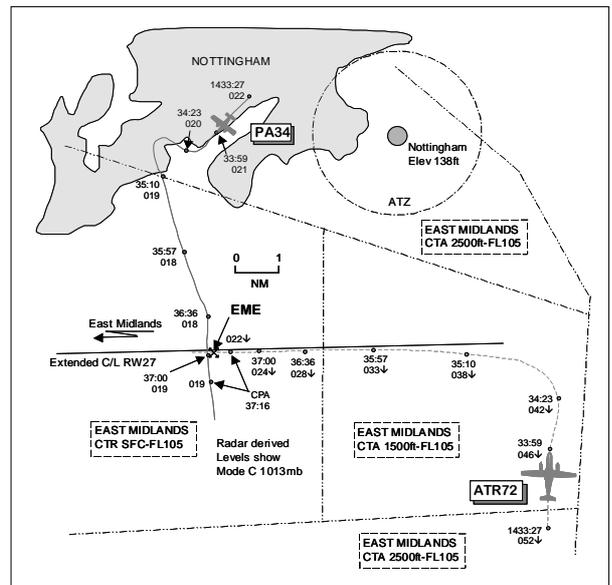
Recorded Separation:
300ft V/0.8nm H

The Board also noted that the frequency was busy when the PA34 was tracking through the CTR, which probably denied the PA34 pilot an earlier opportunity to query the entry clearance. However, the pilot alerted the APR to the situation after he saw the ATR72 in his 10 o'clock high but by the time the APR had issued a squawk code and then realised where the PA34 was the ac were passing each other. Meanwhile the PA34 pilot maintained visual separation against the airliner, he estimated passing 1.5nm ahead and 500ft below it. The ATR72 crew had seen the PA34 closing from the R and had monitored its progress on TCAS (without any TA/RA) before seeing it pass 1nm ahead and below. The radar recording shows the PA34 crossing just over 1nm ahead and 500ft below, the CPA occurring as the ac diverge. These visual sightings allowed the Board to conclude that any risk of collision had been effectively removed.

Cause: The APR vectored the unidentified PA34 into conflict with the ATR72.

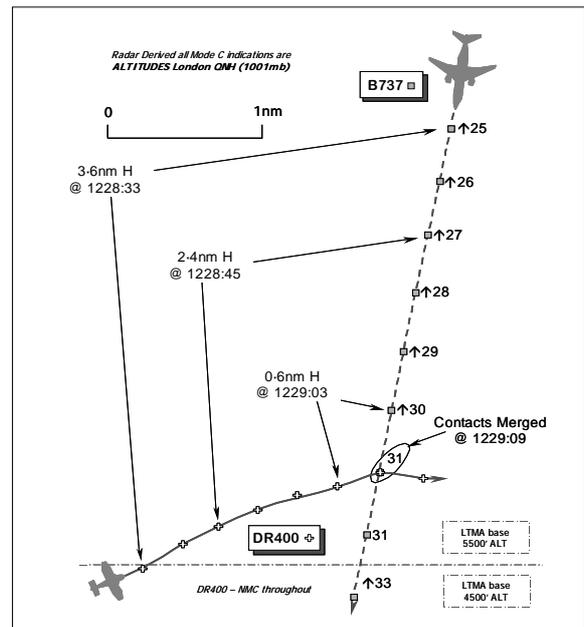
Recorded Separation:
Contacts merged

THE LTC STANSTED INTERMEDIATE DIRECTOR (SS INT) reports 1 month after the event, that the B737 crew was given an airways join on track BKY after departing Cambridge. Climbing initially to 2400ft ALT, when the B737 crew called on frequency the flight was identified and placed under a TS outside CAS. He then co-ordinated the CAS join with TMA N and subsequently climbed the B737 to FL80 with a clearance to enter CAS on track BKY. Whilst in the climb a primary only contact was observed in the vicinity of Duxford. He believed that the primary contact would possibly be in the B737's path but he did not wish to issue an avoiding action vector outside CAS

ATSI reports that the Airprox was reported by the B737 pilot whilst in contact with the LTC Stansted Intermediate Director (SS INT) and occurred about 6nm SW of Cambridge aerodrome at an altitude of 3100ft. Departing Cambridge for Coventry on an initial clearance to “*BARKWAY (BKY) 2400 feet*”, the B737 was first shown on the Stansted 10cm radar, in use by the SS INT controller, at 1227:23 and was observed passing a reported altitude of 800ft. At 1228:00, the pilot of the B737 called on the SS INT frequency, 120.625MHz, on track BKY at an altitude of 2400ft. The indicated Mode C altitude of the B737 was 2500ft London QNH; SS INT instructed the B737 crew to squawk ident and gave a further climb to an altitude of 3000ft.

After SS INT co-ordinated a CAS joining clearance with TC North and identified the B737 3nm SW of Cambridge, at 1228:34, the controller instructed the B737 crew that they were clear to, “*..climb now flight level 8-0 clear to enter controlled airspace*”. The flight was placed under a TS and the clearance and ATS were correctly read-back by the B737 pilot. At 1228:49, SS INT passed TI on, “*..a primary only contact...observed just right of your 12 o'clock passing right to left across you now 1 mile ahead no height information believed to be low level*”. The radar recording shows the primary contact of the DR400 1.7nm SW of the B737. At 1229:09, the two contacts merged within Class G airspace at a position 210°(M) Cambridge airport 6.2nm, the B737 indicating an altitude of 3100ft London QNH (1001mb).

The pilot of the B737 reported to the SS INT controller that the traffic had passed overhead his ac, “*..and we're just passing underneath now no height readout...we estimate about less than 5 hundred foot separation*”. After confirming this, the SS INT controller informed the pilot: “[that traffic] *now observed to have passed behind you had no height information*”. After passing underneath the DR400 the climb rate of the B737 increased, the flight entered CAS, turned westerly and switched en-route without further incident.

Members were disappointed that, although the DR400 was equipped with a SSR transponder, the Mode A & C were switched off thereby preventing ATC from including specific altitude readouts in the TI provided to the B737, and negating the benefit of the B737's TCAS. The Board recognised that in Class G airspace, the operation of the transponder was not mandatory. Nevertheless, National procedures [UK AIP ENR 1-6-2] recommend that 'pilots operate an SSR transponder with pressure-altitude reporting enabled in order to facilitate detection of their aircraft by collision avoidance systems and ATC radar'. The safety benefits of TCAS as an aid to collision avoidance are almost universally recognised, and it would be far better airmanship to fly with the Mode A General Conspicuity Code [7000] selected and Mode C on, especially beneath the LTMA. As it was with the DR400's SSR switched off, the B737's TCAS was rendered blind to the presence of the DR400 and the B737 crew were reliant on ATC to supplement their own lookout. The Board agreed that a Contributory Factor to this Airprox was that the DR400's SSR was switched off, thereby preventing earlier conflict resolution advice from TCAS.

Cause: Conflict resolved by the B737 crew.
