UK AIRPROX BOARD

Analysis of Airprox in UK Airspace

**Report Number 18
January 2007 – June 2007**

‘Analysis of Airprox in UK Airspace’

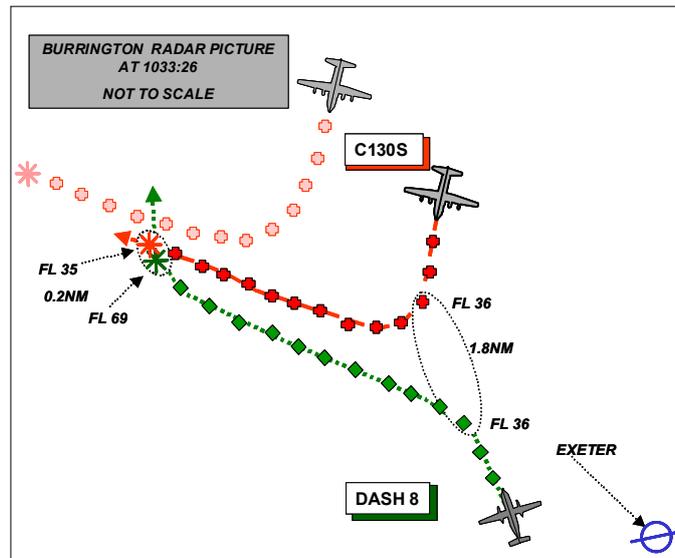
EXETER APR comments that two contacts, later found to be C130's, were seen on radar passing about 10nm NNW of Exeter heading E to W when the ADC requested a departure clearance for a Dash 8. The Dash 8 planned track would pass behind the transiting ac on their observed headings and he estimated that standard separation would be maintained so he released the Dash 8 on an airways clearance to EXMOR at FL70.

The Exeter report concluded: *"This was a conflict in Class G airspace caused by the unexpected turn made by the two C130's towards the RW26 climb-out. Because of the close proximity of the military ac to the climb-out, standard separation was going to be very difficult to achieve. However, the situation could have been improved by more appropriate avoiding action by Exeter Radar".*

Members observed that from the time the C130s turned to the S in their attempt to remain VMC (1029:30) it was inevitable that they would be a problem to the departing Dash 8. At that time the Dash 8 had already received its clearance; had taxied and was just being cleared for take-off, rolling a few seconds later. The ADC gave the Dash 8 crew their first avoidance heading of 290° just after 1031, about 1min after the ac rolled. Members thought that the ADC had acted as quickly as possible after RAD had asked him to stop the ac's turn. In addition the C130s had tracked S for less than 1min before RAD requested the ADC to pass avoiding action to the Dash 8. Bearing in mind that RAD was busy, also handling another ac on a high and late arrival, controller Members did not consider that in such circumstances the delay was excessive or even lengthy. In addition, the timings were such that delaying the takeoff of the Dash 8 had not been a viable option. Having taken off into conflict, it was inevitable the desired separation was not going to be achieved and the Board turned its attention to the RAD's actions after the Dash 8 had become airborne. Although in the end a vertical solution was achieved, passing instructions to the Dash 8 to attain 3000ft separation was never going to be possible particularly bearing in mind that RAD did not know what the C130s were intending to do: indeed, it was thought most likely that the C130 leader also had no clear plan at that precise moment other than to remain outside the Exeter ATZ. Members then considered the horizontal options available to RAD. Perhaps if the Dash 8 had been instructed to continue the right turn (not yet evident on radar) a greater separation would have resulted but it would still be a long way short of the 5nm required; a left turn onto any other heading would have the same effect.

The Board therefore concluded that in the precise circumstances of this event Exeter ATC could not have achieved the 5nm or 3000ft desired separation required when providing a RAS. Furthermore, Members noted that the C130 crews had acted correctly in the circumstances, Swanwick Mil doing as much as they could to assist them. Fortunately both ac were TACS equipped and squawking and were therefore visible to the respective pilots on their TCAS displays. Both ac received only a momentary passive (maintain) RA and the pilots both continued their respective flightpaths thereby removing any collision risk.

Cause: Conflict in Class G airspace resolved by both crews.

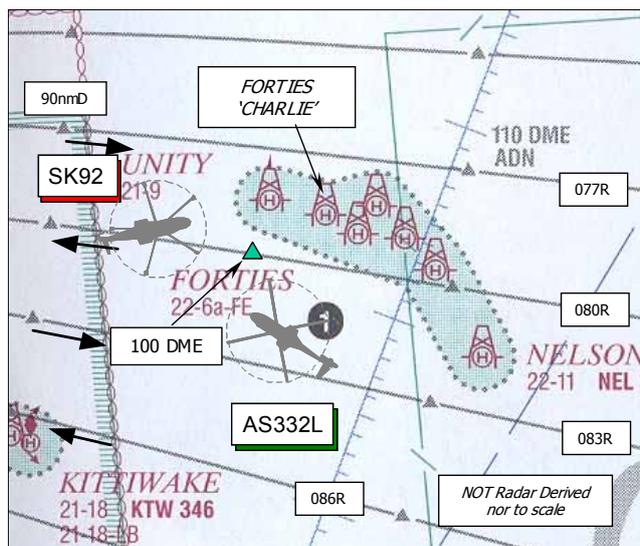
It was also plain that the AS332 pilot was at a disadvantage without any form of TCAS to aid situational awareness; clearly its fitment would be beneficial - as previously recommended by the UKAB. Nonetheless, it was clear that the AS332 pilot's suggestion of utilising a more southerly HMR when departing inbound to Aberdeen had been examined by those involved and accepted as eminently worthwhile, thereby enhancing traffic separation on opposite direction HMRS. The helicopter Member also briefed the Board that participating helicopter pilots had been reminded of the exact extent of the ATSS provided in this inhospitable environment, following recent revisions to the 'Memorandum of Understanding' between NATs as the ATS provider and the helicopter operating companies involved.

Cause: Perceived conflict in IMC within the HMR structure.

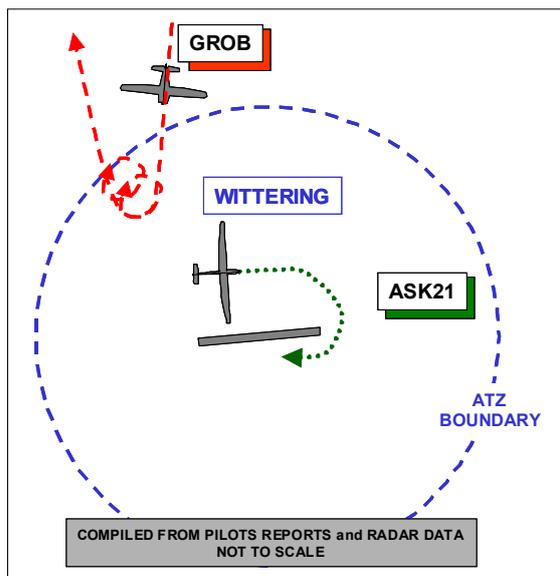
The Board noted that the Grob pilot reported that he was operating at FL035 which equates to 3080ft agl in the prevailing atmospheric conditions. Although the radar recording showed him to be slightly higher (intermittently) there was little doubt that he had been manoeuvring down to about 1000ft above the ATZ and about 1½ nm NNW of the RW. The glider pilot reported being at 1100ft aal at the time of the incident (having descended from 2500ft); this would indicate that the vertical separation at the time of the Airprox was close to 2000ft. Nonetheless the position selected by the Grob pilot, in the opinion of the Board, was not an ideal location to fly aerobatic manoeuvres particularly since he was aware that gliding with winch launching took place nearby.

Since the separation was significant, Members concluded that this had been a sighting report but the presence of the Grob had without doubt caused the glider pilots some concern and, although not germane to the Airprox, temporary suspension of gliding activity.

The Board noted that HQ STC had addressed the misleading entry in the UK En Route Supplement regarding gliding activity at Wittering.

Cause: Sighting report.

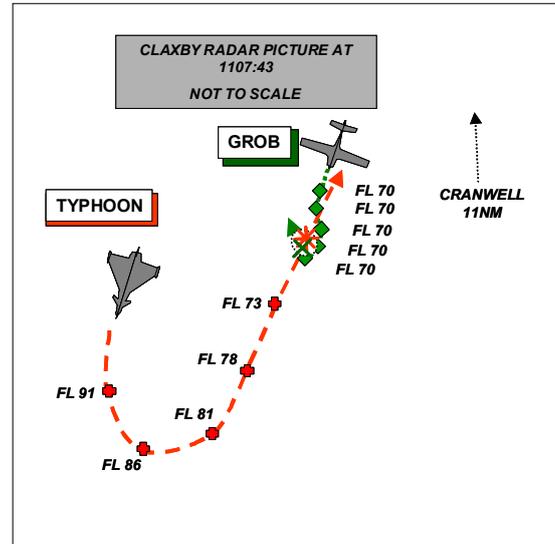
UKAB Note (1): Both ac paint with Mode C until the sweep of the CPA when both Mode C's drop out, the Typhoon for one sweep and the Grob for three sweeps. The Typhoon shows FL073 on the sweep before the CPA and FL071 on the sweep after. The Grob shows FL070 on the sweep before the CPA and FL066 two sweeps (16sec) later.

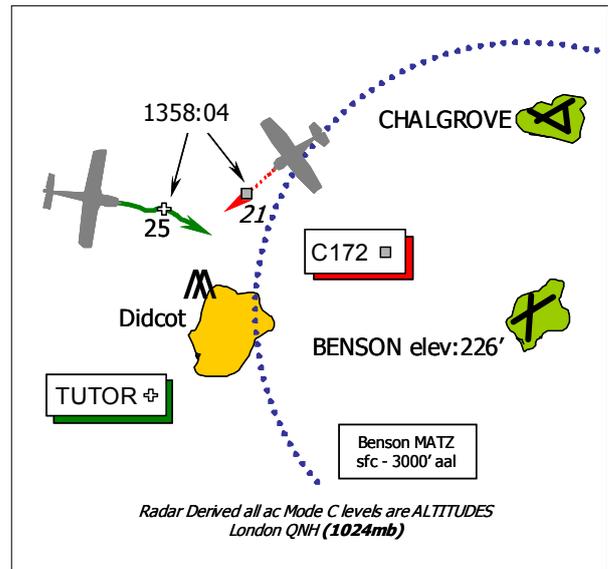
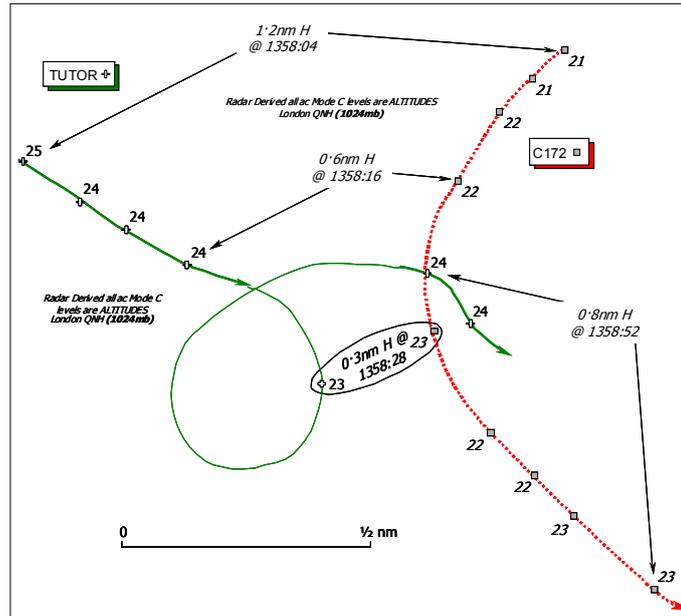
[UKAB Note (2): Analysis of the Heathrow 23cm Radar recording shows the Tutor at 1358:04, tracking 130°, indicating 2500ft London QNH (1024mb), with the C172 at L 10 o'clock - 1.2nm, tracking 240°, indicating 2100ft London QNH (1024mb). On the next sweep the Tutor is tracking 130° and indicating 2400ft QNH, with the C172 still in the Tutor's L 10 o'clock at 1nm, tracking 230°, maintaining 2100ft. At 1358:12, the Tutor's profile is unchanged, but the C172 has closed to a range of 0.8nm on a steady bearing in the Tutor pilot's L 10 o'clock, tracking 230° the former having climbed slightly to 2200ft QNH. By 1358:16, the Tutor is tracking 120° at 2400ft with the C172 0.6nm away in its L 11 o'clock, just before commencing the L turn approaching Didcot. Thereafter good radar contact on the Tutor is lost for a while as the C172 turns L SE'ly just N of Didcot. Whereas the Tutor pilot reports executing a climbing maximum rate turn to the R through 360° to avoid the C172, this is not illustrated by the available data. The Tutor is shown for one sweep at 1358:28, indicating 2300ft QNH, with the C172 indicating the same altitude as it turns through 170°, 0.3nm away. This might be the CPA: however, the veracity of the radar data on the Tutor is questionable as an A0000 SSR return is displayed on the sweep beforehand. The Tutor is not shown again continuously until after 1358:52, in all probability after rolling out from the reported R turn and after the Airprox has occurred, with the C172 0.8nm away to the SE at 2300ft QNH. Thereafter, separation increases as the ac diverge.]

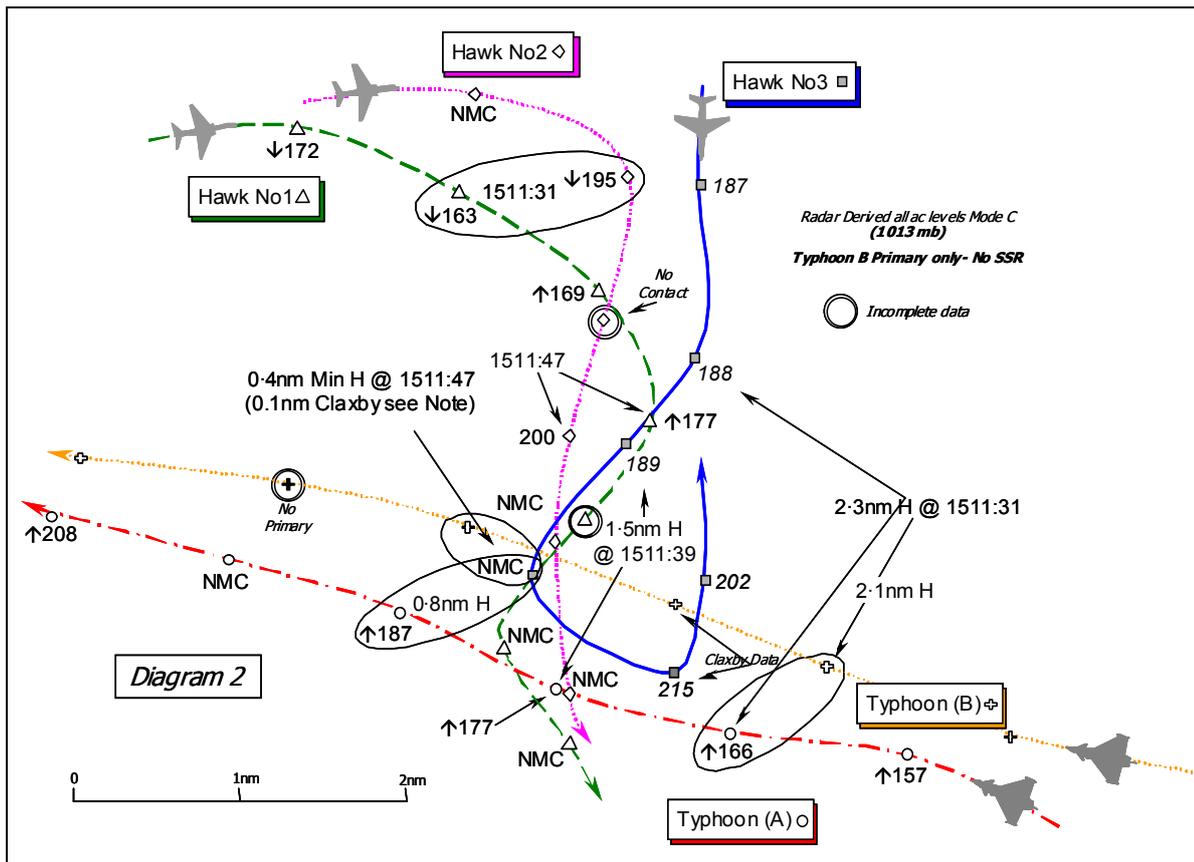
[UKAB Note (2) - See Diagram 1 at the top of this Report and Diagram 2 above. Analysis of the LATCC (Mil) Great Dun Fell (GDF) & Claxby (CLX) Radar recordings show the latter stages of the practice intercept between the Hawk formation as Hawk No3 is shown approaching from the N broadly level at FL185 before commencing a very gentle climb. Hawk No1 & 2 turn about – No1 about 1000ft beneath the No3 - with Hawk No2 descending from above as they prepare to engage Hawk No3 in ACM. Meanwhile the Typhoon pair – Typhoon (A) with Mode C but (B) as a primary contact only throughout about $\frac{3}{4}$ - 1nm apart - turned L from their short ‘loiter’ S of Flamborough Head and steadied WNW’ly in echelon starboard climbing from FL150 and converging on a point SW of Flamborough Head. Diagram 2 illustrates the close quarters encounter between Hawk No3 and Typhoon (B). At 1511:31, Hawk No3 turns right onto a track of 220°, indicating FL188, with No2 & No1 turning in astern, respectively above and below the ‘bandit’; Typhoon (B) is at L 10 o’clock - 2.1nm with Typhoon (A) climbing through FL166, 2.3nm away, 2200ft beneath Hawk No3. On the next sweep of the GDF at 1511:39, Typhoon (B) disappears but the CLX recording shows (B) in Hawk No3’s 10 o’clock 0.9nm, the latter indicating FL189; this is the last Mode C from Hawk No3 until after the CPA and perhaps indicative of a rapid climb. Typhoon (B) maintains course as it crosses through Hawk No3’s 12 o’clock from L to R – in between sweeps - and is shown at 1511:47, 0.4nm NW of Hawk No3 that meanwhile appears to be turning about L in response to the “pull up” warning from his playmate transmitted 13sec earlier. This is the CPA recorded on the GDF with Typhoon (B), the lead ac Typhoon (A) being 0.8nm to the SW climbing through FL187 – some 200ft below the last recorded Mode C

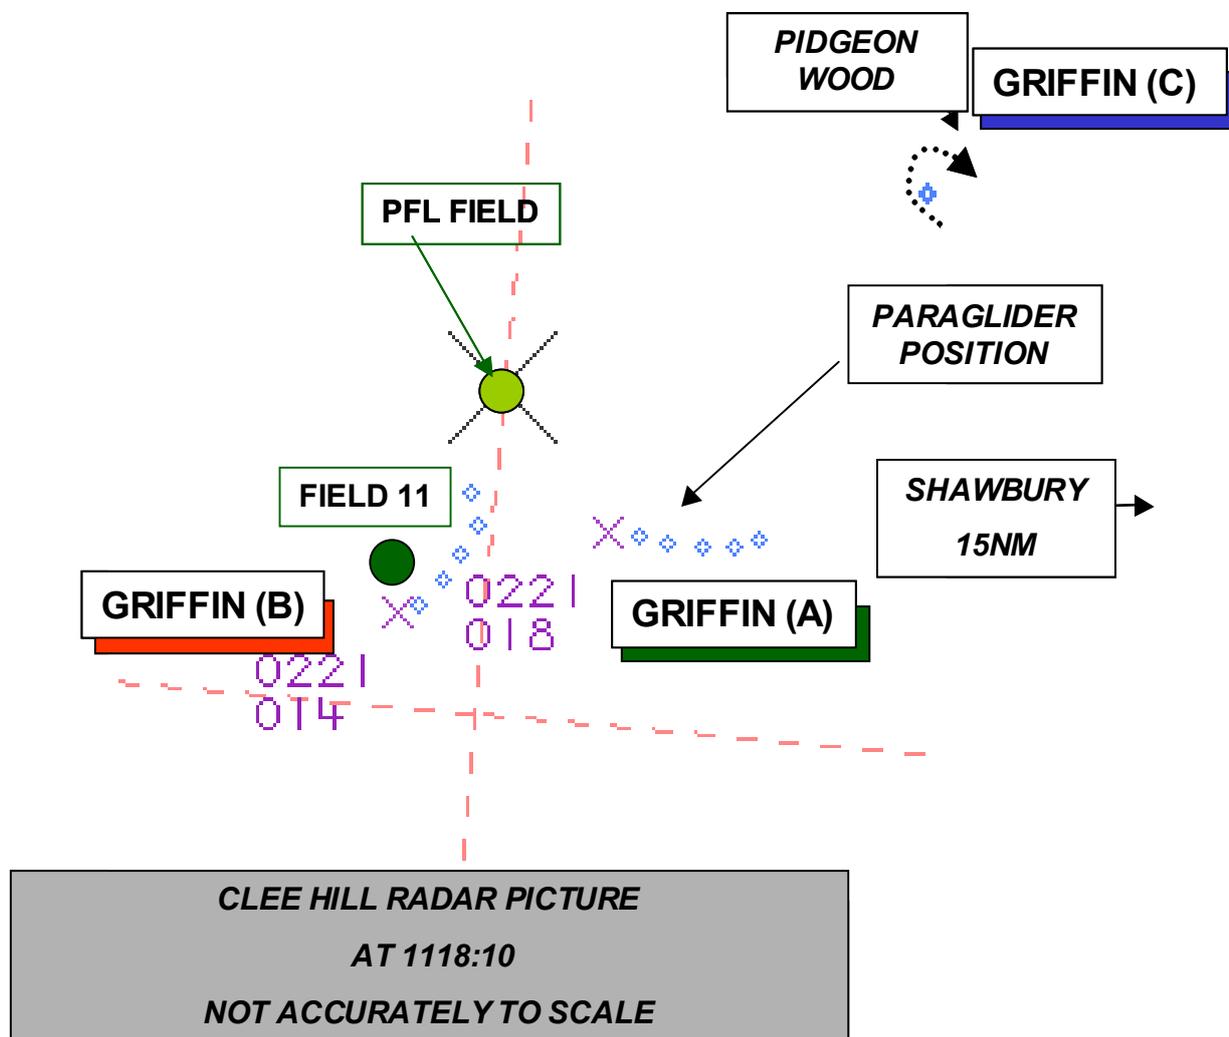
Diagram 2.

UKAB Note (3): Both ac were operating on the Barnsley RPS of 1015. The weather was hazy but otherwise good with a wind of 080/05.
