UK AIRPROX BOARD

Analysis of Airprox in UK Airspace

Report Number 21
July 2008 – December 2008

Twenty-First Report by the UK Airprox Board:

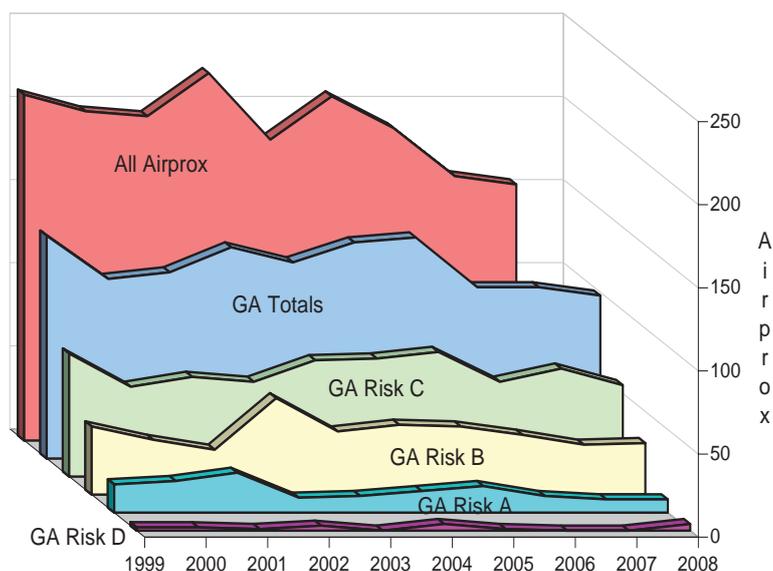
Figure 6: GA Risk distribution 1999 - 2008

Figure 6 shows the Risk distribution for those Airprox in which at least one aircraft was categorised as GA. More often than not flying outside controlled airspace; in aircraft from the size of microlights through to sophisticated aeroplanes and helicopters; piloted by student pilots through to the very experienced professional, this range of activities and experience levels makes it unsurprising that the largest proportion of Airprox in UK airspace involve GA pilots. As Figure 6 illustrates, over the last three years the 'All Airprox' trend is essentially flat as indeed are the figures for Airprox having a GA involvement which now hover around 100 Airprox per annum. In 2008, approximately 40% of the total number of Airprox involving at least one GA aircraft were Risk Bearing, the same as the average figure for the prior nine years.

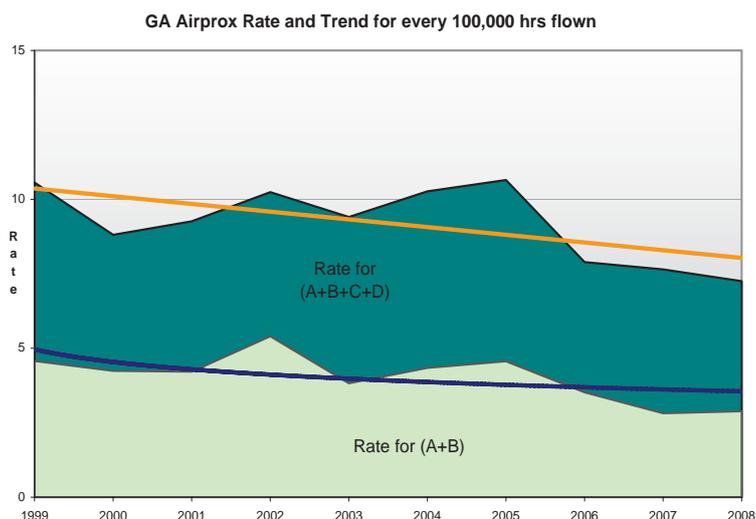
Figure 7: GA Risk rates 1999 - 2008

The chart at Figure 7 and Table 6 give more information regarding GA Airprox, this time from the perspective of rates rather than absolute numbers. The current 'best estimate' of GA hours flown in 2008 is 1,351,000 hours (but see Note 2, in **Notes regarding the calculation of rates of occurrence** on page 5 above). Using this and the numbers of Airprox in Table 5, rates have been calculated both for risk bearing (i.e. Risk A plus Risk B) and for all GA Airprox. Trend lines have been added from which it can be seen that the 10-year trend in rate per 100k hours flown is sloping gently downwards - by visual inspection, more so since year 2002 - for the two groups of events.

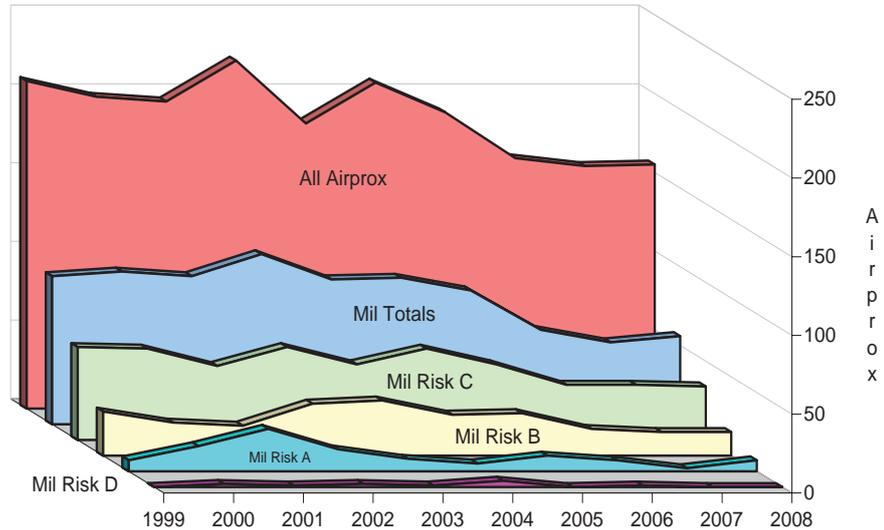
Figure 8: Military Risk distribution 1999 - 2008

Figure 8 below (and Table 8, on which the Figure is based) shows the number of Airprox involving at least one Military aircraft by Risk category. The figure of seven for Risk Cat A events in 2008, a jump from the corresponding figure in 2007, is nevertheless below the average (of 11) for the period 1999~2007. In other respects, numbers of events in 2008 are much as in 2007.

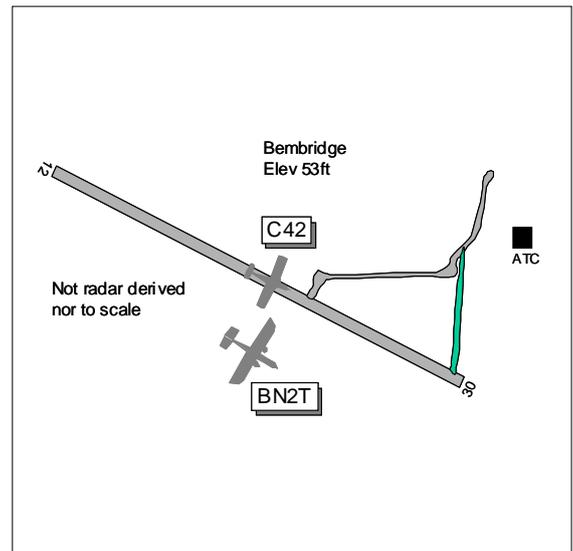
Date/Time: 1 Jul 1415
Position: 5041N 00106W (O/H RW12 Bembridge
 -elev 53ft)
Airspace: ATZ (Class: G)
Reporting Ac Reported Ac
Type: C42 Ikarus BN2T Defender
Operator: Civ Trg Civ Pte
Alt/FL: 100ft↑ ↑
 (QFE) (QFE)
Weather VMC CLBC VMC Haze
Visibility: >20km >10km
Reported Separation:
 50ft 500ft V/1000m H
Recorded Separation:
 NR

Cause: Sighting report.

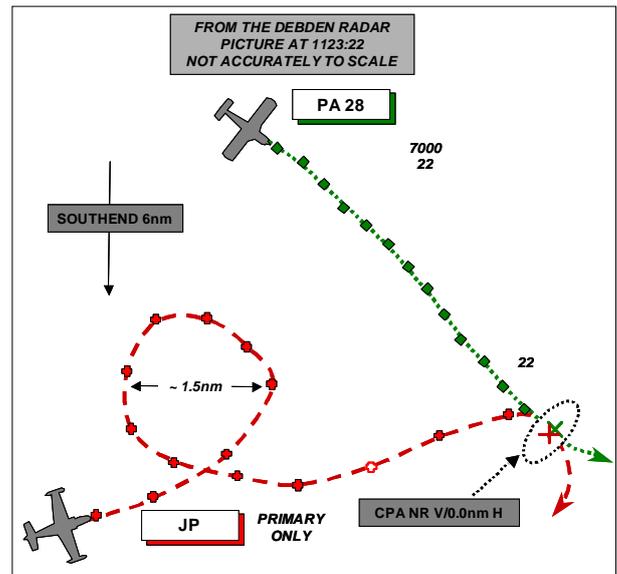
Date/Time: 12 Jul 1123 (Saturday)
Position: 5140N 00042E (5nm N Southend
 - elev 203ft)
Airspace: London FIR (Class: G)
Reporting Ac Reported Ac
Type: PA28 Jet Provost
Operator: Civ Pte Civ Trg
Alt/FL: 2000ft NR
 (1008 QNH) (N/K)
Weather VMC NR VMC NR
Visibility: 30km NR
Reported Separation:
 0ft V/200m H NR
Recorded Separation:
 NR V/0nm H

Cause: A non-sighting by the Jet Provost crew compounded by late avoiding action by the PA28 pilot.

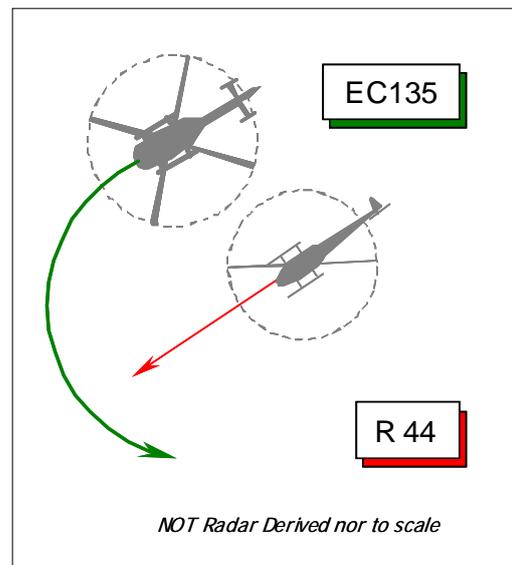
Date/Time: 19 July 0953 (Saturday)
Position: 5019N 00449W
(10nm SSE St Mawgan)
Airspace: London FIR (Class: G)
Reporting Ac Reported Ac
Type: EC135 Robinson R44
Operator: Civ Comm Civ Pte
Alt/FL: 500-600ft 900ft
agl RPS (1004mb)
Weather VMC CLBC VMC NR
Visibility: 10km+ >10km
Reported Separation:
100ft V/nil H 400ft V/1-2km H
Recorded Separation:
NR

In the Board's view the R44 pilot could have given the EC135 a wider berth when he first saw it and concluded that the cause of this Airprox was that the R44 pilot's chosen flight path caused the EC135 pilot concern. However with the R44 pilot visual with the EC135 throughout and able to afford wider separation if need be then the Members agreed unanimously that no risk of a collision had existed in these circumstances.

Cause: The R44 pilot's chosen flight path caused the EC135 pilot concern.

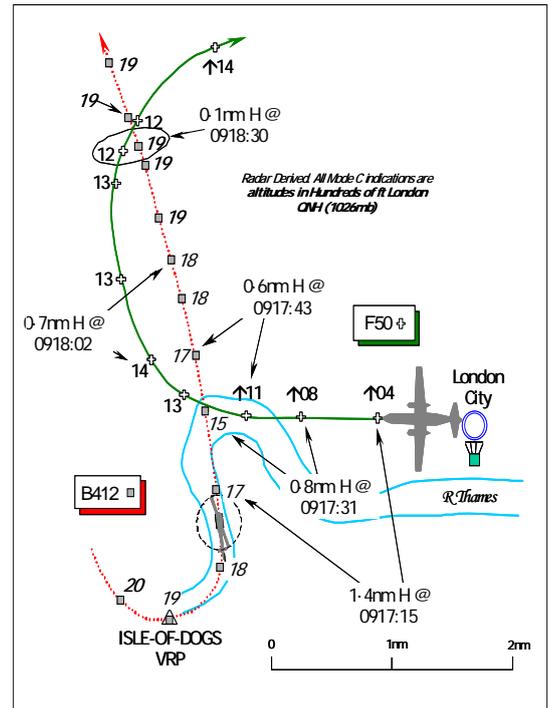
400ft Min V @ 0.7nm H
Nil H - 700ft V

Cause: Having passed the Isle of Dogs VRP, the B412 Griffin crew did not comply with TOWER's instruction to pass behind the Fokker 50 and flew into conflict with it.

Safety Recommendation: In concert with the MoD, the CAA should, for the benefit of controllers and pilots alike, review references to the term 'clearance limit' in MATS Pt 1; CAP413 and the applicable JSPs to ensure consistency both of meaning and usage of this RT phraseology.

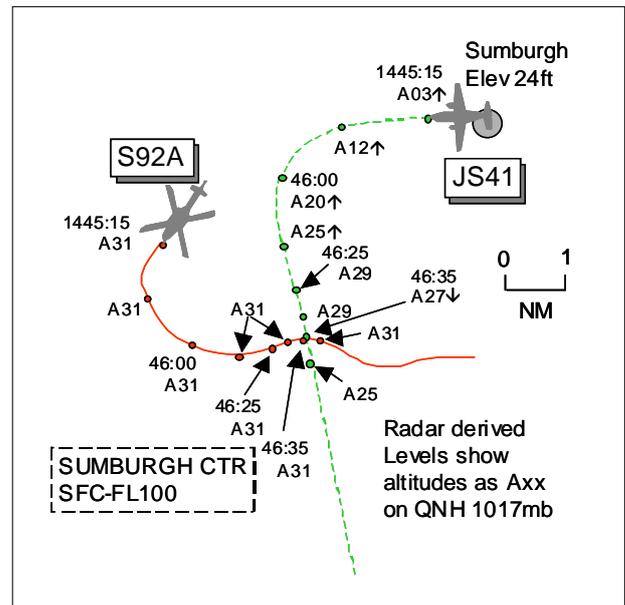
Date/Time: 22 Jul 1446
Position: 5949N 00123W (4.5nm SW Sumburgh
 - elev 24ft)
Airspace: CTR (Class: D)
Reporter: Sumburgh Radar Controller
First Ac Second Ac
Type: JS41 S92A
Operator: CAT Civ Trg
Alt/FL: 3000ft↑ 3100ft
 (QNH 1022mb) (QNH)
Weather VMC CLAC VMC CLAC
Visibility: 10km >10km
Reported Separation:
 800ft V/0.5nm H 500ft V/0.5nm H
Recorded Separation:
 >400ft V/Nil H

Cause: Sumburgh Radar Controller released the JS41 into conflict with the S92A.
