UK AIRPROX BOARD

Analysis of Airprox in UK Airspace

**Report Number 17
July 2006 – December 2006**

Seventeenth Report by the UK Airprox Board:

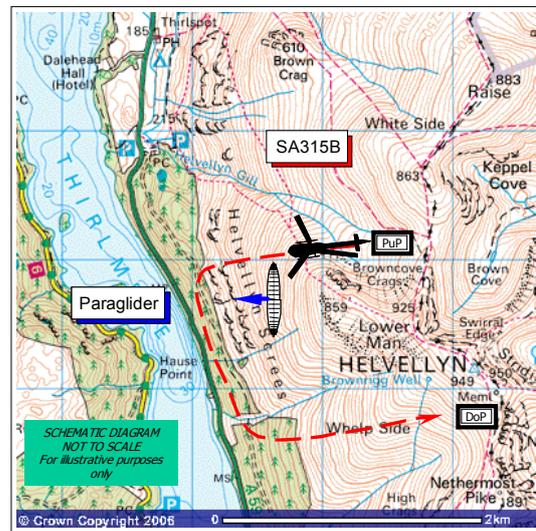
Date/Time: 6 Jun 1245
Position: Vicinity of 5432N 00302W (Helvellyn
 Screes Cumbria)
Airspace: London FIR (Class: G)
Reporting Ac Reported Ac
Type: Paraglider Lama SA315B
Operator: Civ Pte Civ Comm
Alt/FL: ~600m 300ft
 (amsl) (agl)
Weather VMC CLBC VMC NK
Visibility: ~40nm >10km
Reported Separation:
 Nil V/100m H nil V/100m H
Recorded Separation:
 Not recorded

Cause: The Paraglider pilot entered the area of the SA315B pilot's operations and was subsequently concerned by the helicopter's proximity.

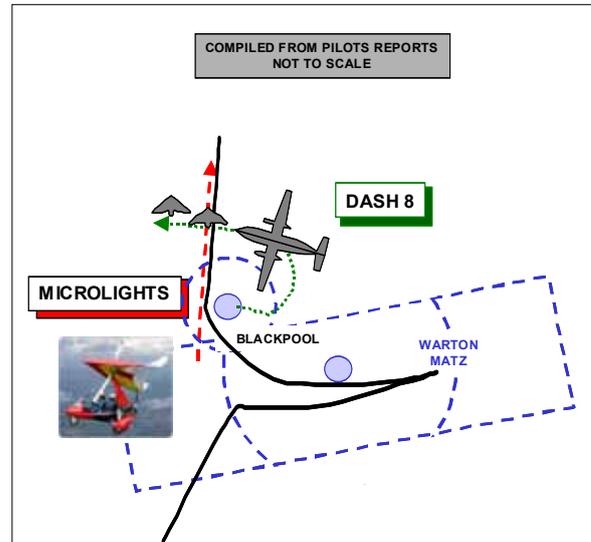
Date/Time: 2 Jul 1040 (Sunday)
Position: 5348 00306W (4nm NW Blackpool)
Airspace: London FIR (Class: G)
Reporting Ac Reported Ac
Type: DHC-8 Microlight
 GT450
Operator: CAT Civ Trg
Alt/FL: 3500ft↑ 4000ft
 (QNH 1019mb) (QFE NR)
Weather: VMC HAZE VMC HAZE
Visibility: 7km 6nm
Reported Separation:
 500ft V/½nm H 200ft V/600m H
Recorded Separation:
 NR

Cause: Sighting Report.
