**UK AIRPROX BOARD**

# **Analysis of Airprox in UK Airspace**

**Report Number 16  
January 2006 – June 2006**

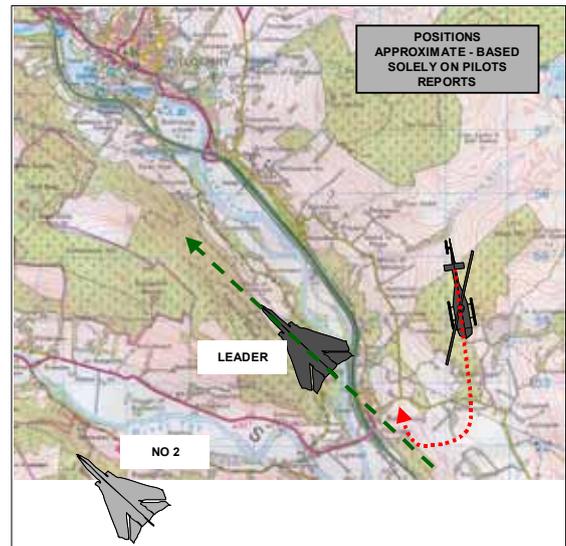
Date/Time: 4 Jan 1358  
Position: 5640N 00340W (4nm SE Pitlochry  
 - elev ~400ft)  
Airspace: UKDLFS/Scot FIR (Class: G)  
Reporting Ac Reported Ac  
Type: Tornado GR4 Bell 206 JetRanger  
Operator: HQ STC Civ Pte  
Alt/FL: 605ft (Rad Alt) 400ft agl  
 (RPS 1018 mb) (NR)  
Weather: VMC CLOC VMC CAVOK  
Visibility: 25km unltd  
Reported Separation:  
 100ft V/200ft H NR  
Recorded Separation:  
 NR

Members noted that the relative positions of the ac involved were only approximate since the pilots' reports could not be confirmed from the radar recording. Members were unanimous, however, in their view that in the circumstances it would have been very difficult for the respective pilots each to see the other ac. The JetRanger was below the horizon, at least in the final stages of the approach, and was of a very similar colour to the forested background with little relative motion. Members also agreed with the helicopter pilot's view that while he was on a heading which would have allowed him to see the Tornados they would have been too far away. After his turn(s) the Tornados would have been behind him and his attention was then on locating the landing site and manoeuvring for an into-wind landing.

The Board considered whether the cause of this incident had been a sighting issue or was simply a conflict in the FIR, Members concluding that none of the pilots involved could have reasonably expected to see the opposing ac any earlier than they did. That being the case, although the cause of the incident was a conflict in the UKDLFS/FIR, since the ac had passed before any action had taken effect, safety had not been assured.

Cause: Conflict in the UKDLFS/FIR.

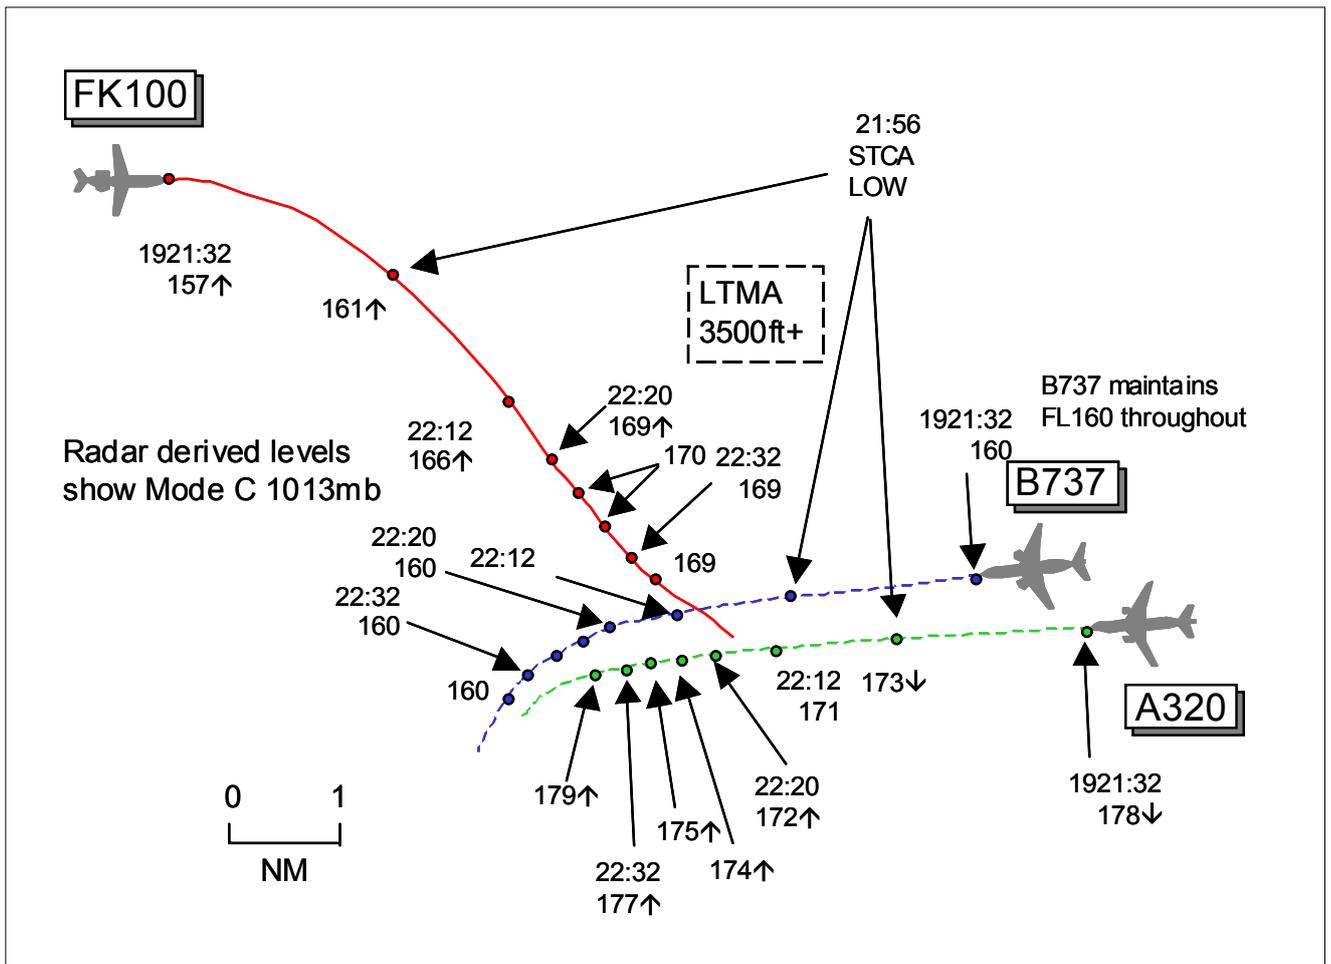
## AIRPROX REPORT No 002/06

FK100 v B737 1000ft V/1.25nm H; FK100 v A320 800ft V/1nm H

**THE LTCC LAM SC** reports that the B737 and A320 were inbound to LAM and the Coordinator had arranged for the next LAM inbound to arrive at FL190 as NE Deps were climbing the FK100 to FL180 and avoiding his other LAM traffic. He observed the FK100, as it was climbing through FL160, to turn towards the B737 and A320. He gave avoiding action to the B737 flight that took it followed by avoiding action to the A320 flight that advised him of a TCAS climb.

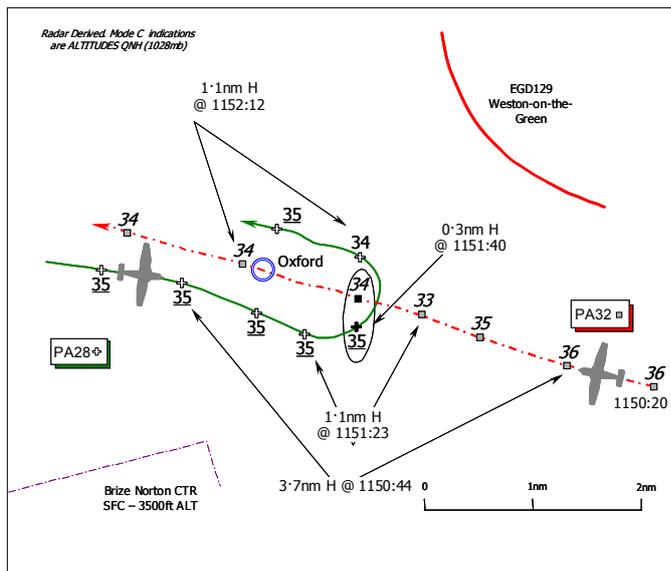
Date/Time: 21 Jan 1151 (Saturday)  
Position: 5149N 00119W (Overhead Oxford Kidlington - elev 270ft)  
Airspace: Oxford AIAA (Class: G)  
Reporting Ac Reported Ac  
Type: PA28 PA32  
Operator: Civ Trg Civ Pte  
Alt/FL: 3500ft 3400ft  
(QNH) (QNH)  
Weather: VMC CLOC VMC CLOC  
Visibility: 10km 10km  
Reported Separation:  
50ft Not seen  
Recorded Separation:  
100ft V/O-3nm H

Cause: Non-sighting by both pilots.
