UK AIRPROX BOARD

Analysis of Airprox in UK Airspace

**Report Number 22
January 2009 - June 2009**

Twenty Second Report by the UK Airprox Board:

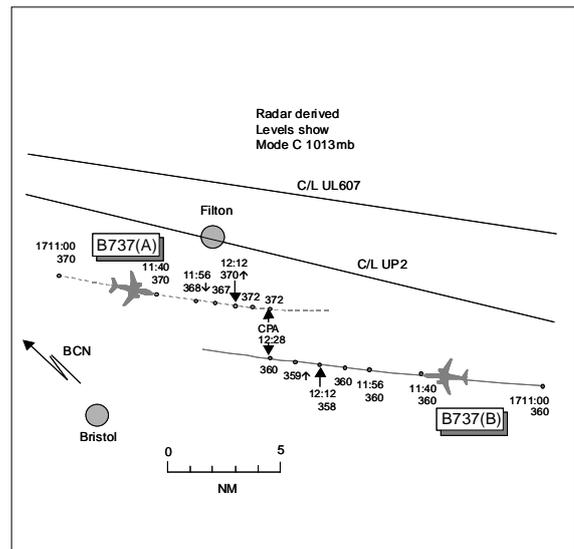
Weather IMC CLBL VMC NR
Visibility: 5000m NR
Reported Separation:
500ft V/NR H 800ft V/NR H
Recorded Separation:
1200ft V/2.3nm H

Although the NUMPO fpps for B737(A) was missing, the oncoming S35T could see the E'bound B737(A) on radar at FL370 and was aware of its previously-issued descent clearance as given by the off-going controller when he transferred the flight to S5. B737(B) at FL360 was still not within S35T's displayed range. One ATCO Member opined that immediately prior to this action, the S35T had visibility of both W'bound ac's fpps which could have reminded him of the potential conflict. However, the Airprox occurred about 10mins after the initial descent clearance had been issued by the off-going S35T and 6min after the flight was transferred to S5 when B737(B)'s exact position was unknown. Members agreed that as the S35 team were responsible for separating the subject ac. By allowing B737(A) to 'descend when ready', the ac was placed into conflict with B737(B) and this had caused the Airprox.

Cause: The S35 team descended B737(A) into conflict with B737(B).

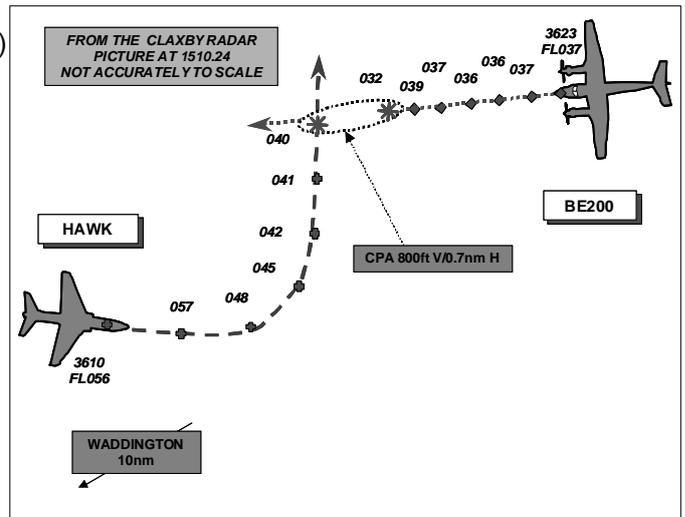
Date/Time: 22 January 1510
Position: 5313N 00014W (10nm ENE Waddington)
Airspace: London FIR (Class: G)
Reporting Ac Reported Ac
Type: BE200 Hawk T1A
Operator: HQ Air (Trg) MOD ATEC
Alt/FL: 2500ft NR
 (QFE 973mb) (N/K)
Weather VMC CLAC NR
Visibility: 6km NR
Reported Separation:
 200ft V/500m H Not seen
Recorded Separation:
 800ft V[by interpolation]/0.7nm 1300m)H

The analysis showed that both simulations for this encounter indicated the BE200 was issued with an 'upward sense' RA before a downward sense RA as the conflict deteriorated in a very short time (~10 sec). The simulation based on the Claxby single source radar [nearest to the incident position] indicated that the ac began its descent before a downward sense advisory was issued. However, this was in contrast to the Clee Hill simulation which indicated that the descent of the Beech occurred after the 'Descend' RA was issued.

HQ AIR (TRG) comments that the 500ft coordination plan between the King Air and Hawk seemed reasonable but it did not leave much room for error. Consequently, the small altitude difference between the ac and the Hawk's downward flight vector as it turned across the King Air's flight path caused the King Air's TCAS to react.

Cause: The TCAS profile flown by the BE200 pilot against the descending Hawk resulted in a loss of stipulated separation.

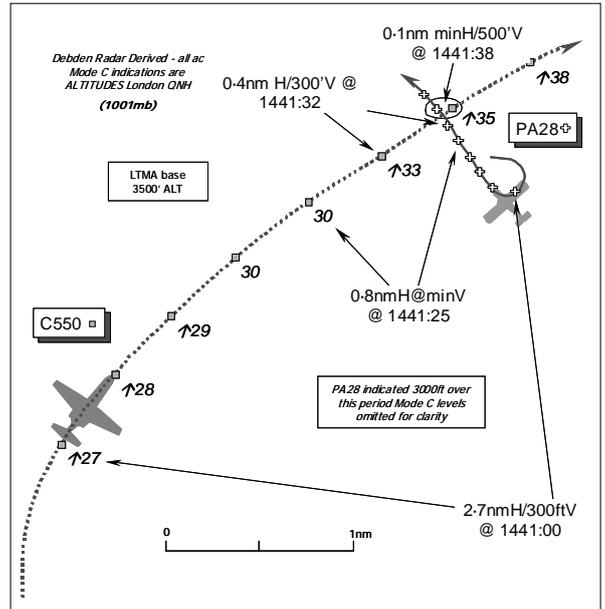
Date/Time: 26 January 1441
Position: 5138N 00031E (7½nm NW of Southend - elev 49ft)
Airspace: London FIR (Class: G)
Reporting Ac Reported Ac
Type: Citation II C550 PA28
Operator: Civ Comm Civ Trg
Alt/FL: 3400ft 3000ft
 QNH (1001mb) QNH (1001mb)
Weather VMC CLAC VMC CLOC
Visibility: 10km+ 20nm+
Reported Separation:
 Nil V/0.1nm H Not seen
Recorded Separation:
 Nil V @ 0.8nm H
 0.1nm Min H @ 500ft V

It was evident from the flying instructor's frank account that neither he as the tutor in the PA28 nor any of his student instructor colleagues had observed the C550 at all as it closed from their port side and climbed above them. It was plain from the radar recording that the C550 had approached to the left of the PA28 and with the tutor seated on that side a very experienced GA pilot Member wondered if the tutor had been focused on an important teaching point to the 'instructors under training' at the time. For whatever reason, it was clear that the three pilots in the PA28 remained unsighted throughout and this non-sighting by the PA28 crew was, in the Board's view, part of the cause.

Cause: A non-sighting by the PA28 crew and a late sighting by the C550 crew.

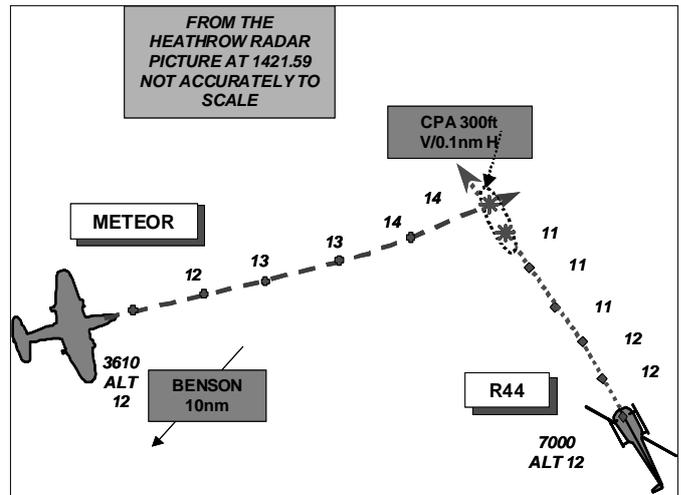
Date/Time: 29 January 1422
Position: 5143N 00055W (7nm NW Wycombe Air Park)
Airspace: London FIR (Class: G)
Reporting Ac Reported Ac
Type: Robinson R44 Meteor
Operator: Civ Pte MOD ATEC
Alt/FL: 1100ft 1000ft
 (QNH 1015mb) (Benson QFE 1007 Benson 226ft amsl)
Weather VMC CAVOK VMC CAVOK
Visibility: NR NR
Reported Separation:
 NR NR
Recorded Separation:
 300ft V/0.1nm H

The Board noted that the Meteor pilot was in receipt of a RIS from Benson to assist him with his responsibility to see and avoid other ac in the Class G airspace in which he was conducting his test flight. The R44 pilot was on a short transit flight from Wycombe, also through Class G airspace, and a LARS would most likely not have been available to him due to his position and altitude. Members also observed that in the circumstances of the incident, under the Rules of the Air (Rule 9 (3)) the Meteor should have given way to the R44. That however is dependent on the Meteor pilot seeing the R44 and in this case, despite accurate TI, he had not: Members therefore discussed possible reasons for this non-sighting. The R44 is a small ac and can therefore be difficult to acquire visually, particularly when - as in this case - it was shown by the radar recording to be on a line of constant bearing with almost no relative motion. Further, the R44 may have been obscured to the Meteor pilot who was preparing his ac for the trial, being about to turn back inbound to Chalgrove for his test run: the R44 may have been below the Meteor's wing or behind the starboard engine nacelle.

Cause: A non-sighting by the Meteor pilot and a late sighting by the R44 pilot.

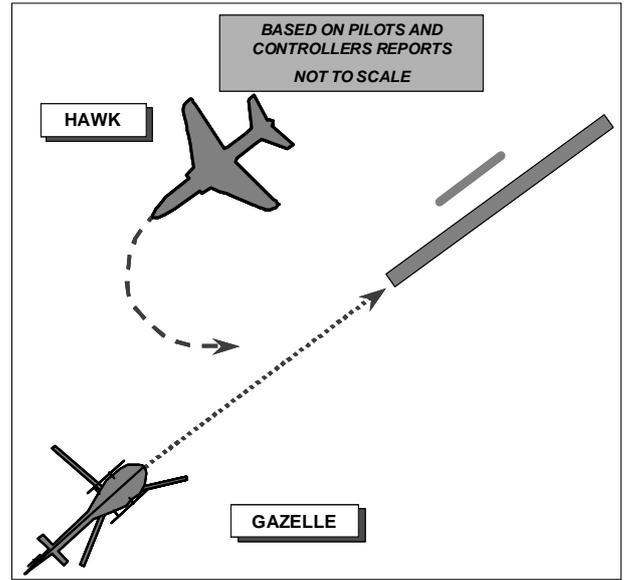
Date/Time: 13 February 1202
Position: 5108N 00148W (Boscombe Down - elev 407ft)
Airspace: Boscombe MATZ (Class: G)
Reporting Ac Reported Ac
Type: Gazelle Hawk
Operator: ATEC ATEC
Alt/FL: 500ft 300-500ft
(QFE) (QNH)
Weather VMC CLBC VMC NR
Visibility: 10km NR
Reported Separation:
50ft V/50m H NR
Recorded Separation:
NR

THE GAZELLE PILOT reports flying a local instrument training flight from Boscombe Down. On recovery while conducting a PAR to RW05 and having broken cloud at 4nm from touchdown, he saw a Hawk ac turning in front of them to land. The safety pilot considered that this could result in the PAR being discontinued and this proved correct as ATC confirmed that they were VMC and then instructed them to “break off approach” and contact Boscombe TWR. After the frequency change the handling pilot in the right seat established comms and the ac commander in the left seat asked if their approach had been broken off for fixed wing traffic. At that moment a second Hawk ac was seen close to their left and descending through the level of their ac, turning onto finals for RW05. When first seen, the second Hawk was 50ft above them, descending through their level with slight overtake and 75m ahead. The handling pilot took immediate avoiding action to the right and the ac commander subsequently asked ATC to mark the tape and inform the Supervisor of his intent to file an Airprox report. He assessed the risk as being high.

Cause: In a busy and complex traffic situation, the Hawk pilot turned into conflict with the Gazelle which he did not see.

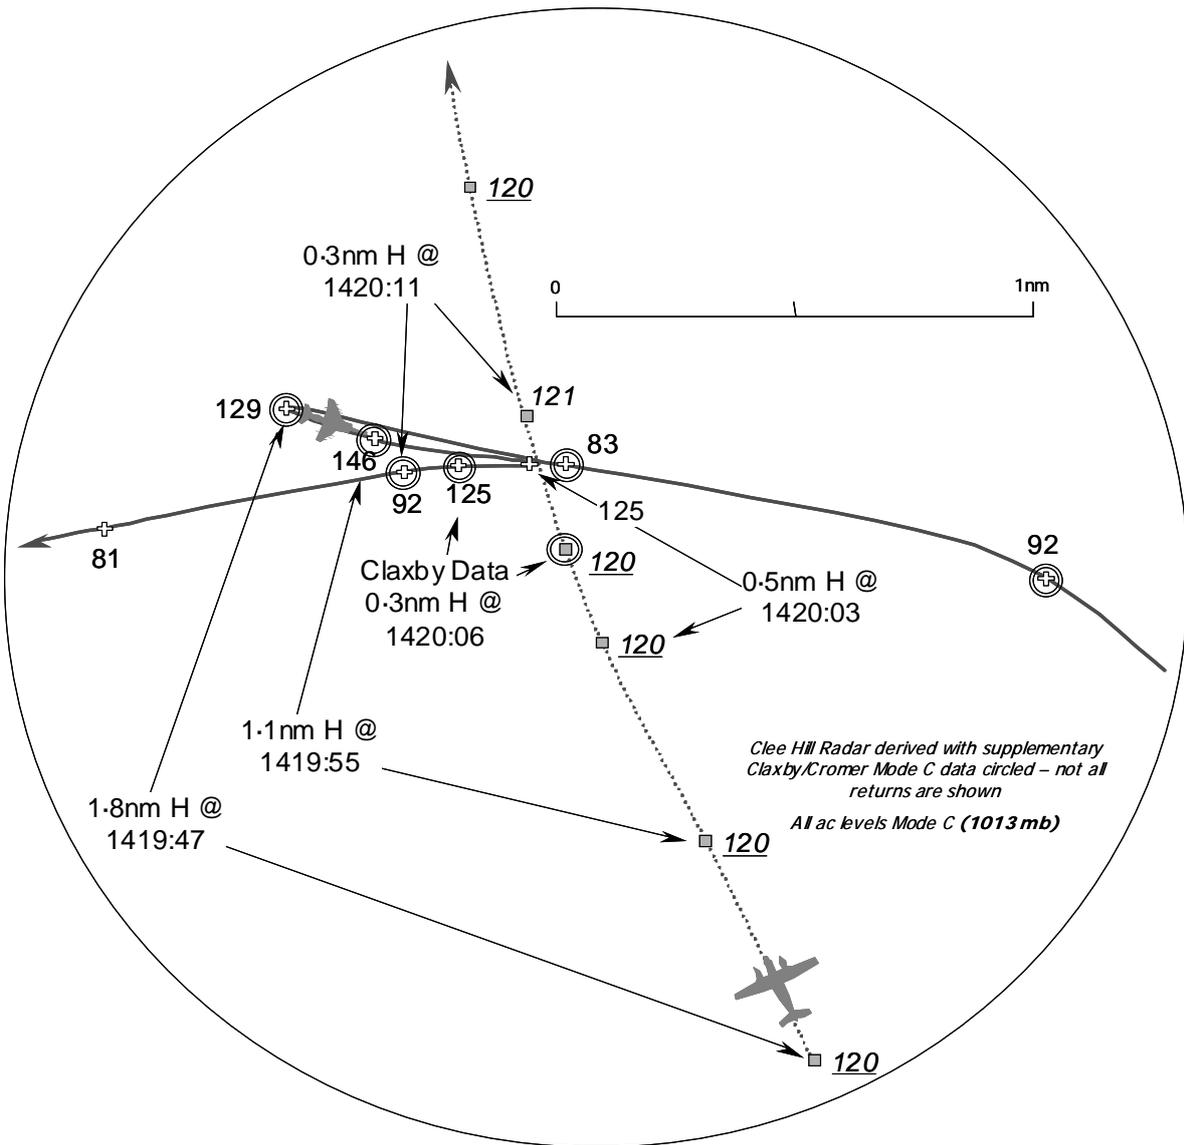
The controller's workload at the time of the incident was higher than recommended (4 tracks on 3 frequencies and one free-calling on a fourth frequency). The Unit Order Book (UOB) states that when CON15 is operating as an ALLOCATOR, further consoles are to be opened when the controller has 2 ac under control. Usually, another console would already have been opened and/or traffic offloaded at an earlier stage than in this instance (other controllers were available) but the controller believed that the BE200 and the other flight would be off frequency before the pre-noted Harrier called. The higher than normal workload could have been a factor in the controller not updating the traffic information for both the Harrier and the BE200 but further traffic information in the time available would not have prevented the Airprox. As a result of this incident both CON15 and the SUPERVISOR have been re-briefed on the requirement to adhere to the UOB with regard to opening further consoles at an early stage to allow for unexpected increases in workload.

UKAB Note (1): The recording of the Clee Hill Radar shows the BE200 at 1419:07, after the R turn tracking NNW'ly level at FL120, after the Harrier GR7 had originally crossed from L-R 1.5nm ahead some 2000ft below the twin turbo-prop at FL100. The Harrier then turned L about and the jet's Mode C is lost in the turn through N as it apparently commences an aerobatic manoeuvre. Because of the absence of consistent displayed Mode C data on the Clee Hill recording thereafter, the data from several other sources was reviewed, including the Claxby, Cromer, Great Dun Fell, Stansted 10cm and Heathrow heads in an attempt to discover the jet's profile. The recorded video gave only intermittent data so the radar head plot list data of the Claxby and Cromer Radars was helpfully provided by NATS Ltd through the RAC. Whilst it was not clear which specific radar selection was in use by CON15 at the time, it was evident that whilst the Harrier was manoeuvring, a significant amount of Mode C data had apparently been suppressed by the individual radar data processing system and not displayed on the recording because it was perceived to be "invalid". At face value, the plot data appeared broadly consistent when compared across the two radar sources, given that the individual radar scans would have occurred at different times. The Board was briefed that following the investigation of Airprox 17/06 and the subsequent response to the associated Safety Recommendation, it had been revealed that there was indeed a technical limiting factor to the display of Mode C data derived from ac conducting vigorous manoeuvres. In general terms, it was explained that Mode C plots are declared "invalid" at the 'head' if successive scans vary by more than 1000ft from scan to scan and consequently are not displayed – the controller seeing a line of three dashes in place of the numeric
