ASSESSMENT SUMMARY SHEET FOR UKAB MEETING ON 21 APRIL 2010

AIRPROX REPORT No 2009-109

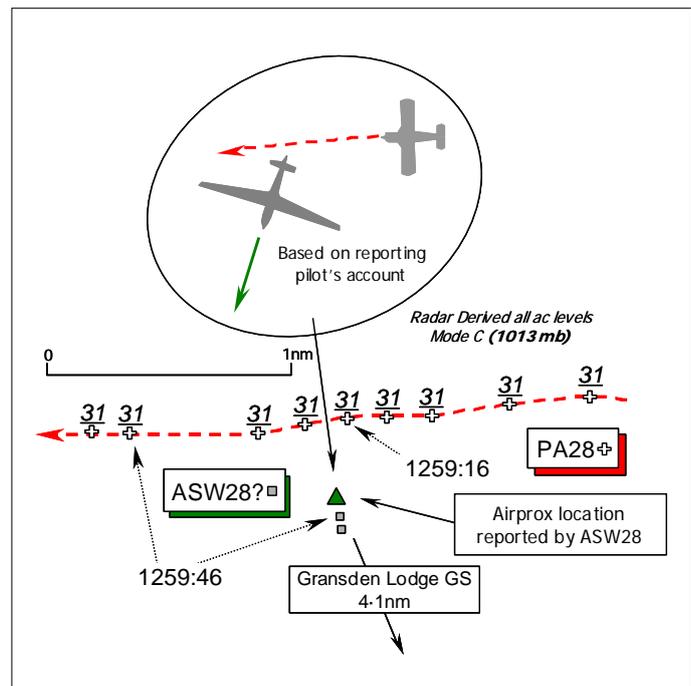
Cause: Apparent non-sighting by the PA28 pilot and effectively a non-sighting by the ASW28 pilot.

Degree of Risk: A.

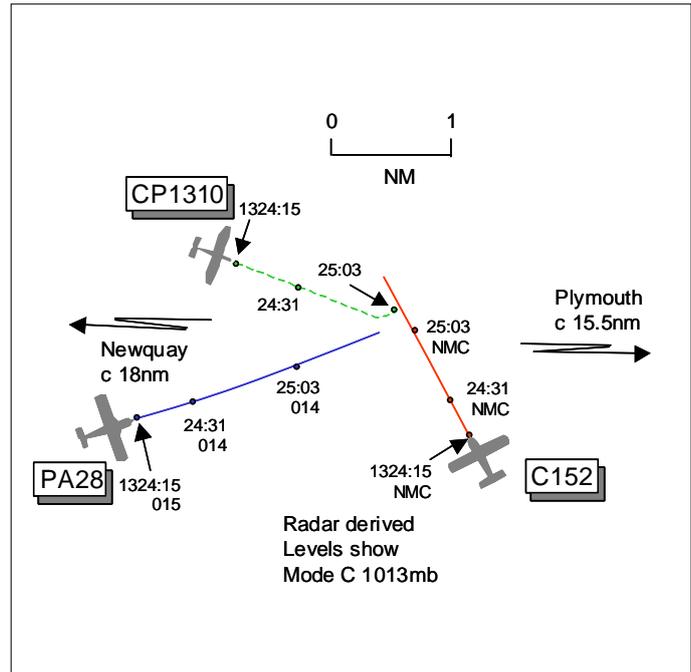
AIRPROX REPORT No 2009-111

Cause: Effectively a non-sighting by the C152 pilot and a late sighting by the Emeraude pilot.

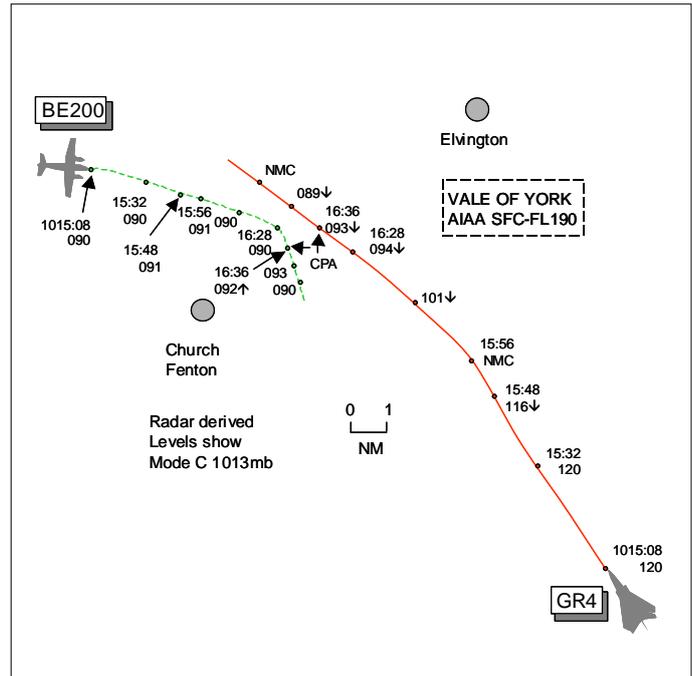
Cause: Sighting report (TCAS).

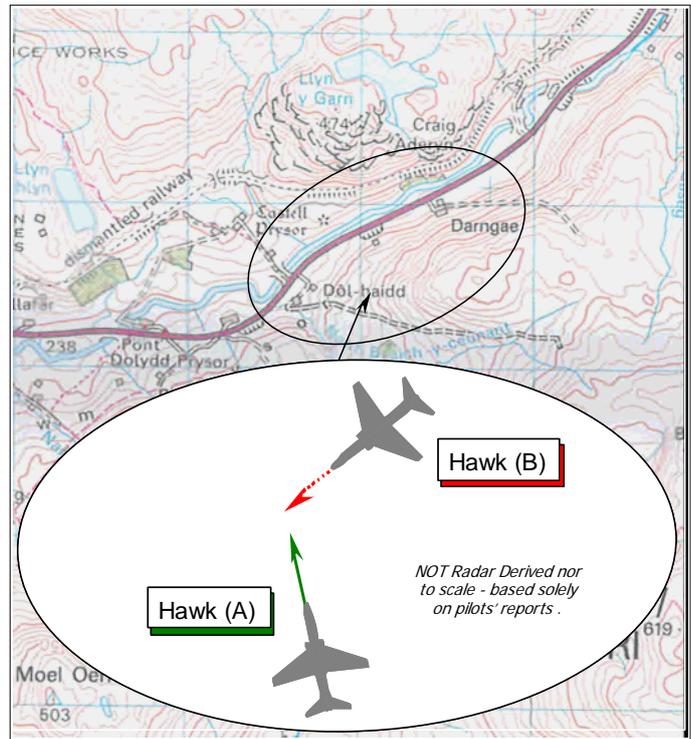
Cause: Conflict in the LFS resolved by the crew of Hawk (B).

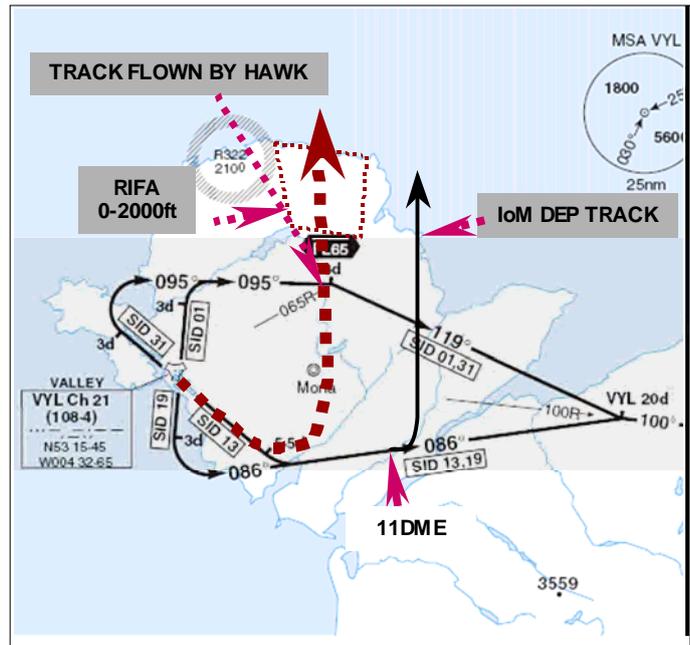
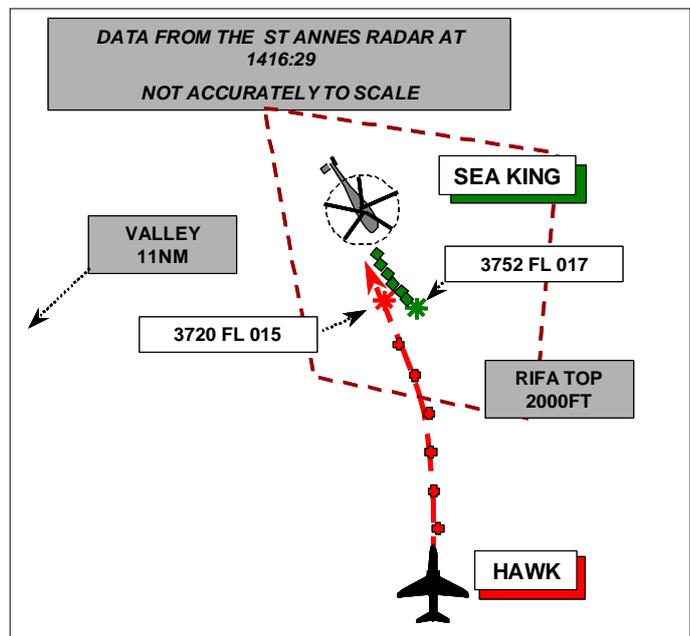
Members agreed that this incident occurred because the Hawk crew were not passed the status of the RIFA by RAF Valley ATC iaw the FOB procedure. The Board observed that the FOB requires the APP controller to pass details of the RIFA but outbound traffic does not routinely contact APP, so they would never be in a position to notify pilots of the RIFA status; however, it is understood anecdotally that this information is usually passed by APP to RAD who in turn pass it to departing traffic. Since on this occasion no information was passed to the Hawk crew, they incorrectly assumed that the area was not active and that they could transit through it. On becoming aware of the potential confliction after the Hawk turned left, the RAD Screen controller passed TI to the Hawk crew (at 4nm) that, despite them only partially hearing it due to their listening to the Ronaldsway ATIS on another frequency, enabled them to see the helicopter shortly thereafter at a distance they estimated as 2nm, and avoid it. Specialist military pilot Members agreed, however, that the Hawk crew should have afforded the Sea King greater separation, perhaps by climbing as well as avoiding it laterally; this, they thought, might have avoided the incident and alleviated the Sea King captain's concern. The Board noted that the TI passed by APP to the Sea King had been transmitted after the captain had already seen the Hawk about 1nm away, taken control from the HP and initiated a turn away from it, i.e. too late to have been effective.

<u>Cause:</u>	Having not been informed that the RIFA was active, the Hawk crew flew into conflict with the Sea King.
<u>Degree of Risk:</u>	C.
<u>Recommendation:</u>	RAF Valley procedures for the notification of the RIFA status should be reviewed.

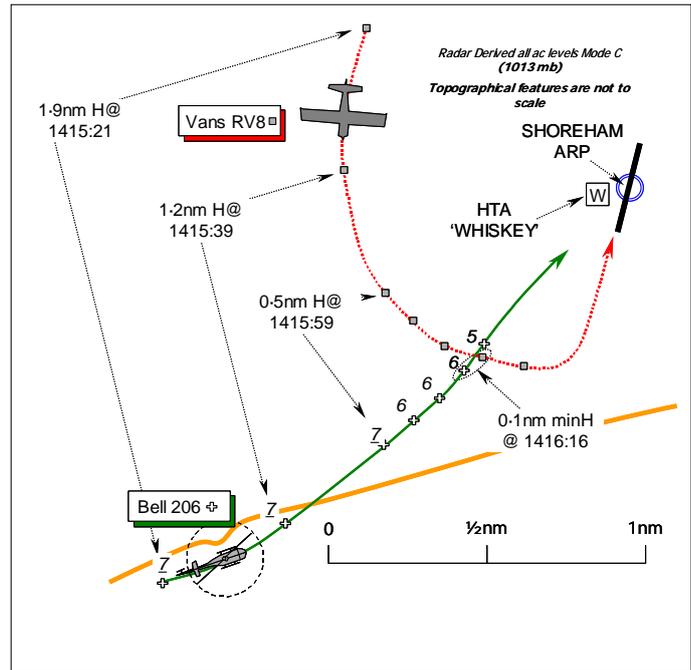
Cause: The ADC did not provide traffic information to either pilot in the ATZ.

Safety Recommendation: That the Aerodrome Operator should review the Shoreham Aerodrome AIP entry regarding helicopter operations.

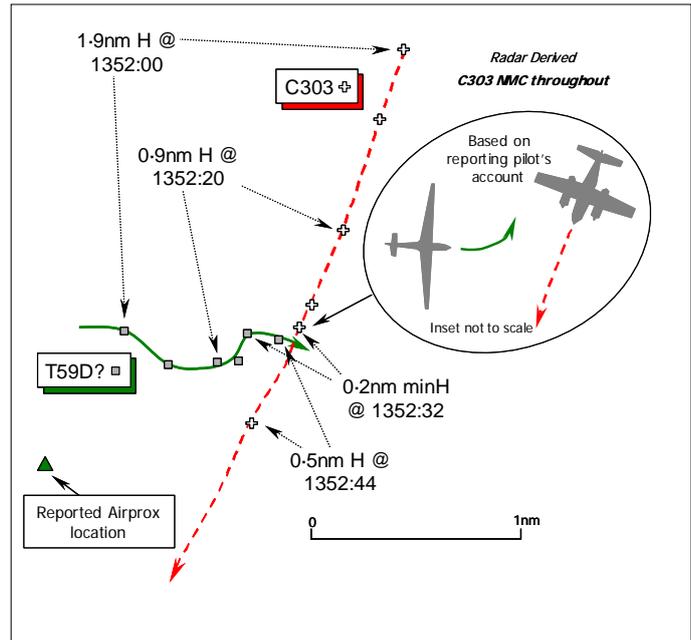
Cause: A non-sighting by the C303 pilot and late avoiding action by the T59 pilot.

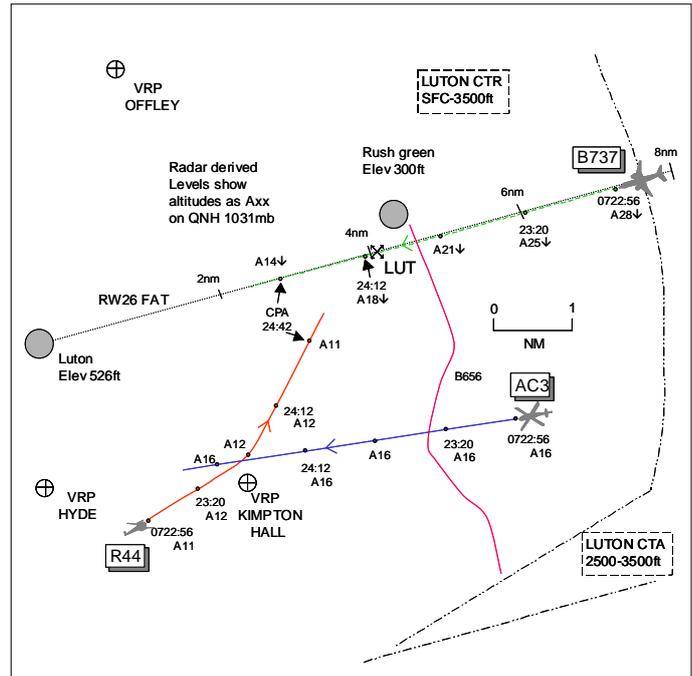
Cause: Sighting report (TCAS).

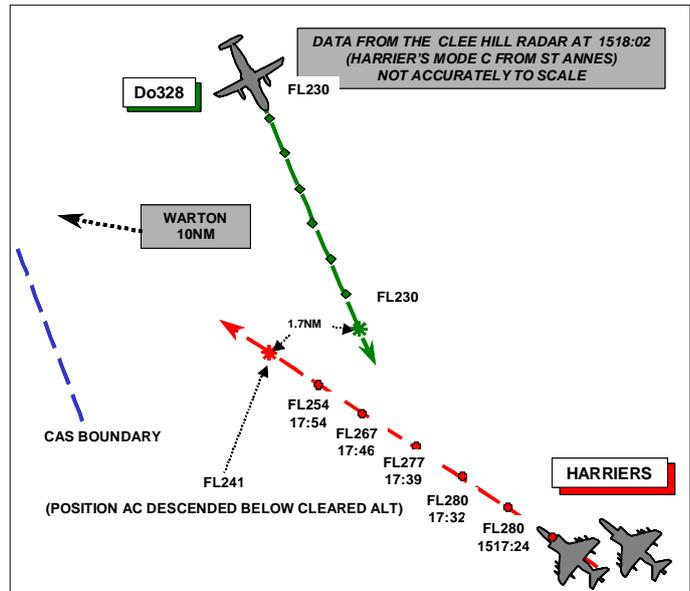
Cause: The Harrier formation descended below its cleared flight level.

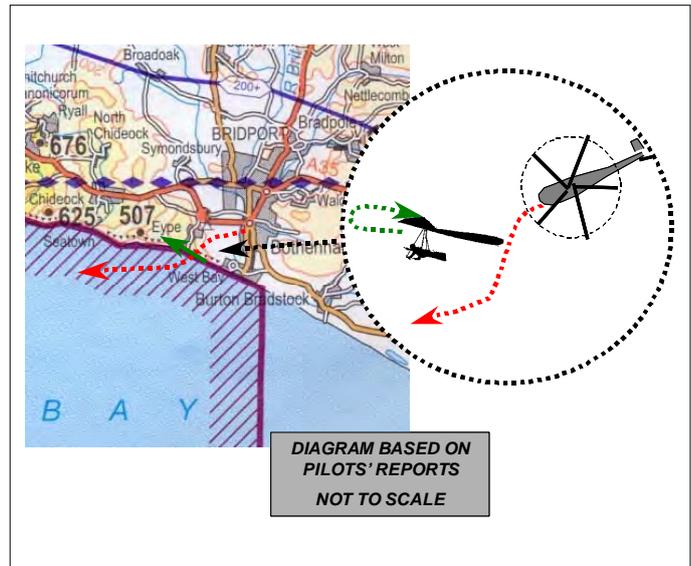
Cause: The Sea King crew flew close enough to the paraglider to cause its pilot concern.

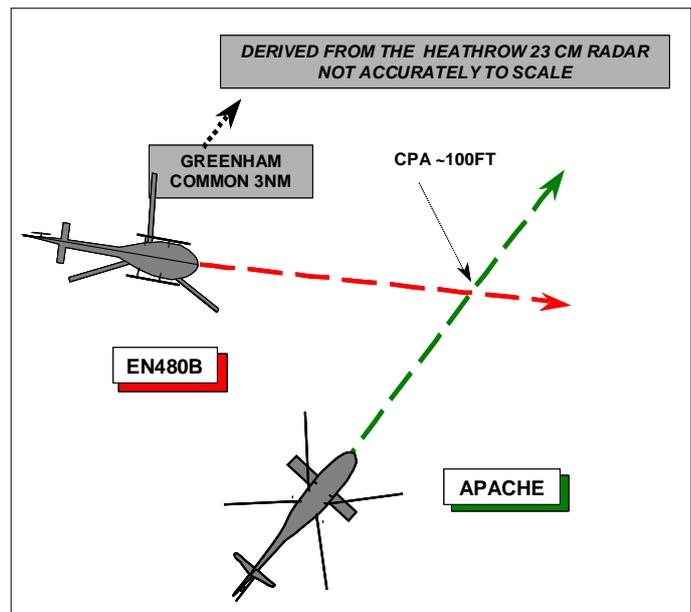
Cause: The EN480B pilot flew close enough to the Apache to cause its crew concern.

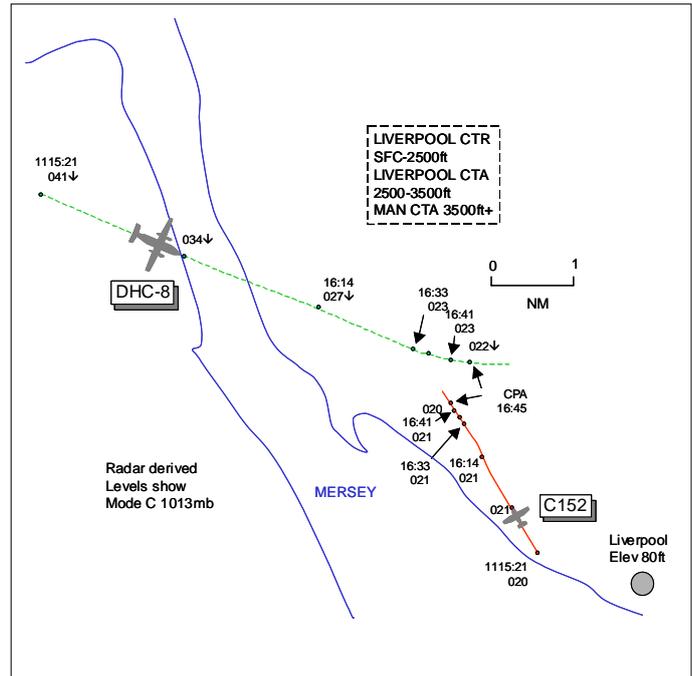
Cause: The DHC-8 crew was cleared for a visual approach without a height restriction, which resulted in a conflict with the C152.

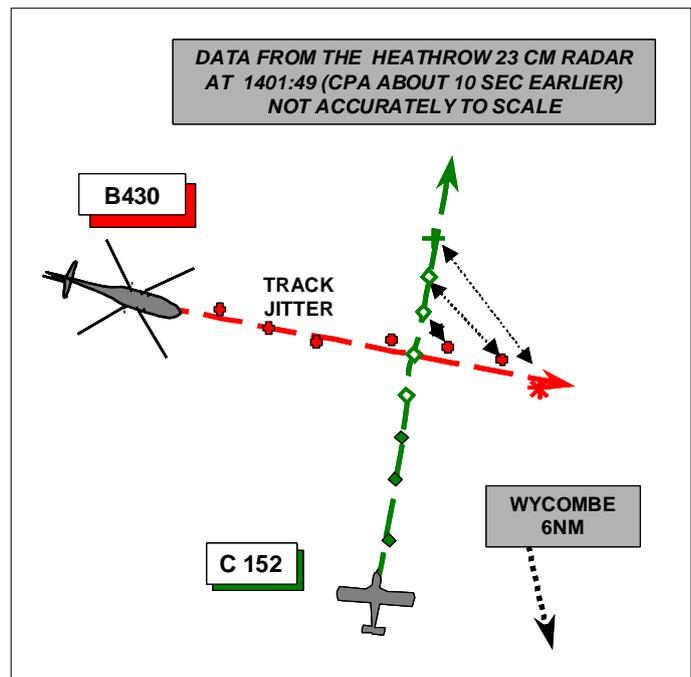
Cause: The B430 pilot flew close enough to the C152 to cause its pilot concern.

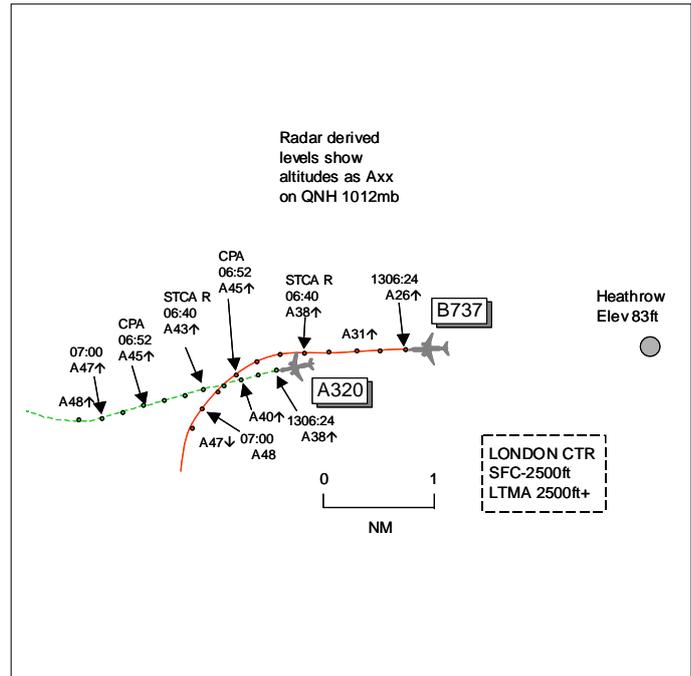
Cause: The Air N mentor did not comply with the Heathrow MATS Part 2 procedures.

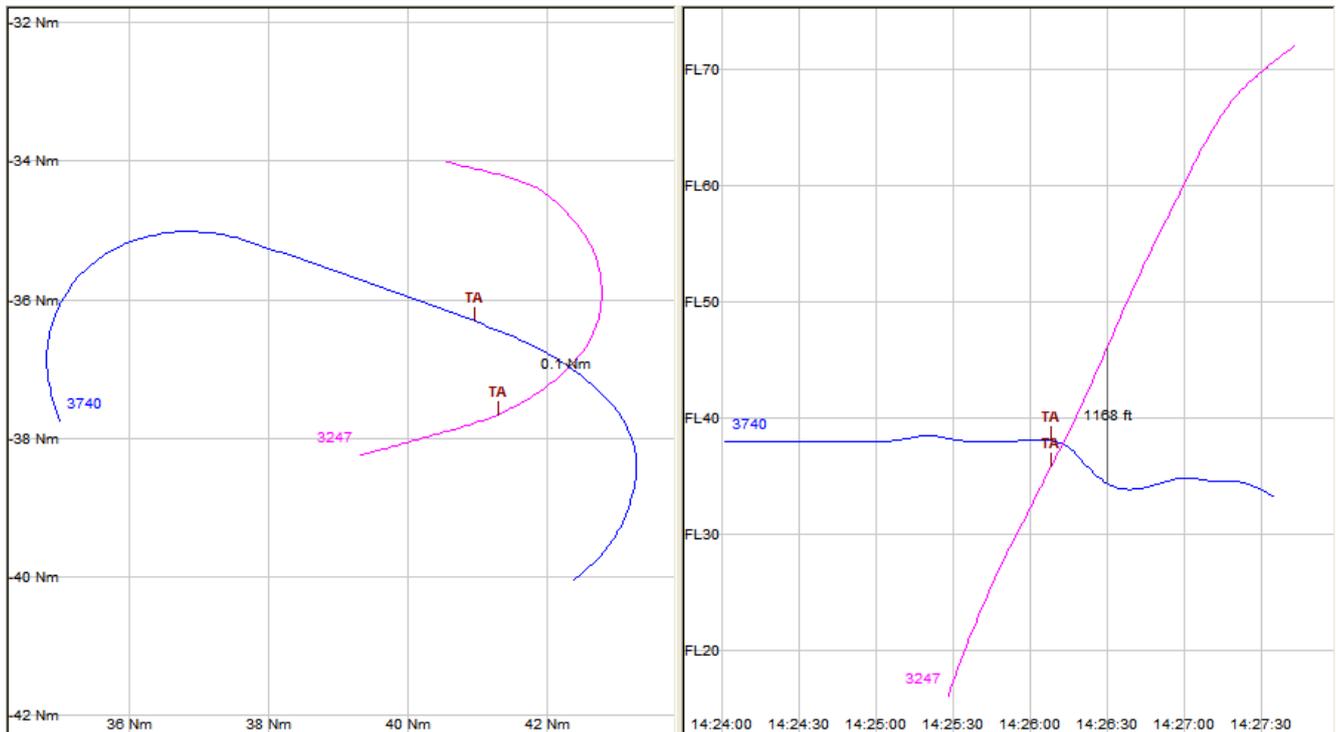
INCAS SIMULATION

The InCAS simulation based on interpolated single source radar data from the Clee Hill Radar only simulated the generation of TCAS TAs, which were received by both aircraft at 1426:08 at a range of 1.4nm. The ACAS diagnostics provided by the InCAS simulation indicates that although the 'Range Test' that would have enabled an RA was passed at 1426:14, the subsequent 'Altitude Test' showed the predicted vertical miss distance at the CPA of 881ft was greater than the threshold value of 600ft. In summary, the results of the simulation confirm and explain the TCAS warnings reported by both crews and that an RA would not be triggered in these circumstances.
