ASSESSMENT SUMMARY SHEET FOR UKAB MEETING ON 13 APR 2011**Total: 15 Risk A: 2 Risk B: 1 Risk C: 11 Risk D: 1**

AIRPROX REPORT No 2010113

Date/Time: 17 Aug 2010 1225Z

Position: 5403N 00115W
(Linton-on-Ouse – elev
53ft)

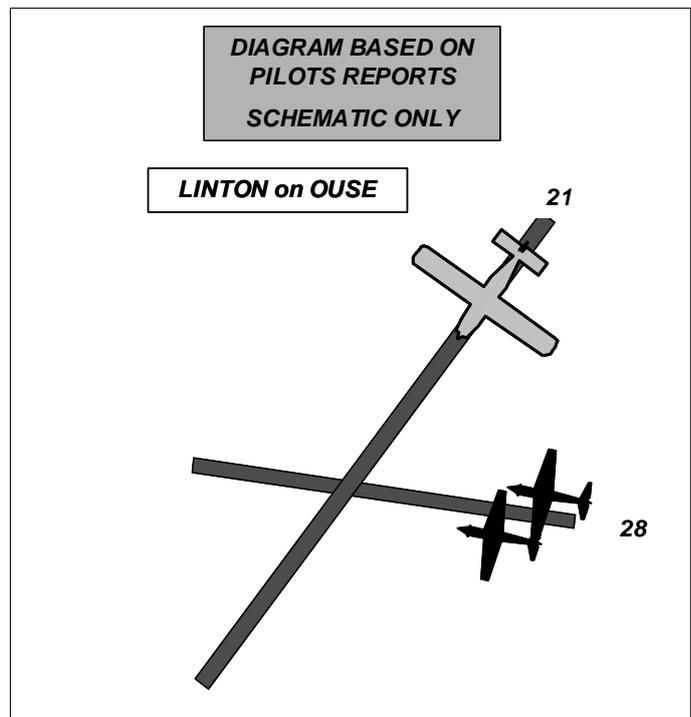
THE TUCANO PILOT reports that he was leading a pair of Tucanos on [a pairs] take-off from RW28 at Linton on Ouse, in receipt of an aerodrome control service from them. During the take off roll at about 20kt, a civilian registered GA-8 ac landed on RW21, the intersecting RW. He assessed the risk as being low. The incident was subject to a Unit Inquiry (UI) and a video from a hand-held camera was provided.

Cause: The GA-8 pilot landed on the out of use RW, without clearance, into conflict with the Tucano pair taking off on the duty RW.

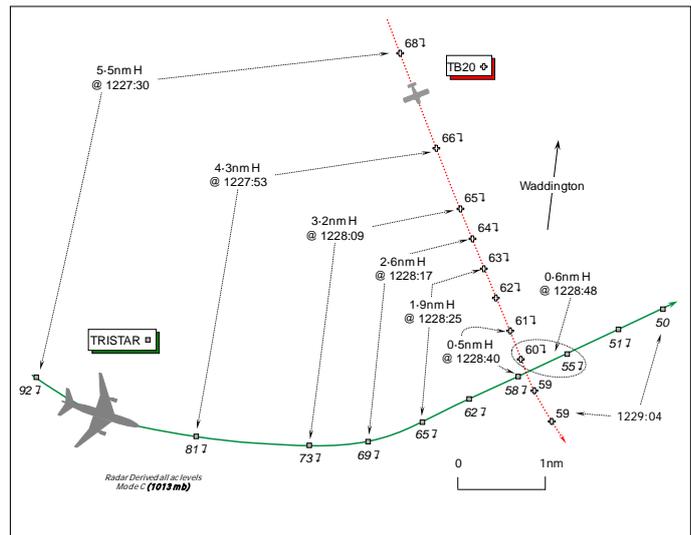
THE TRISTAR PILOT, a QFI, reports he was instructing an IFR training flight inbound to Waddington, descending to FL50 under a TS, as 'cleared' by LATCC (Mil) following a handover to Waddington APPROACH (APP) on VHF 123.3MHz. A squawk of A3612 was selected; Mode S and TCAS are fitted.

Cause: The Tristar was vectored into conflict with the TB20.

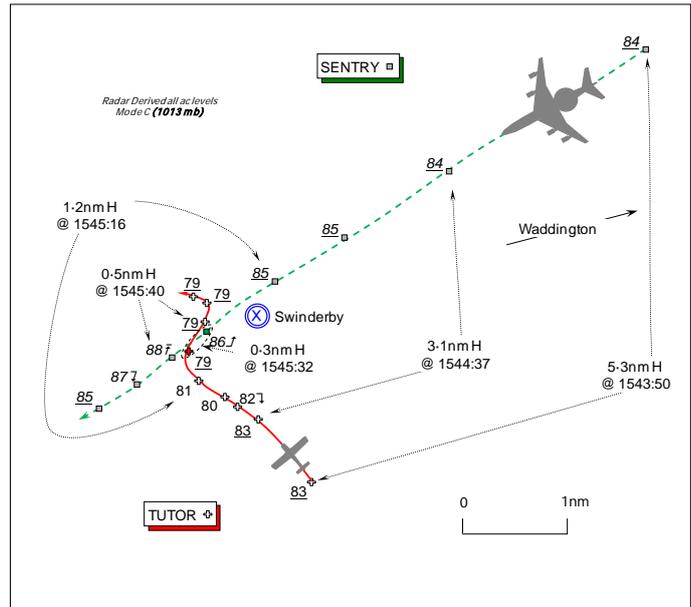
THE BOEING SENTRY PILOT reports he was on an IFR recovery to base at Waddington and in receipt of a TS from Waddington APPROACH (APP) whilst holding in the Waddington COLBY hold - approximately 210° WAD 7nm - heading 245° at 220kt. A squawk of A3612 was selected; Mode S and TCAS are fitted. The ac has a grey colour-scheme; the HISLS were on.

Cause: Sighting Report.

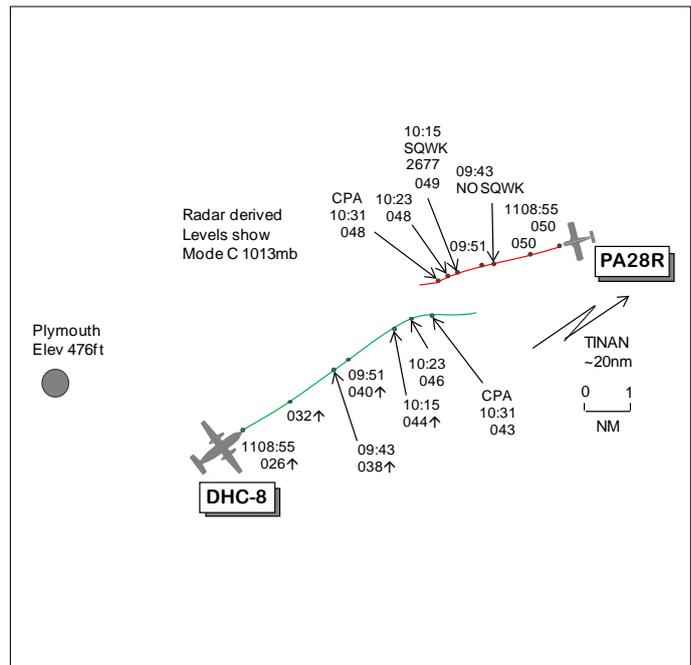
THE DHC-8 PILOT reports departing Plymouth under IFR and in receipt of a PS from Plymouth Approach on 133.55MHz, squawking 1407 with Modes S and C. The Wx was layered cloud, SCT to BKN but improving towards the S Coast. Both RWs were in use and they elected to use RW13 for departure. On taxiing out they received the initial clearance to make a R turn out (through 300°), rather than a L turn that was expected before setting track to TINAN, owing to traffic passing through the climb out from W to E. However, the taxi phase took longer than expected resulting in the transit ac having passed well to the E, thus the R turn out was cancelled. They took off from RW13 and made a L turn towards TINAN onto heading 065° at 150kt. Approach asked for them to call passing 3000ft but as they did the frequency was busy with another flight transmitting. Passing FL45 heading 065° and 150kt an open cyan diamond (not depicted as proximate traffic) suddenly appeared on the TCAS screen in their 12 o'clock range 2.25nm and 1100ft above. It appeared so suddenly it was as if the ac's transponder had just been switched on. This coincided with another flight checking in on the frequency for the first time and being assigned a squawk of 2677. He pointed this out to the FO, PF, and within seconds it had changed to a 'descend' RA with a green arc demanding a ROD of 1000-1500fpm. The RA was followed with a R turn being initiated as it seemed as though the traffic was opposite direction. The other ac passed 200ft above and clear to their L. Normal flight was resumed following satisfactory resolution. He assessed the risk as high. He commented that the TCAS display went from clear of ac to 'other traffic' to full blown RA with exceptional speed, certainly not appearing to represent a closing speed of circa 300kt. After speaking to the ATCO, it appears that London Military saw the potential conflict either by PSR or SSR and had luckily taken the initiative to contact Plymouth Approach, asking if they were aware of the traffic. Plymouth ATC was not aware of this traffic and about this time the flight made its initial call. Plymouth immediately asked the flight to squawk conspicuity before informing the crew of the traffic to the E. It appeared to him that the ac's transponder was selected on at this stage but this was only his perception of events, and it was at this stage the RA occurred.

Cause: A conflict in Class G airspace resolved by the DHC-8 crew using TCAS.

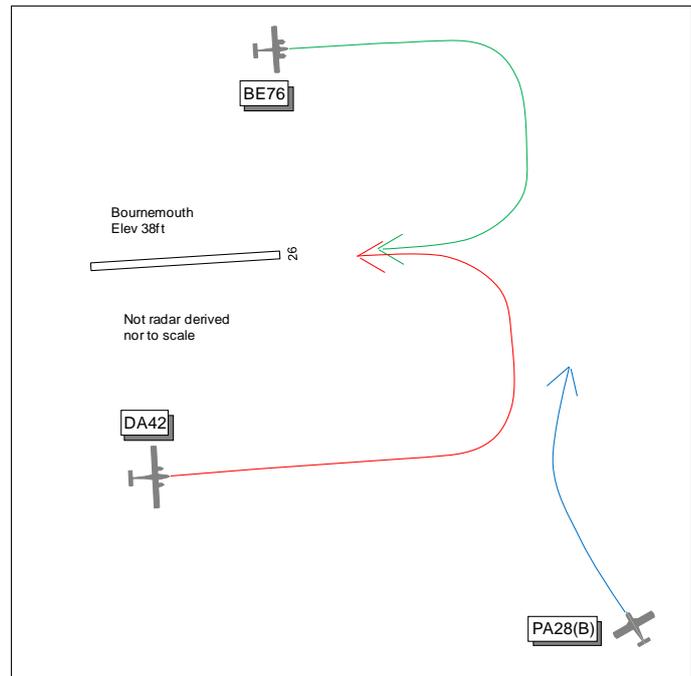
THE BE76 PILOT reports returning from a dual training sortie to the NW of Bournemouth and positioning RH downwind for RW26 at 1200ft as requested. He reported downwind and was told he was No2 to a PA28. Towards the end of the downwind leg both he and the student saw the PA28 on final and turned onto base leg. The student called R base for RW26 and recalls being told that he was No1. Both he and the student heard a RT exchange between ATC and a DA42 flight in which its pilot was told that he was No2 to their BE76 on R base. The student called R base for RW26 and was told to continue approach. They commenced their final turn at about 600ft after the instructor had looked up the final approach path and at L base and believed them to be clear of other ac. The ac's Rate 1 turn meant that the L wing obscured the view to the S (L base) for about 30sec. They rolled wings level at about 500ft aal where the student believes he called final, although the instructor cannot recall this for sure. At about 450ft aal and 90kts in a normal descent profile both he and the student became aware of a DA42 overtaking them from below, directly below, at a very close vertical distance. The student estimated 20ft and he thought it possibly that close but certainly no more than 50ft; both of them were totally unaware of where the DA42 had come from. He initiated a 'go-around' and informed ATC and then the DA42 flight called 'final' and was subsequently cleared to land. They repositioned into the cct to land behind another ac.

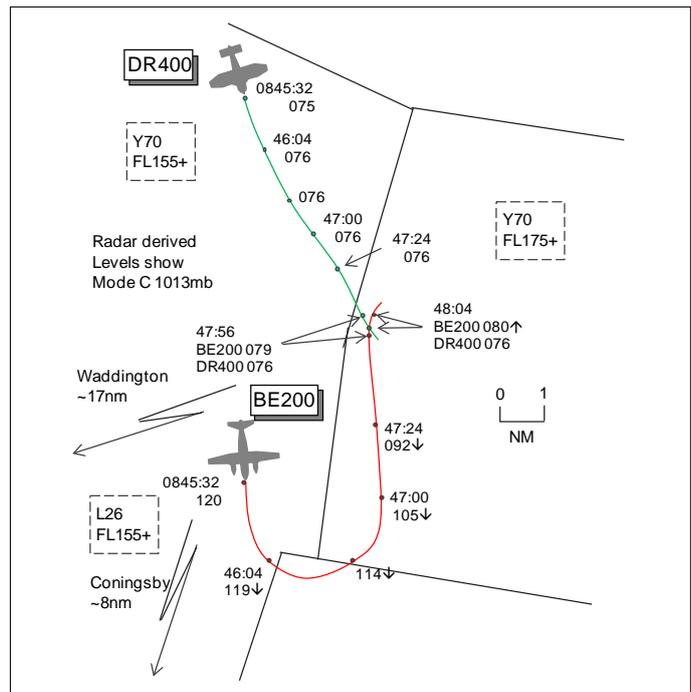
HQ AIR (TRG) comments that the ac were both provided with accurate and timely TI but elected not to act upon it or did not sufficiently register the detail they were passed. The reasons for this are not clear but both had the opportunity to manoeuvre to avoid the impending conflict and the BE200 did so only on receiving a TCAS RA. It is also not clear why the reported TCAS TA was apparently very late and in error. However, with the available TI, the TCAS TA was actually superfluous. It is also noted that the equipment was not snagged and that there is no trend of similar occurrences to indicate a problem with the TCAS. The BE200 formal pre-sortie brief stresses the limitations of the TCAS in respect of it only detecting transponding ac and hence the continuing need for a robust lookout scan. It is disappointing that this incident was permitted to proceed to a point where a well flown TCAS RA response was required.

Cause: Late sightings by the pilots of both ac.

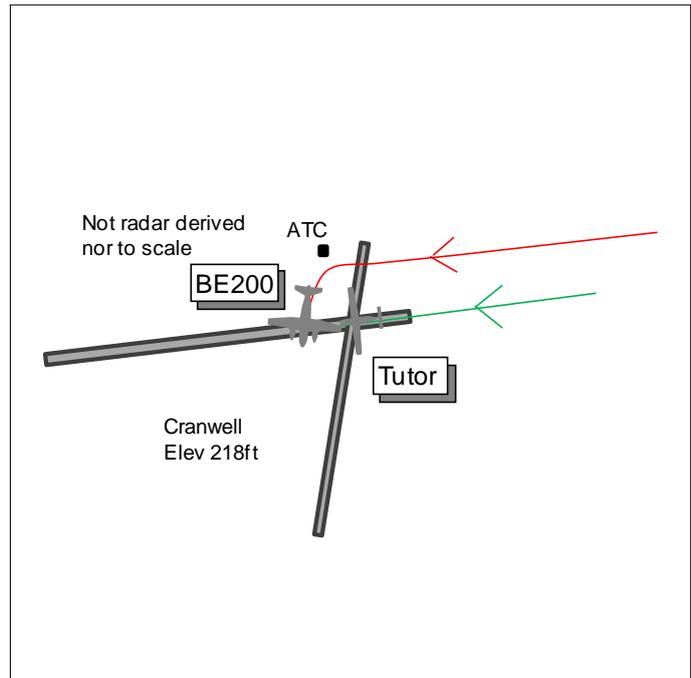
THE TUTOR PILOT reports flying a local dual training sortie from Cranwell, VFR and in communication with Cranwell Tower on 125.05MHz; the transponder was switched off. Heading 264° at 80kt during the climbout from a touch and go, a BE200 King Air was noticed on the deadside of RW26 approximately 200ft above and 500m behind them. Once it was passing abeam, the King Air turned L but before it crossed in front of him the Tutor pilot levelled-off at 300ft QFE 996mb, which led to the King Air passing 100ft in front and 200ft above. He assessed the risk as medium.

Cause: The BE200 crew elected to turn downwind early and flew into conflict with Tutor(A), of which they had lost sight.

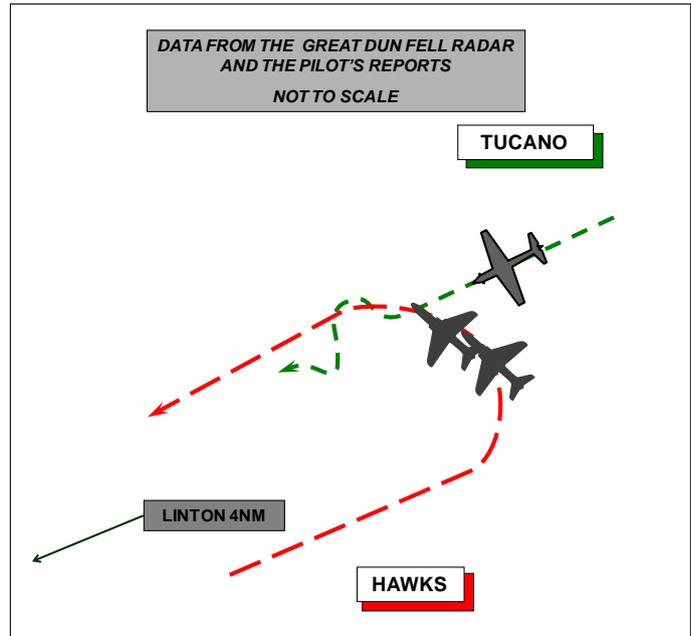
THE TUCANO STUDENT PILOT reports he was solo and flying a visual recovery to RAF Linton-on-Ouse, squawking 7001 with Mode C, having just exited from low level and he was in receipt of a BS from Linton APP [See UKAB Note: (1)]. He was heading 230° at 160kt and 2000ft QFE, in poor visibility, and he had transmitted his recovery call to APP at about 9nm from the airfield but the reply was interrupted by a 'Practice PAN' call by another Tucano. He then became visual with the airfield and switched from APP to TWR. He later learned that 2 Hawks were also recovering [to RW 21] on a radar-to-visual recovery from the W but they were not displayed on his TCAS [1]. He was also informed later by ATC that APP had become aware of the possible confliction but was unable to warn them due to the 'Practice PAN' call in progress. The Airprox occurred as the 'Practice Pan' call was being completed and the pair of Hawks in echelon left, passed about 70m away in his 10 o'clock at the same height, in a 60° bank left turn, belly up to him. He did not take any avoiding action as he first saw the other ac at the CPA and he assessed the risk as being high. The visibility into sun (the direction of the Hawk's approach) was poor.

Cause: The Hawk pilots flew into conflict with the Tucano which they did not see.

Recommendation: That RAF Linton on Ouse reviews the SOP requiring visiting ac to squawk standby when transferring to TWR.

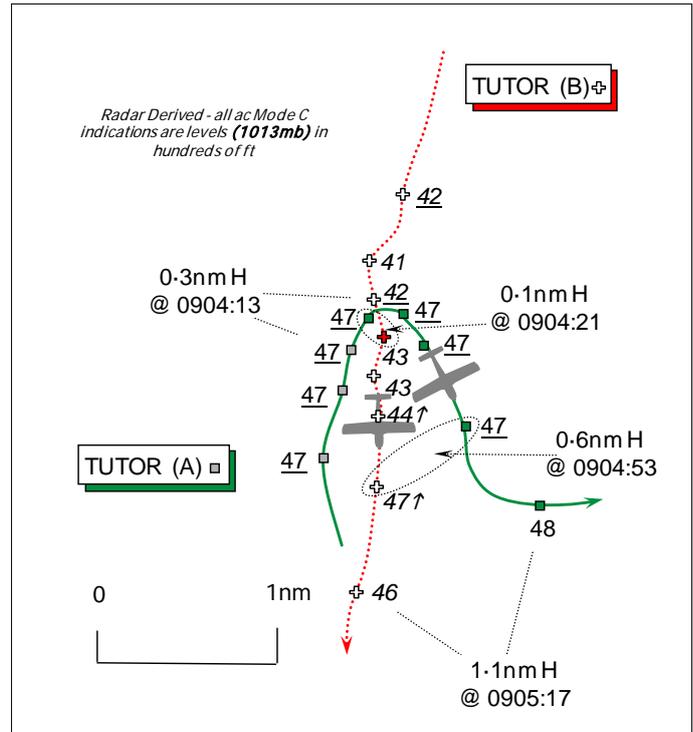
THE PILOT OF GROB TUTOR T Mk1 (A) reports he was flying a local dual staff continuation training flight from Barkston Heath. He was operating on a discrete frequency not in receipt of an ATS, squawking A2637 [Cranwell] with Mode C; elementary Mode S is fitted, TCAS is not. The ac has a white colour-scheme; the HISLs, nav lights and the landing-light were on.

Cause: Effectively a non-sighting by the pilots of Tutor (A) and a late sighting by the pilots of Tutor (B).

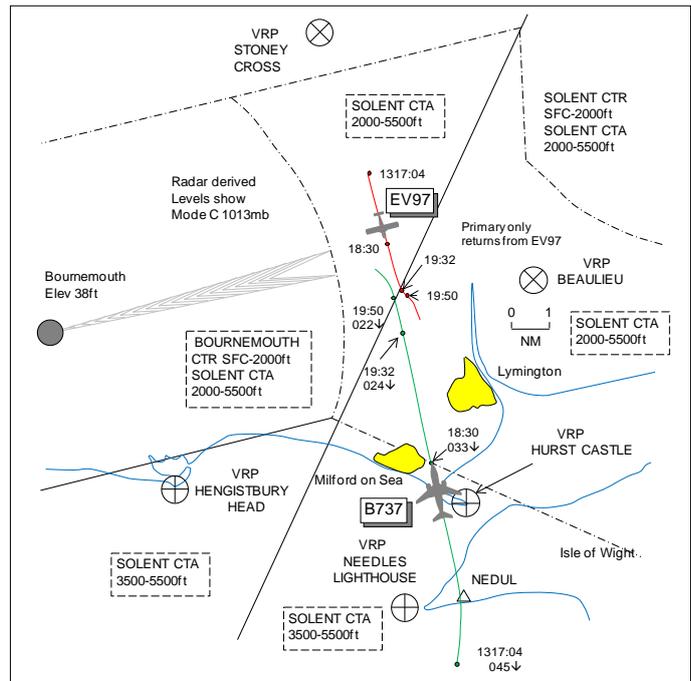
THE B737 PILOT reports inbound to Bournemouth IFR and in receipt of a RCS from Bournemouth on 119.475MHz, squawking an assigned code with Modes S and C. The visibility was 5nm in VMC and the ac was coloured white/red with nav, landing and strobe lights all switched on. They were under radar vectors towards the LLZ RW26 about 10nm E of BIA, heading 350°, descending to altitude 2500ft at 210kt reducing to 180kt. They received instructions to descend to altitude 2000ft and turn L heading 290° to intercept the LLZ. On reaching over to set the new values into the MCP he saw a light ac in his 1-2 o'clock at the same level. This white coloured low-wing ac with winglets remained clear and proceeded down their RHS by about 3nm. No avoiding action was needed owing to the turn being commenced. He assessed the risk as low/medium.

Cause: Perceived loss of separation.

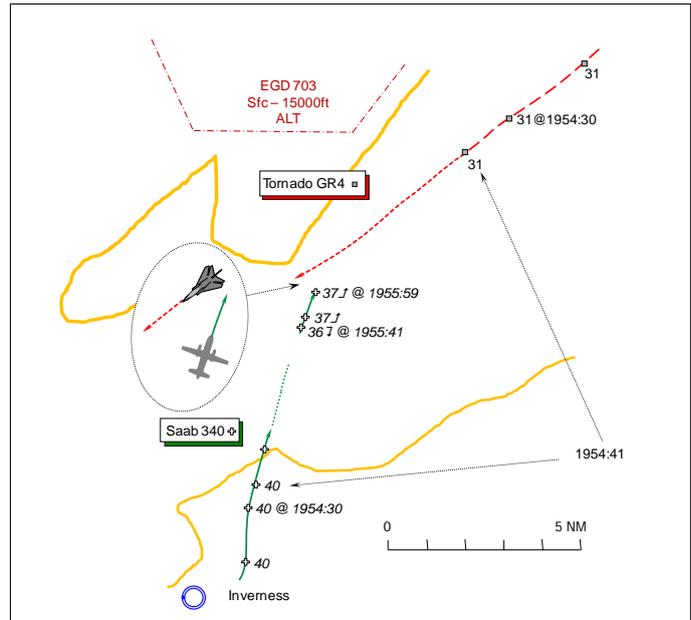
THE INVERNESS COMBINED TOWER AND AERODROME CONTROLLER reports that the SF34 crew had been cleared to carry-out the VOR/DME procedure for an ILS to RW23 under a PS. As they did so a return was observed on the ATM exiting Tain AWR on a SW'ly heading indicating 2600ft Mode C. He advised the SF34 pilot, who responded that the contact was showing on his TCAS display in his 12 o'clock. The SF34 pilot continued descent on the procedure and then at 1955 UTC advised he had received a TA on the other ac, which was believed to be a Tornado GR4. He believed the GR4 passed down the SF34's port side at a range of 1nm. The SF34 appeared to level-off but then the crew advised that the other ac had passed and they would continue on the procedure. The SF34 landed without further incident and it was then that the crew indicated that they wished to file an Airprox. The pilot later telephoned to confirm the details of the Airprox and advised that he had been flying in IMC at the time and had not seen the other ac.

Cause: The GR4 crew flew close enough to the SF34 to cause its crew concern.

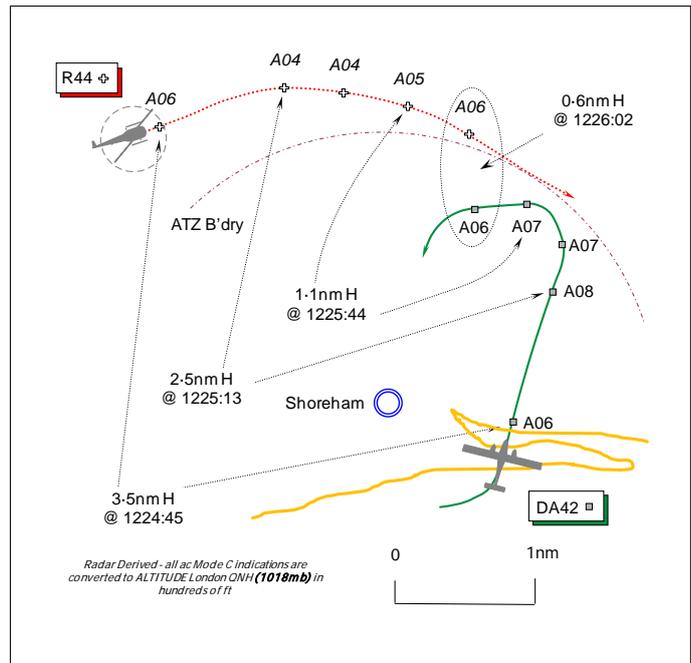
Cause: A controller perceived conflict.

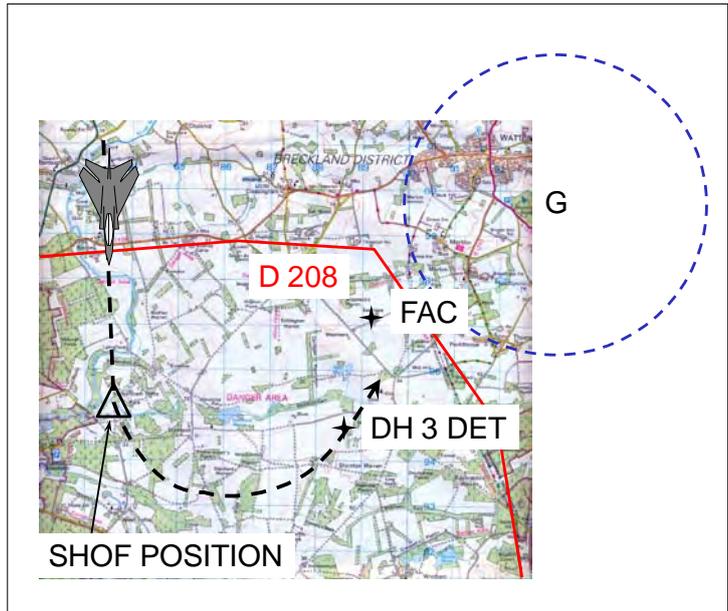
THE DESERT HAWK flight safety officer reports that they were conducting proving flights within the STANTA training area and at the time of this incident he was located at 5km E of Buckenham Tofts with the UAV control station.

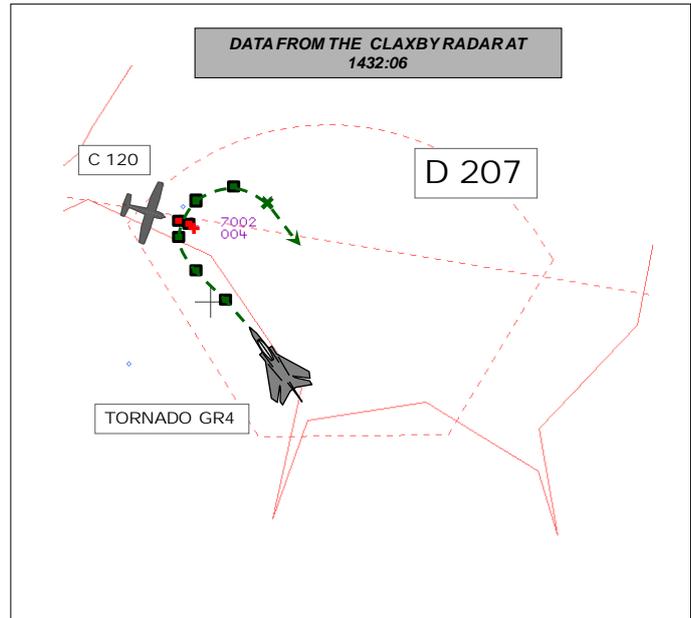
THE TORNADO PILOT reports flying a grey ac with all lights switched on, on a practice weaponry sortie in Holbeach AWR, squawking 7002 with Mode C. They had joined Holbeach AWR from Marham and on initial RT contact they were advised of a light aircraft just outside the AWR to the W of the targets. Following a level attack at 200ft, heading 330° at 480kt, they were in a shallow climb and turning right onto a reciprocal heading, in a medium workload situation, when they saw a light coloured (possibly orange) high-wing, light ac flying straight and level on an opposite track, about 800ft above them and 200ft laterally spaced; they continued the turn to increase the separation.
