ASSESSMENT SUMMARY SHEET FOR UKAB MEETING ON 25 APRIL 2012

AIRPROX REPORT No 2011135

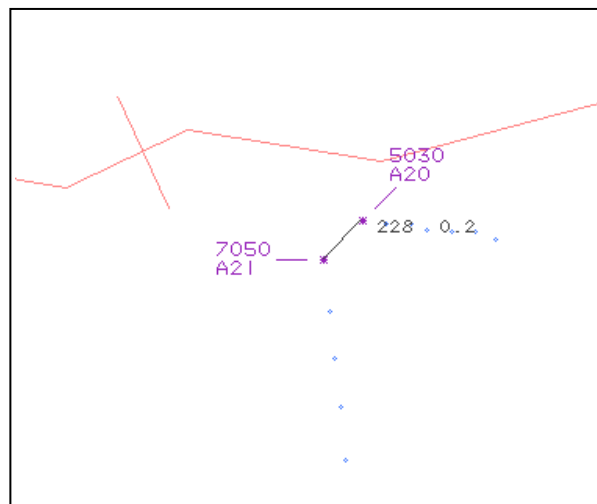
Figure 1: Swanwick MRT at 1957:54

At 1957:54 the ac were 7nm E of Elstree with the C425 was in the Dauphin's 11 o'clock at a range of 0.2nm, crossing left to right; the C425 was at 2100ft and the Dauphin at 2000ft (see Figure 1).

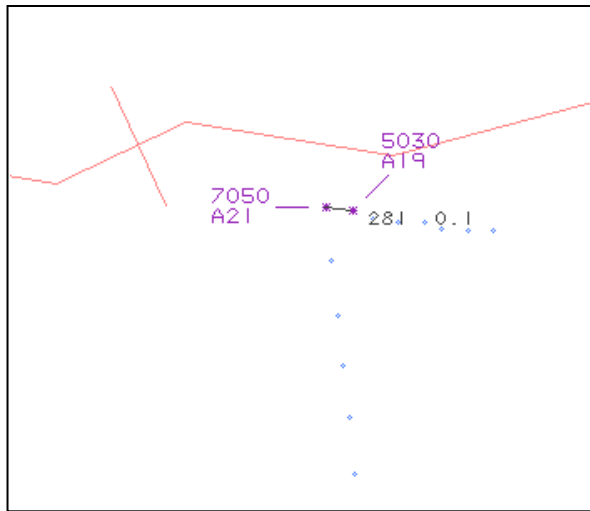
Figure 2: Swanwick MRT at 1957:58

The C425 crossed through the Dauphin's 12 o'clock, left to right, at 1957:58. The C425 was at 2100ft, 0.1nm ahead of the Dauphin, which was at 1900ft (see Figure 2).

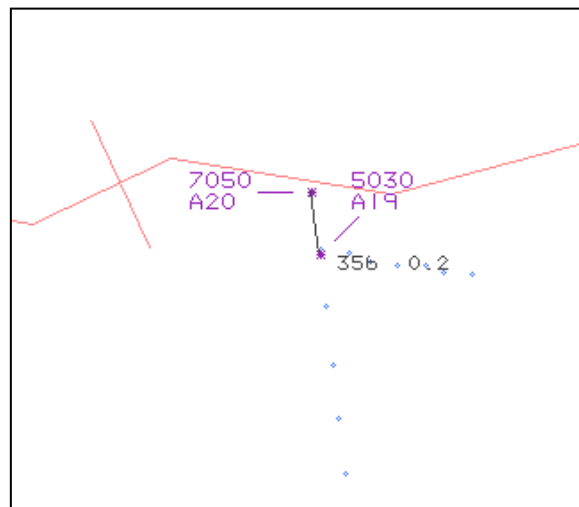
Figure 3: Swanwick MRT at 1958:02

The next update of the MRT replay, at 1958:02, showed the C425 in the Dauphin's 3 o'clock, range 0.2nm (see Figure 3).

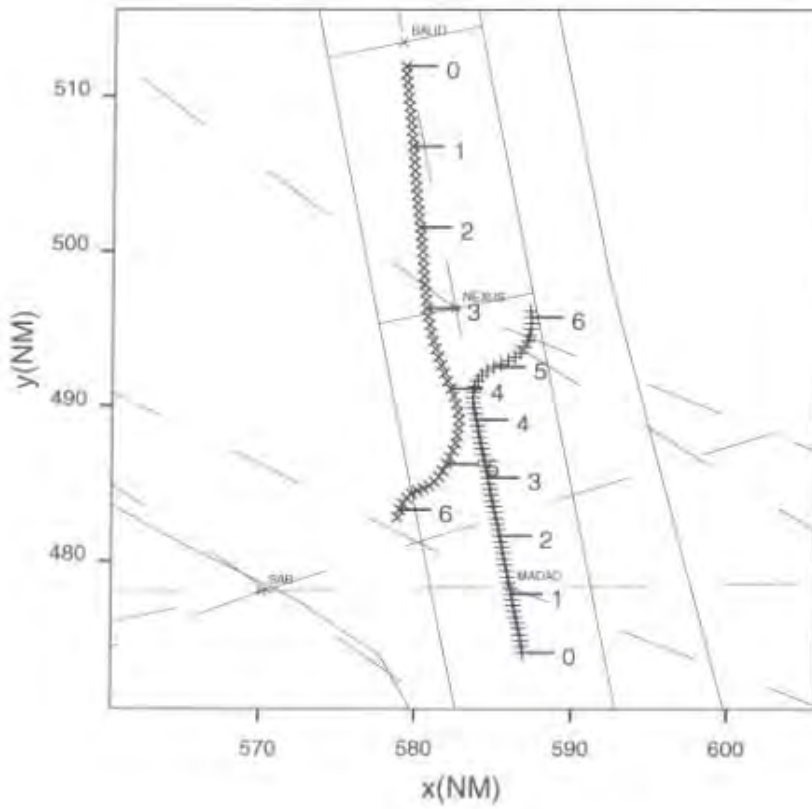
SMF data 1

The following data was produced by SMF (Separation Monitoring Function) which supports the minimum separation already assessed.
