**ASSESSMENT SUMMARY SHEET FOR UKAB MEETING ON 15 Dec 2010**

## AIRPROX REPORT No 2010053

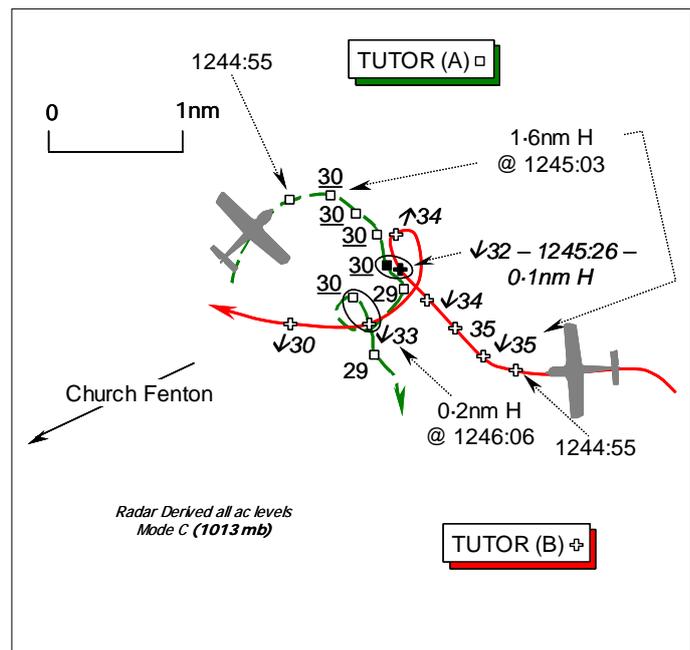
Cause: Late sightings by the pilots of both ac.

Degree of Risk: C.

Safety Recommendation: It is recommended that outside CAS, where local procedures deem that an ATS may be automatically provided, that controllers state the actual service on the RT as a reminder to pilots of the ATS actually being given.

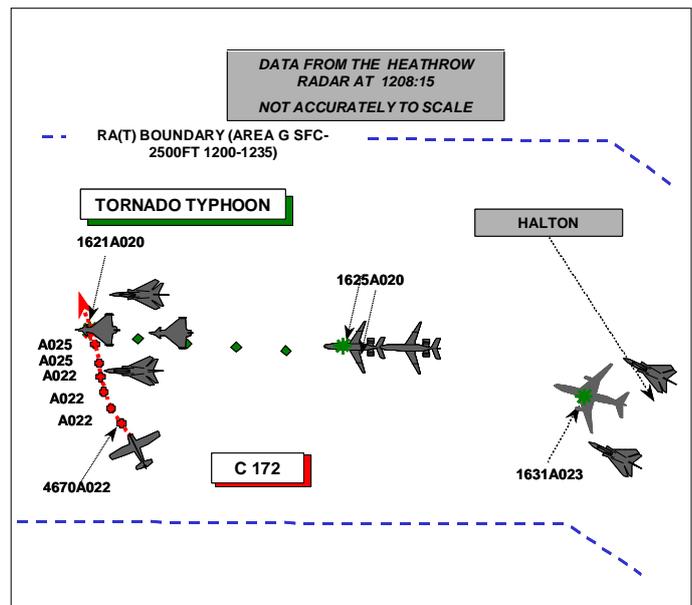
Cause: The C172 pilot infringed the RA (T) and flew into conflict with the military formation.

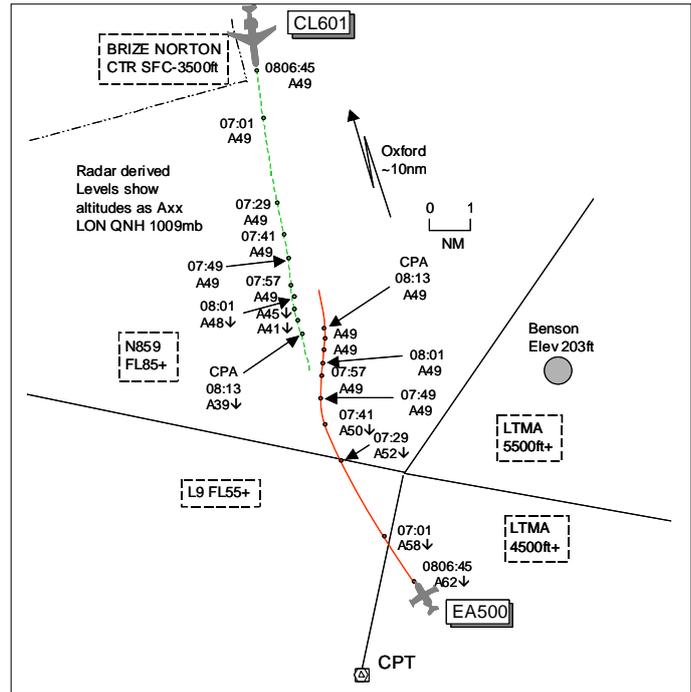
Cause: A conflict between IFR traffic in IMC in Class G airspace.

Members endorsed the ATSI recommendations that Oxford Airport review tactical and coordination procedures for inbound and outbound IFR ac and that controllers are reminded of the importance of using correct and precise standard phraseology.

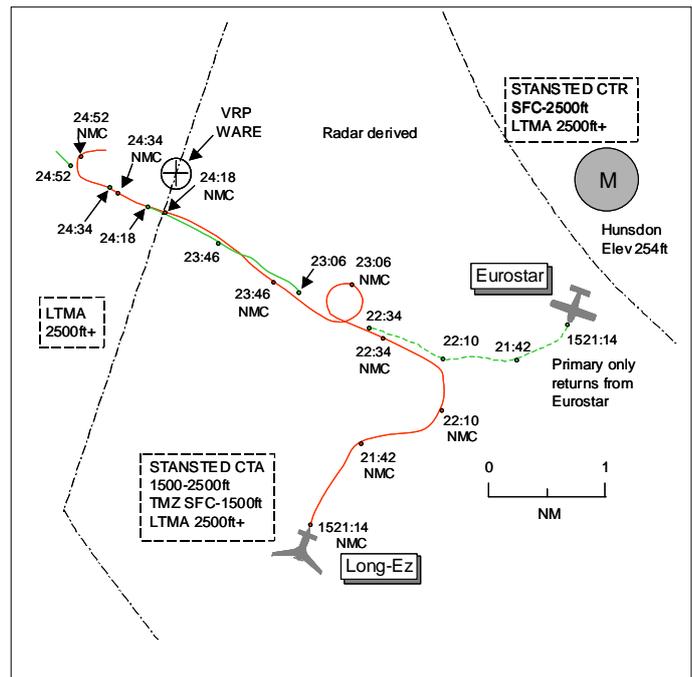
Cause: The Long-Ez pilot flew close enough to the Eurostar to cause its pilot concern.

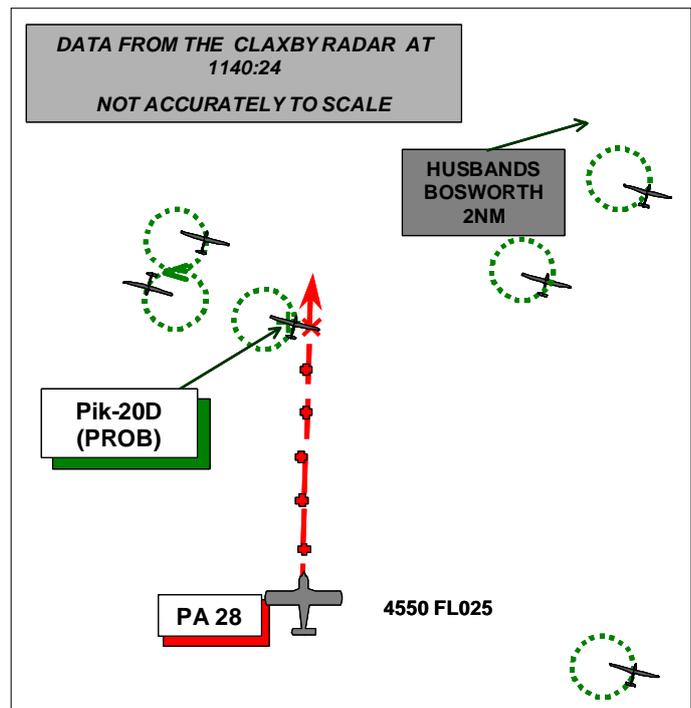
Cause: Effectively non-sightings by the pilots of both ac.

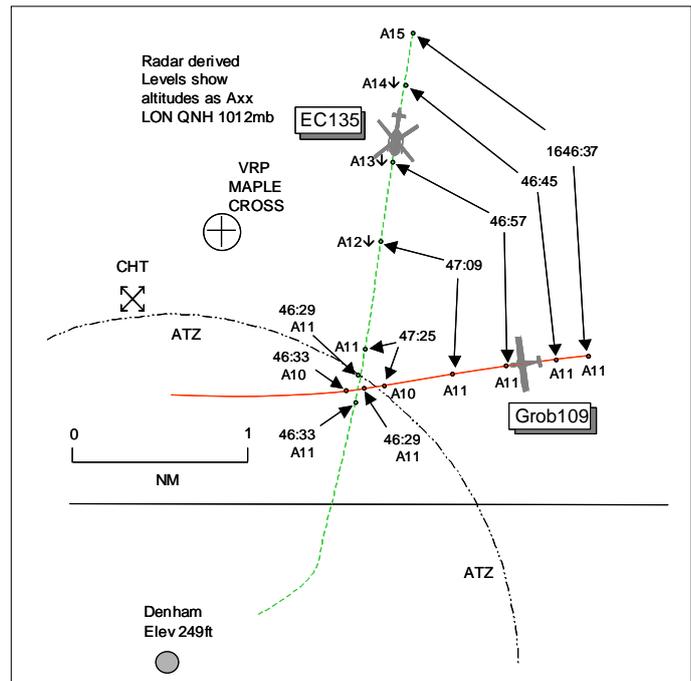
Cause: Late sightings by the pilots of both ac.

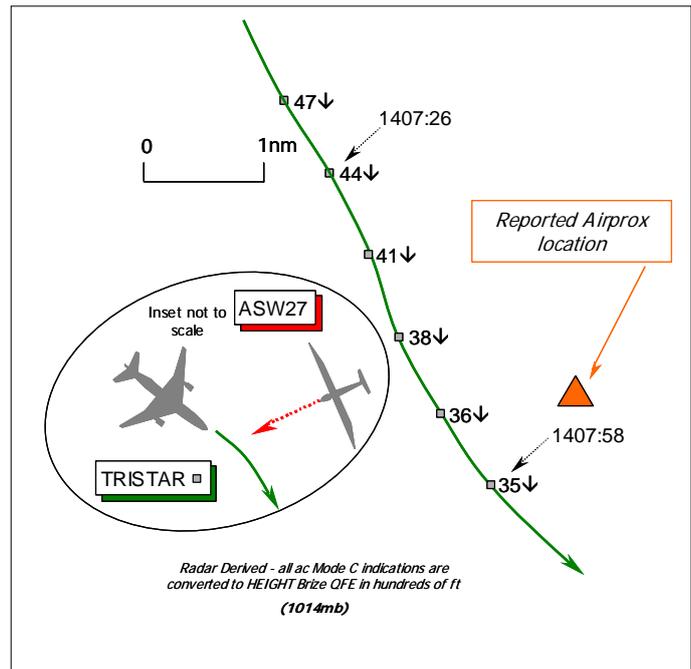
Cause: A conflict in Class G airspace.

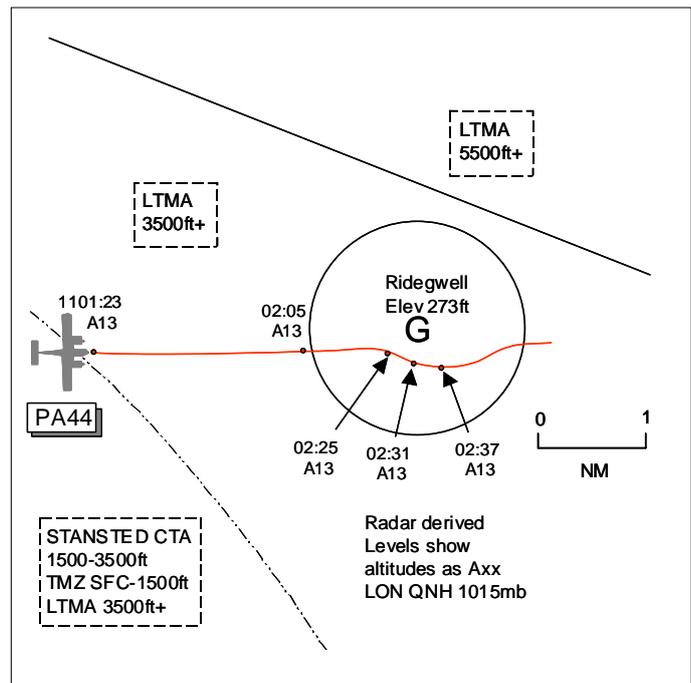
Cause: The PA44 pilot flew over a notified and active glider launching site below the promulgated winch cable release height and into conflict with the ASK21 glider.

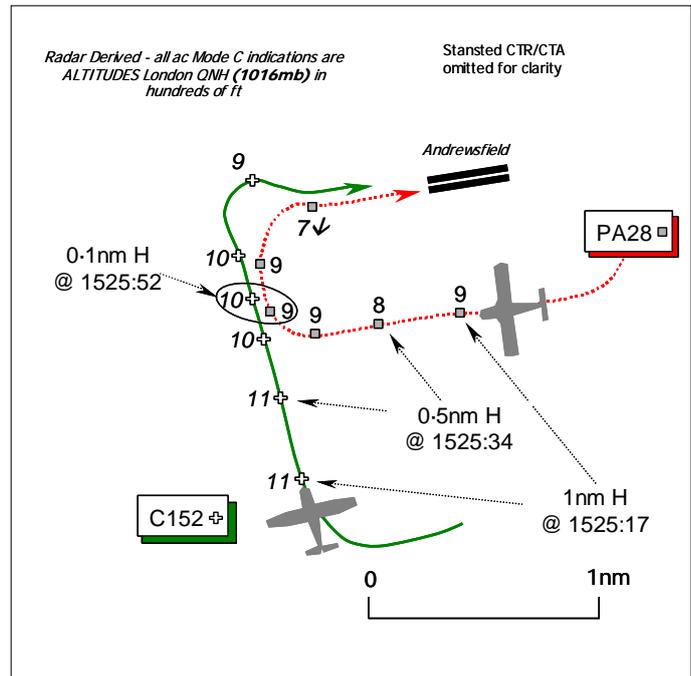
- Cause:
- i. The PA28 pilot did not integrate into the circuit pattern established by the C152.
  - ii. The non-standard Andrewsfield circuit pattern is not published in the UK AIP.
- Degree of Risk: C.
- Safety Recommendation: The Aerodrome Operator is recommended to review the Andrewsfield AIP entry.

Board recommended that the aerodrome operator review the Andrewsfield AIP entry, with a view to including details of the stipulated non-standard cct pattern.

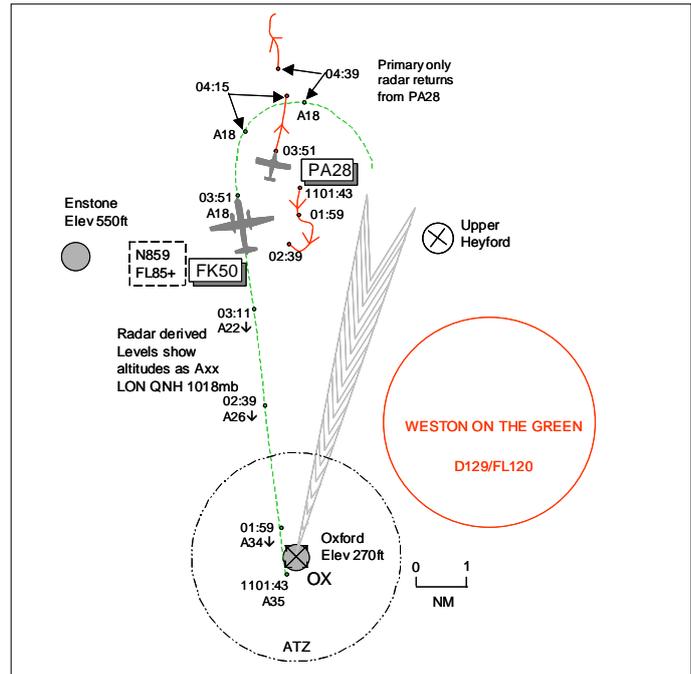
Cause: A sighting report.

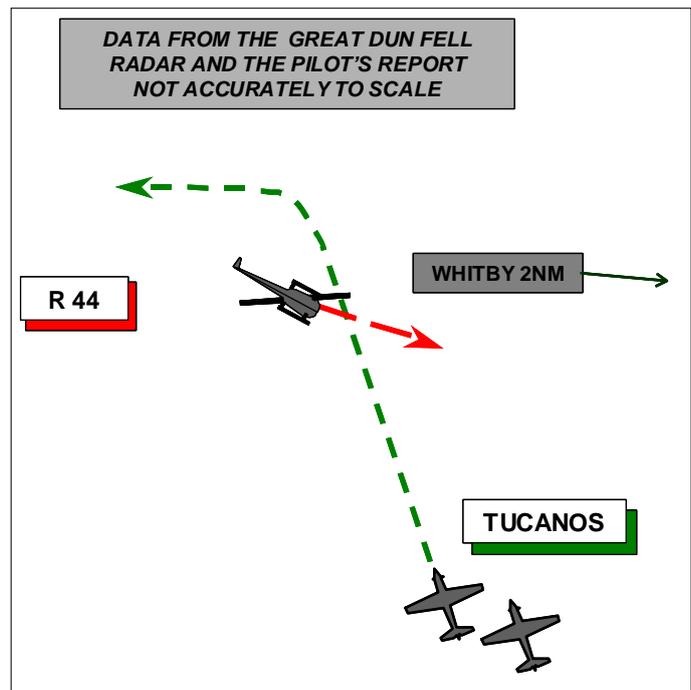
Cause: A late sighting by the Tucano crews and a probable late sighting by the R44 pilot.

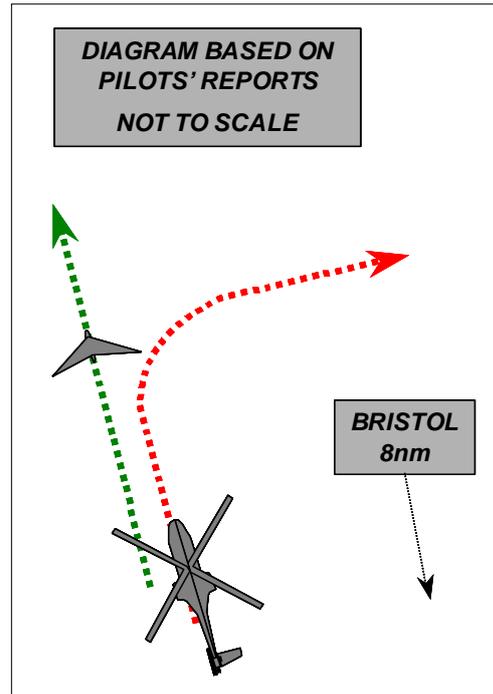
Cause: The Puma pilot flew close enough to the Microlight to cause its pilot concern.
