INDEX AND ASSESSMENT SUMMARY Meeting Date: 10 February 2010**Totals: 10 Risk A: 1 Risk B: 2 Risk C: 7 Risk D: 0**

AIRPROX REPORT No 2009-074

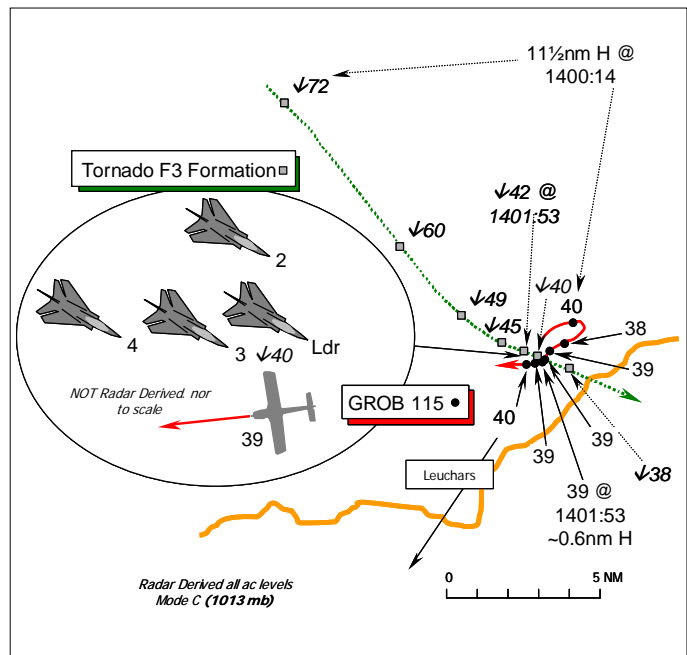
Cause: Late sighting by the Grob 115 pilot and the F3 crews.

Degree of Risk: B.

(i) The MoD should review the performance of the Watchman primary ASR and associated SSR system at RAF Leuchars to ensure that it provides appropriate solid radar coverage in the lower airspace commensurate with its rôle.

(ii) ATC and aircraft operators at Dundee airport, together with RAF Leuchars staff, should review the requirement for agreed General Handling Areas and Air Traffic procedures to improve the mutual deconfliction of civilian light aircraft and military fast jets operating in this vicinity.

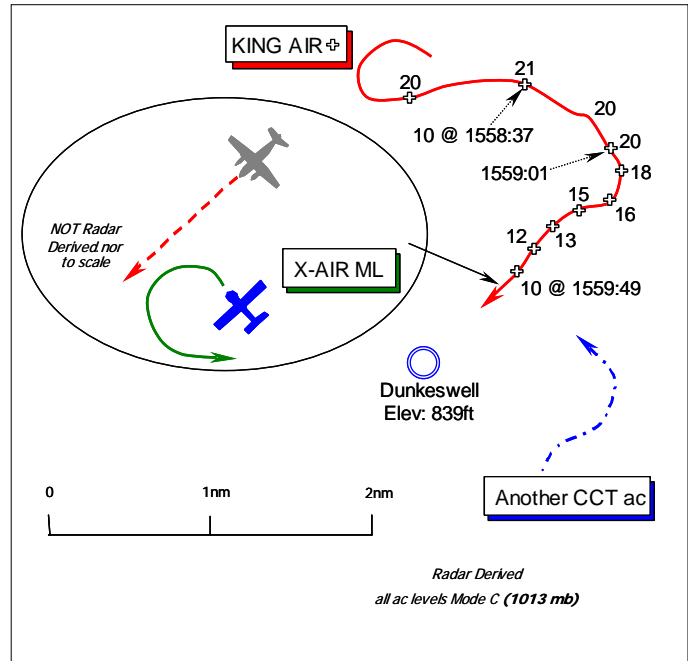
AIRPROX REPORT No 2009-082

Cause: Conflict in the Dunkeswell circuit resolved by the X-Air microlight pilot.

Degree of Risk: C.

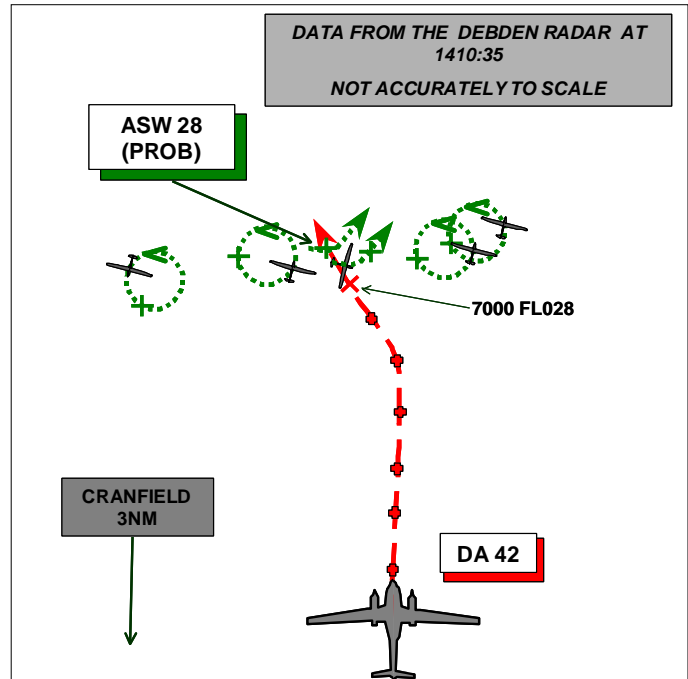
AIRPROX REPORT No 2009-084

Cause: Late sightings by the pilots of both ac.

Degree of Risk: A.

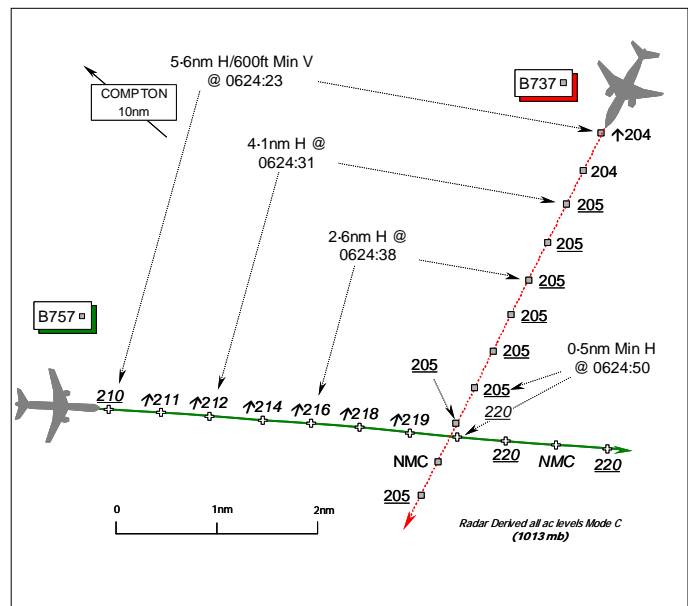
AIRPROX REPORT No 2009-089

Cause: The LTC CAPITAL controller climbed the B737 into conflict with the B757.

Degree of Risk: C.

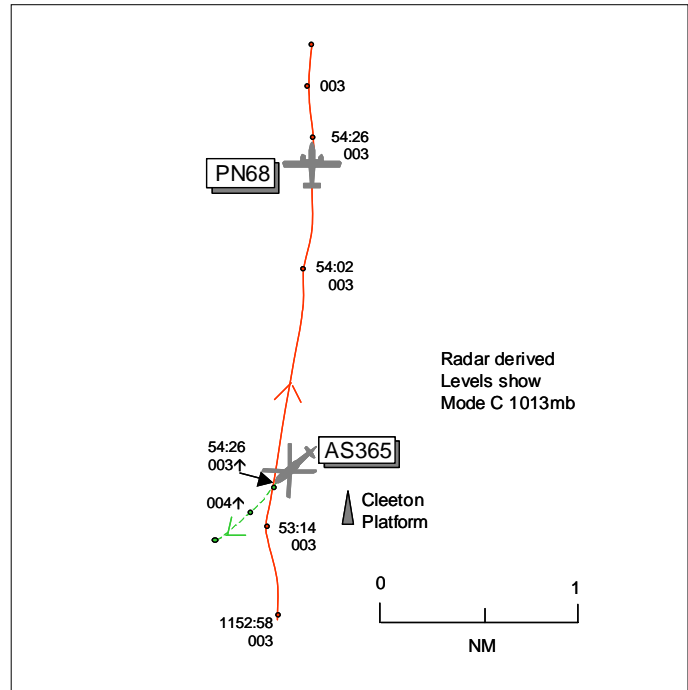
Cause: Sighting report in a HPZ.

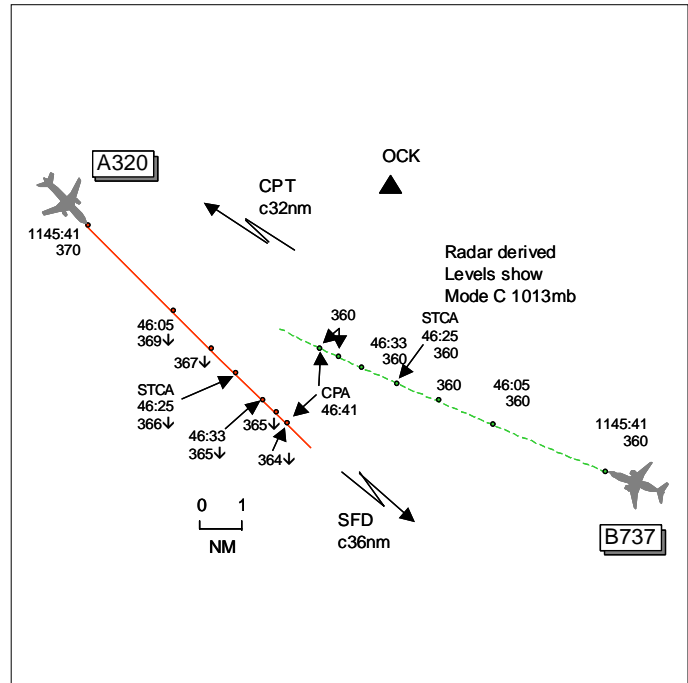
Cause: The LAC S1/24T controller descended the A320 into conflict with the B737.

Additionally, a local recommendation has been made, as a result of the number of incidents, for the LAC Operations Department to determine the best solution for highlighting ac on direct routeings in potential confliction with ac on standard routes.

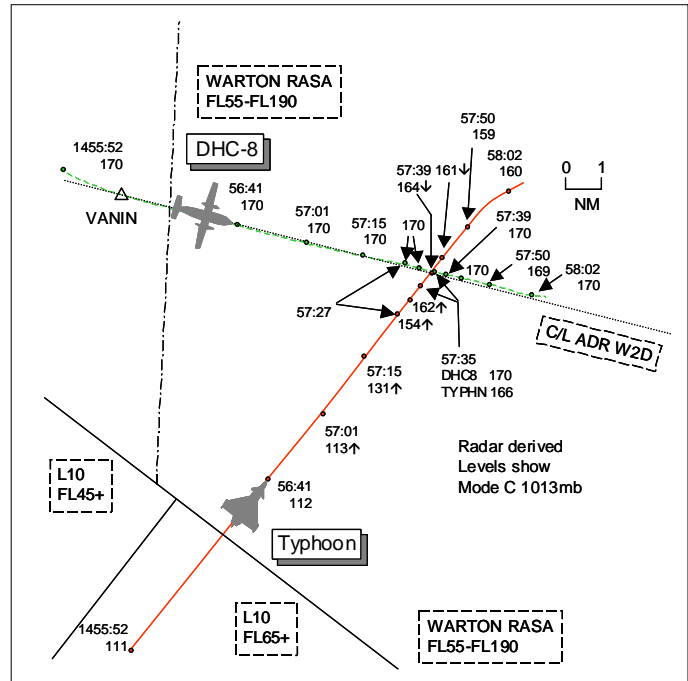
Cause: The Typhoon pilot climbed above his assigned and coordinated level into conflict with the DHC-8.

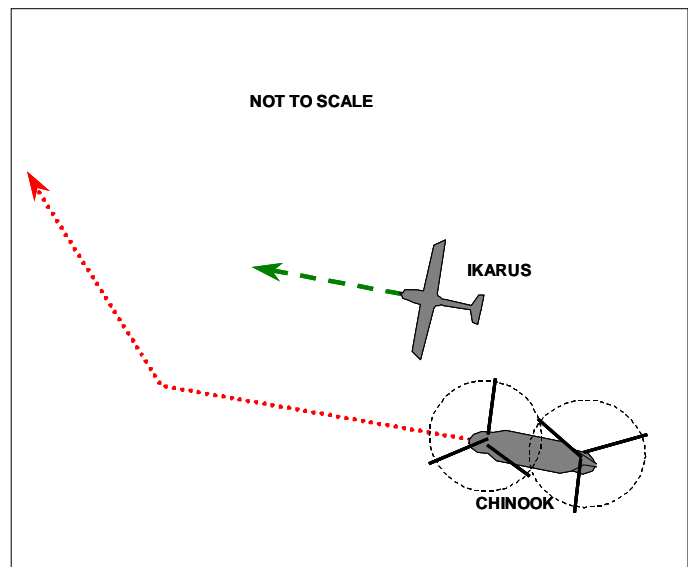
Cause: The Chinook crew flew close enough to the Ikarus to cause its pilot concern.

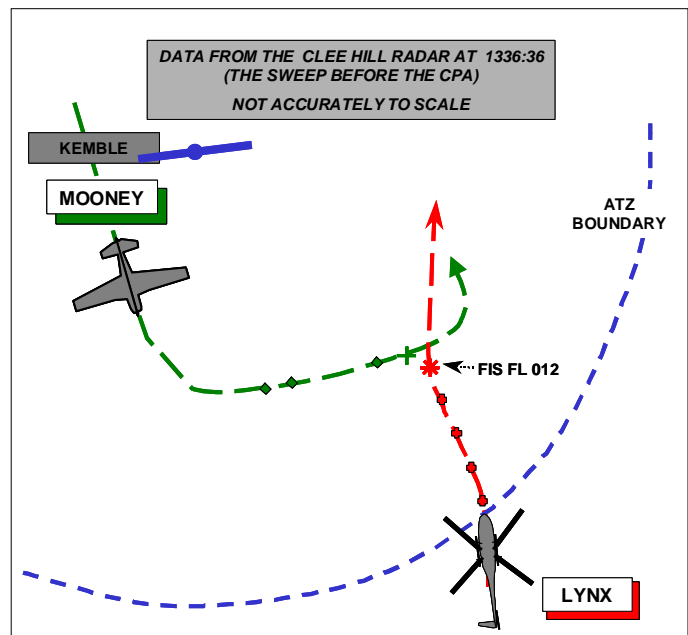
Cause: The Lynx entered the Kemble Civil Aerodrome Avoidance area and flew into conflict with the Mooney M20C.
