ASSESSMENT SUMMARY SHEET FOR UKAB MEETING ON 22 FEBRUARY 2012

AIRPROX REPORT No 2011125

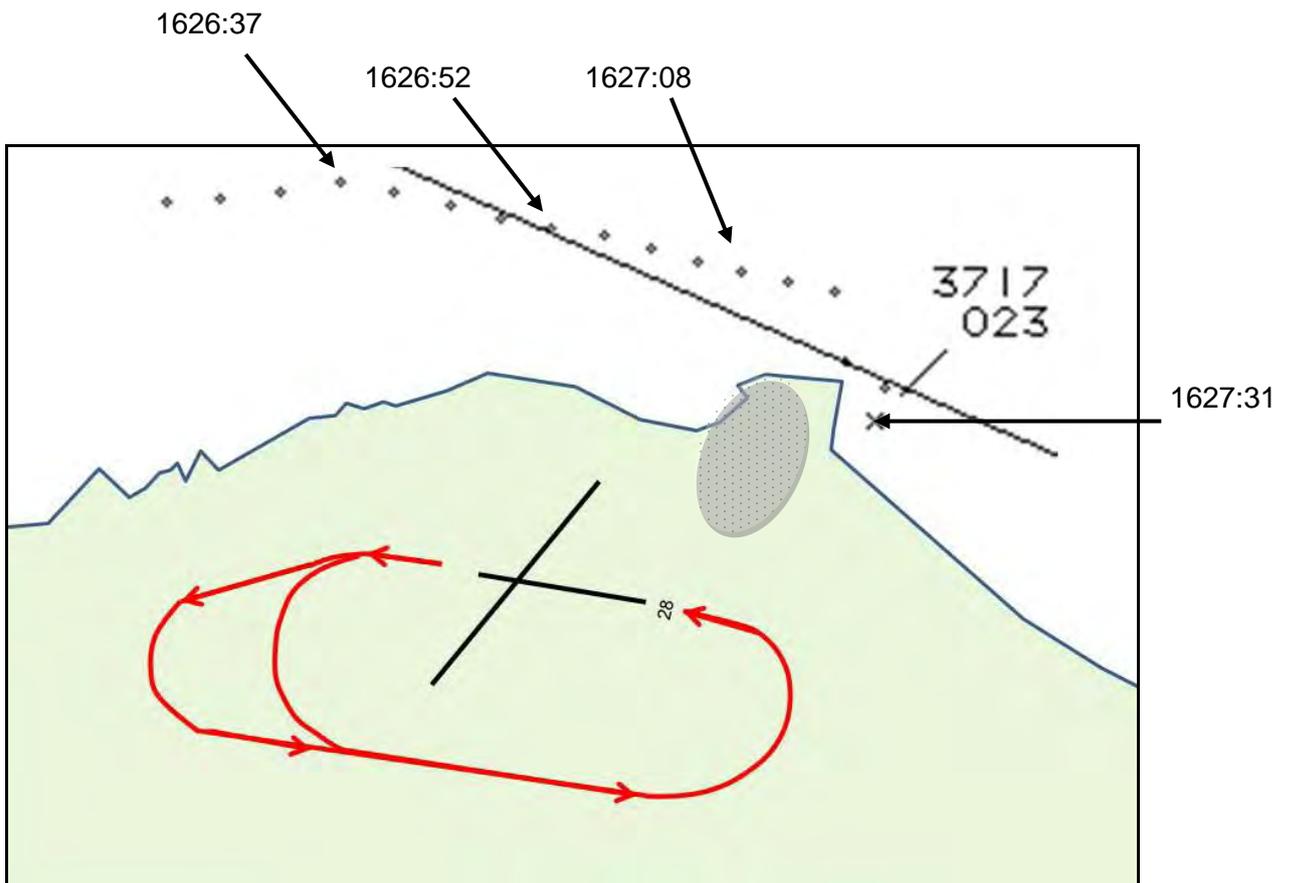
Fig 2: Approximate ground track of Hawk

Figure 2 depicts the Hawk's approximate ground track, based upon the radar replay; the grey shaded area is Lossiemouth village which is a noise-abatement avoid. At 1626:29, at a position 3.1nm NNW of Lossiemouth, the Hawk pilot informed APP that he had the, "...field in sight." APP replied, "[Hawk C/S] maintain please and maintain eastbound, got radar traffic 2 miles and visual joiners about 10 miles" which was acknowledged by the Hawk pilot. During this transmission, at 1626:37, the Hawk pilot turned to track 105°. APP then informed the Hawk pilot that it, "won't be much of an extension" to which the Hawk pilot replied, "Okay, I can't go far...shall I remain this or go to TOWER now?" At 1626:52, APP asked the Hawk pilot to, "confirm you're visual with the ones [the GR4 pair] at 8 miles?" The Hawk replied, "...negative this time." APP then stated, "radar traffic at 8 miles, correction, visual joiners at 8 miles" that was the GR4 pair. The Hawk was 2.9nm NE of Lossiemouth tracking 105° when the pilot stated at 1627:00 that he was, "visual with the one at 3 [radar traffic] but I can fit in behind him if I join downwind and turn finals now." APP replied at 1627:06, "[Hawk C/S] roger, continue inbound, call TOWER, good-day" which was acknowledged by the Hawk pilot at 1627:08 stating, "To TOWER, squawking standby."

[UKAB Note (1): Fig 2 Indicated Hawk Mode C of 2300ft is based on 1013mb and equates to a height of about 1640ft Clutch QFE (991mb).]

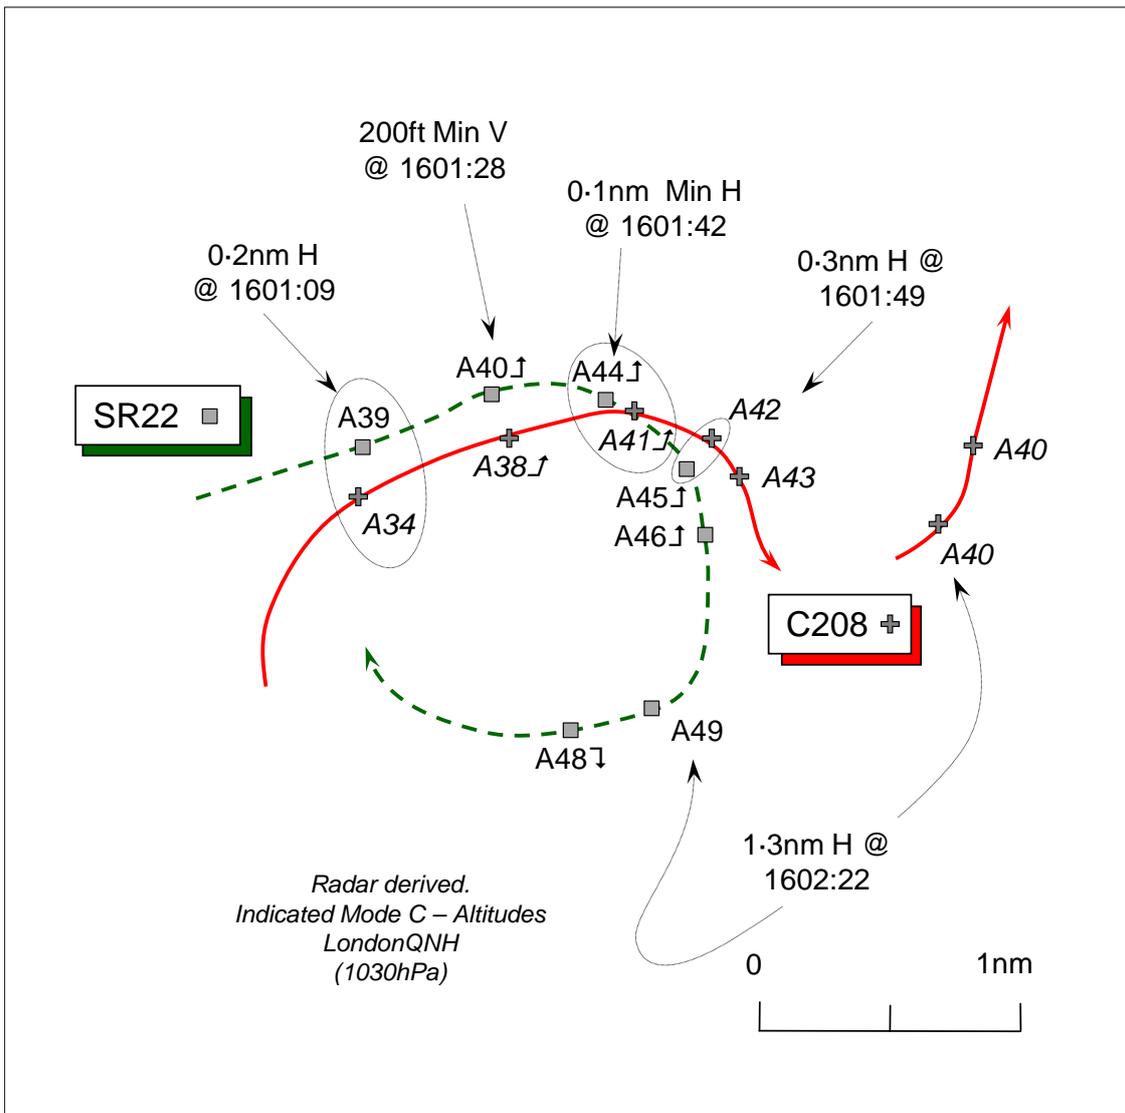
Fig 2

[UKAB Note 1: In Fig 1 the LAC radar recording shows the SR22 on a steady ENE'ly track indicating 3700ft QNH (1030mb) and converging with the C208, which is ahead at 2 o'clock on a NE'ly course climbing slowly through 2800ft QNH (1025mb) to 3000ft. As the ac close to a range of 2-4nm the C208 turns R into an orbit, rolling out on its original course 0.5nm off the SR22's starboard wing, as the latter, which had already climbed slightly indicates 3900ft, some 800ft above the C208. As the C208 steadies NE'ly at 1601:09, the ac's Mode C indicates a climb through 3400ft in the SR22's 4 o'clock at a range of 0.2nm. Moving to Fig 2, the C208 starts to overhaul the SR22 and climbs to 200ft beneath it; the SR22 then turns R into an orbit climbing at a higher rate through 4400ft with the C208 300ft below indicating 4100ft. At 1601:42, the C208 was at a range of 0.1nm from the SR22 still climbing and turning R, crossing 300ft above and slightly astern of the C208 in between sweeps at the CPA. The C208 commences a L turn but contact is then lost for several sweeps as the SR22

continues the R orbit, ascending to a maximum altitude of 4900ft at 1602:22, when the C208 is shown once more at 4000ft on a NNE'ly course.]
