ASSESSMENT SUMMARY SHEET FOR UKAB MEETING ON 19 JAN 2011

AIRPROX REPORT No 2010090

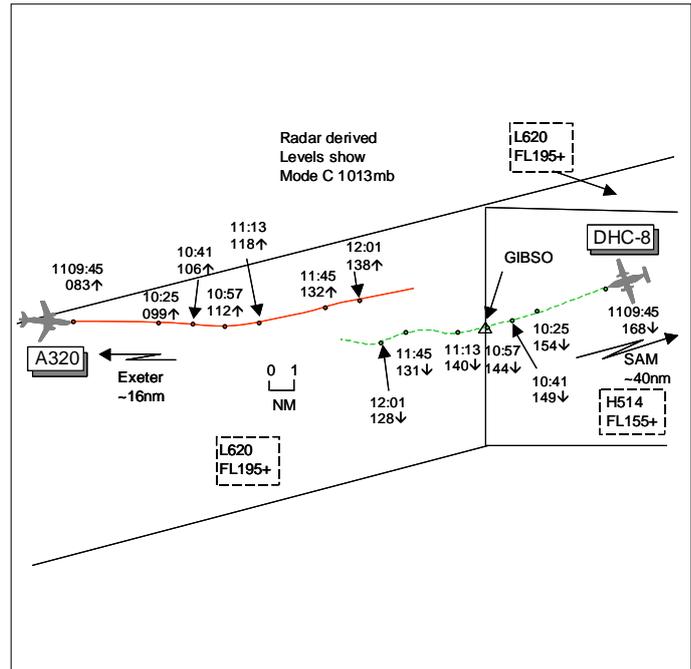
THE DHC-8 PILOT reports inbound to Exeter IFR and in communication with London squawking 6260 with Modes S and C. Descending from FL180 to FL100 outside CAS in the area of GIBSO heading 270° at 340kt they were not under Western Radar cover. They saw proximate traffic on TCAS before seeing the A320 flying level, he thought, on their R in the opposite direction. As they descended through its level, a TCAS TA was generated; they turned L due S away from the A320 to avoid, estimating 1000ft vertical and 2.5nm horizontal separation at the CPA. They heard the A320 flight report a TCAS RA. He assessed the risk as low.

THE A320 PILOT reports outbound from Exeter IFR squawking an assigned code with Mode S and C. During the climb at 240kt towards GIBSO to FL160 they were handed over early to London, given a TS and informed of a descending ac leaving GIBSO for Exeter. They made a request to turn L to avoid the traffic and increase their track distance to GIBSO, as they were unable to make GIBSO level FL160 in accordance with their clearance owing to an increasing tailwind component. They picked up the descending ac on TCAS and visually, and saw that it would pass down their RHS. However a TCAS TA and then a brief RA - <1sec – was received and they carried out the RA actions.

Cause: Sighting report.

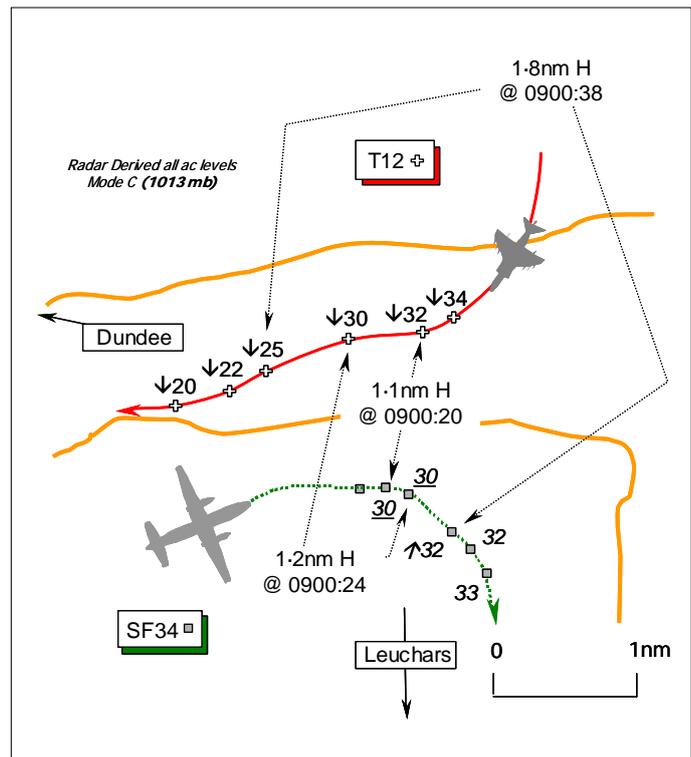
THE SAAB 340B (SF34) PILOT reports he was inbound to Dundee from the S at 7000ft under VFR and in receipt of a TS from Leuchars APP. He was instructed by Leuchars APP to descend to 3000ft Dundee QNH (1009mb) and asked to report visual with Dundee Airport. At a range of 6nm DME, in good VMC, they reported visual with the Airport and requested to transfer to Dundee APPROACH if Leuchars had nothing further [to affect their flight]. They were handed over, he thought, [free-called following a pre-note] to Dundee whilst maintaining level flight at 3000ft and began to position L base for RW27 with the A/P engaged, when a TCAS contact appeared on the screen to the NE rapidly approaching their position, displayed at +900ft and at a range of 8nm. The TCAS contact continued to converge on a constant 'heading' whilst descending and both he and his 1st Officer looked for the other ac but could not see it. TCAS then enunciated a 'TRAFFIC' alert. At this point, heading 070° at 180kt, with the TCAS contact about 2nm away, the Captain (PF) disconnected the A/P and turned R into a climbing turn avoidance manoeuvre. TCAS then enunciated an RA - MONITOR VERTICAL SPEED. The other ac was now showing red on the TCAS display at +100ft. Within a few seconds TCAS enunciated CLEAR OF CONFLICT. Despite good visual conditions and a good lookout from both pilots the other ac was never visually identified.

Cause: The Harrier crew flew close enough to the SAAB 340B to trigger a TCAS RA.

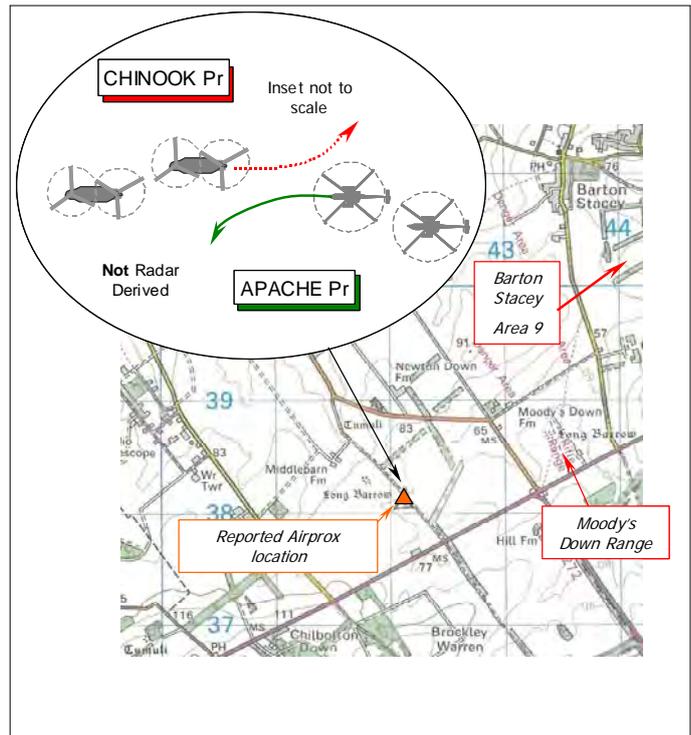
THE APACHE AH1 HELICOPTER PILOT, a QHI, reports he was leading a pair of Apache ac, flying dual with a student as the PF, on a pairs final handling test for conversion to type. He was flying approximately 4-5 rotor spans in front of the No2 Apache. In accordance with SOPs, his lead helicopter was showing IR lighting and the No2 was fully lit; both ac were displaying glimmers [non-NVG compatible tactical lights not visible all round] and conventional navigation lights on steady bright; in addition his No 2 also had red HISLs on. He was not in receipt of an ATIS but monitoring UHF LFS Common - 278.00MHz. A squawk of A2676 was selected [unverified Middle Wallop conspicuity] with Modes C & S on; TCAS is not fitted.

Cause: Conflict in Night Rotary Region 1 between two helicopter formations.

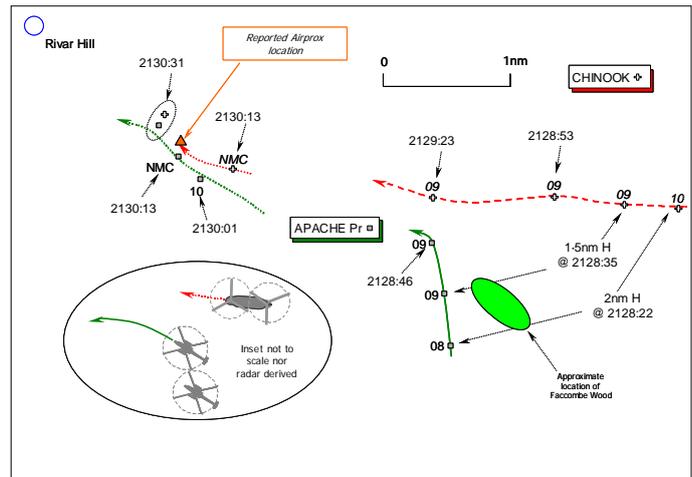
THE APACHE AH 1 PILOT reports he was leading a pairs night low-level conversion training sortie departing from Middle Wallop and routeing N from Andover at 300ft agl, VFR and not in receipt of an ATS. A squawk of A2676 was selected [unverified Middle Wallop conspicuity] with Mode C on; TCAS is not fitted. Both ac were displaying glimmers [non-NVG compatible tactical lights not visible all round] and conventional navigation lights on steady bright; in addition his No 2 also had red HISLs on.

Cause: Whilst overtaking, the Chinook pilot flew sufficiently close to cause the Apache formation concern.

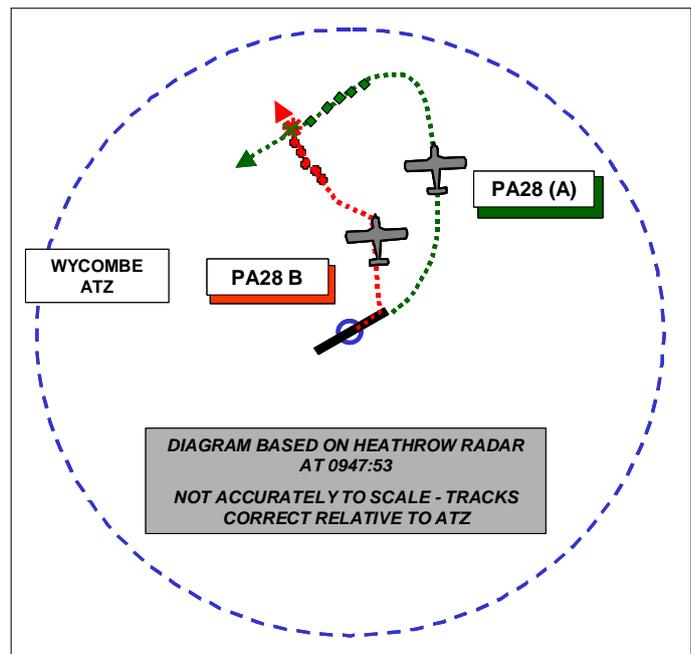
THE PA28 PILOT (A) reports that she was conducting a CPL Skills test (partial) in the cct in a white ac with orange stripes and was squawking 7000 with Mode C, while in receipt of an Aerodrome Control Service from Wycombe TWR. The cct traffic was light and only a few transmissions were heard on the RT. While at the mid-point downwind for RW06 (LH) heading 240° at 120kt, and discussing what type of approach to do next, her candidate saw another PA28 (with wheel spats) 150m away in their 10 o'clock, crossing their flightpath from left to right, at a similar height. As he exclaimed the ac passed 100m ahead of them heading in a northerly direction.

Cause: PA28 (B) turned into conflict with PA28 (A) in the Wycombe ATZ.

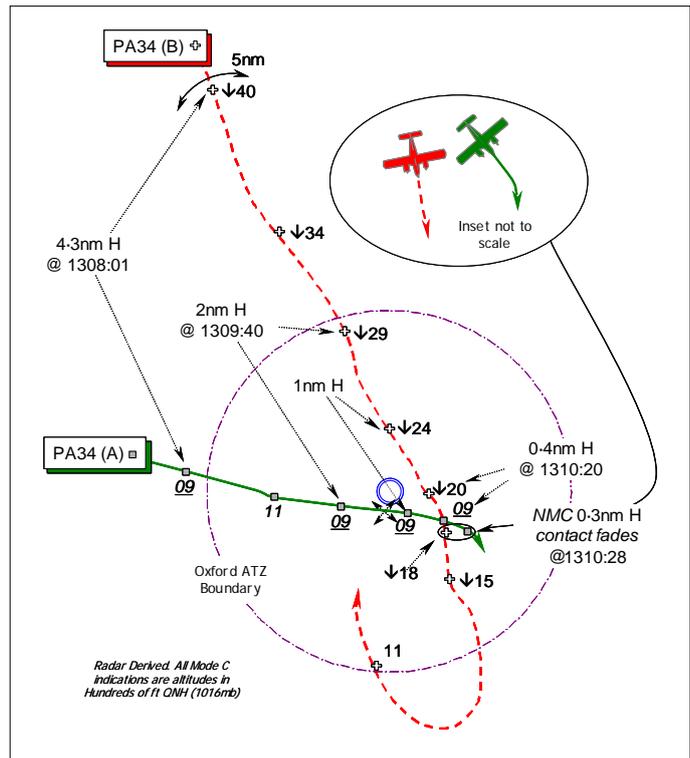
THE PILOT OF PA34-200T (A) reports that he was instructing a local instrument training flight at Oxford under VFR in VMC finishing with an NDB approach. The runway in use was RW01 and he was flying the published OXFORD/KIDLINGTON NDB (L)/DME 100° procedure with visual manoeuvring to the active RW. On completion of the approach, as instructed by Oxford TOWER, they were joining visually to RW01RHC - low level - at 800ft QNH (1016mb) [a height of about 530ft]. The controller had instructed them to position No2 to a Zlin on final approach but at the end of the downwind leg heading 190° at 120kt, TOWER alerted them to another ac joining the cct – another PA34 that was inside of them - and therefore to position as No3 in the pattern. Looking to their R nothing was seen until his student indicated the ac was above them, where it was seen 200ft above them, gear down and descending. No avoiding action was taken as they were visual with it and he assessed the Risk as 'low'.

Cause: The pilot of PA34 (B) did not comply with the APPROACH controller's instructions.

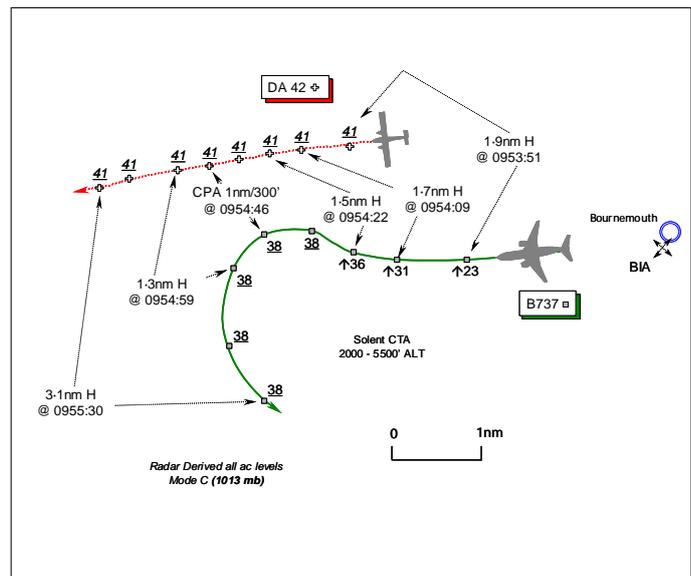
THE BOURNEMOUTH APPROACH RADAR CONTROLLER (RADAR) reports that the B737 was departing IFR under a RCS and released to stop climb at 3000ft Bournemouth QNH. The restriction was because of a DA42, operating IFR, holding on the BIA at 4000ft QNH to the WNW of the Airport. The DA42 had been 'locked' onto a heading of 260° and the B737 crew was instructed to fly a heading of 080°, which was queried by the B737 crew but the transmissions crossed. The B737 was then observed climbing through 3000ft, so the crew was instructed to 'stop climb now' by which time their ac was at an altitude of 3700ft. TI was passed to the B737 crew about the DA42 and the airliner was turned L onto a heading of 080°. Minimum separation was estimated to be 200-300ft/1nm; once horizontal separation was achieved the B737 was climbed to FL70.

TOWER did not ensure that the 'standard clearance' was amended to include the climb-out restriction of 3000ft and did not check the fps to ensure that the amendment had been passed. The TOWER controller did pass TI about the DA42 in the hold, which aided the B737 crew's SA and alerted them to the position of the DA42 on TCAS. It was evident that the delay to the B737's departure caused by the fox, together with discussion amongst the VCR staff caused a distraction. This delay and distraction broke the natural sequence of events and interrupted TOWER's normal thought process.

Cause: TOWER did not pass the altitude restriction to the B737 crew resulting in a conflict with the DA42.

- b. The Unit include, as part of their Training in Unusual Circumstances and Emergencies (TRUCE) programme, unusual events or circumstances that cause a period of delay or break in operations, with a view to ensuring that controllers pause to complete a situational check, before resuming normal operations.

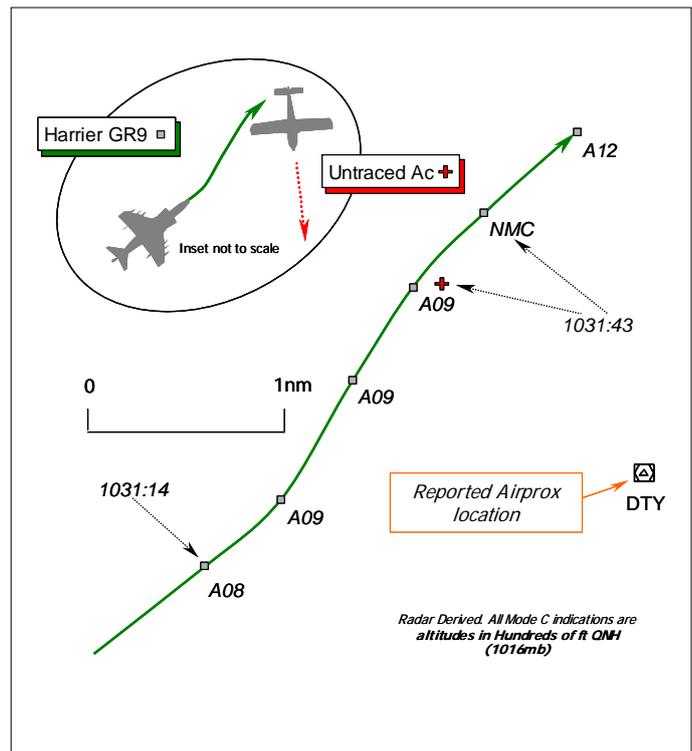
THE BAe HARRIER GR9 PILOT reports he was on the final leg of a low-level training flight from Wittering. He was not in receipt of an ATS; a squawk of A7001 was selected with Mode C. Neither TCAS nor Mode S is fitted.

Cause:	Conflict in Class G airspace resolved by the Harrier pilot.
Degree of Risk:	C.

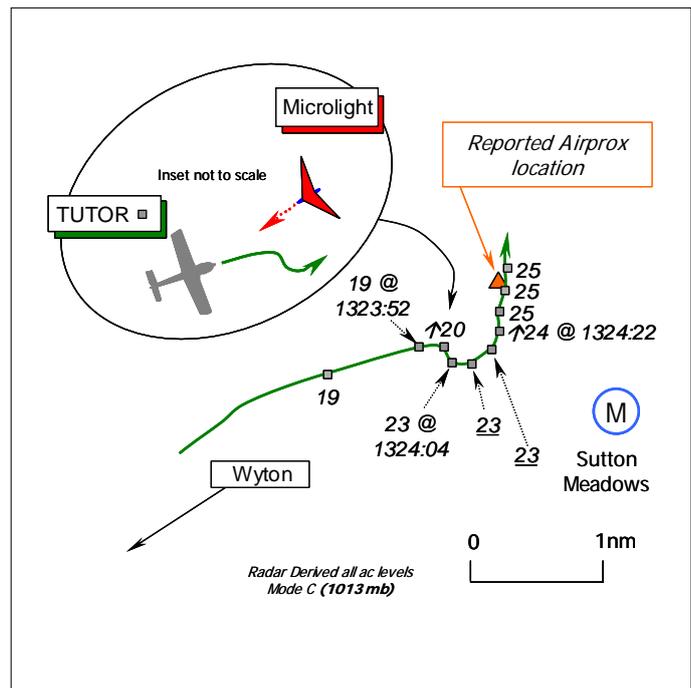
THE GROB TUTOR II PILOT reports he was conducting a local VFR instructional sortie from Wyton and was in receipt of a BS from Wyton APP on 134.05MHz. A squawk of A7000 was selected with Mode C on; elementary Mode S is fitted but the aeroplane is not equipped with TCAS.

Cause: Conflict in Class G airspace resolved by the Grob Tutor pilot.

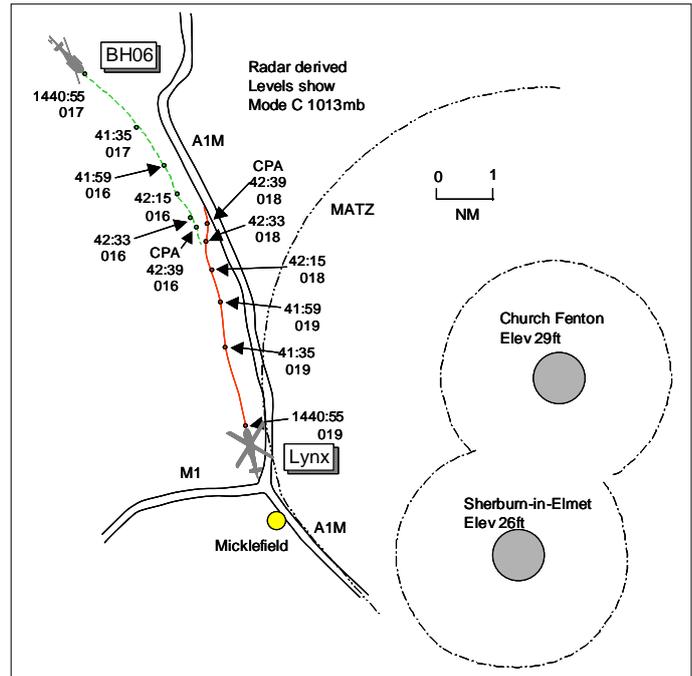
THE BH06 JETRANGER PILOT reports en-route from a private site in N Yorks to Sherburn-in-Elmet (SIE) VFR and in receipt of a BS from Church Fenton on 126.5MHZ, squawking an assigned code with Mode C. The visibility was 30km flying 4000ft below cloud in VMC and the ac was coloured blue with anti-collision and nav lights switched on. Heading 160° at 110kt and 1500ft QNH he had been handed over from Leeming to Linton-on-Ouse then Church Fenton involving 3 frequencies and 3 squawk changes. He received a call from Church Fenton on opposing traffic, 0.5nm, slightly lower to which he responded, "He's just gone past my window". He saw the Army helicopter late and turned R to avoid it, assessing the risk as high. He spoke to Linton ATC after the Airprox who informed him that under a BS there was no requirement for ATC to report conflicting traffic. He asked ATC why did he receive a very late call and was told that ATC need not have done that either. Later he asked what would have happened if there had been a mid-air collision and was told that there would be an inquiry.

Cause: Conflict in Class G airspace resolved by both pilots.

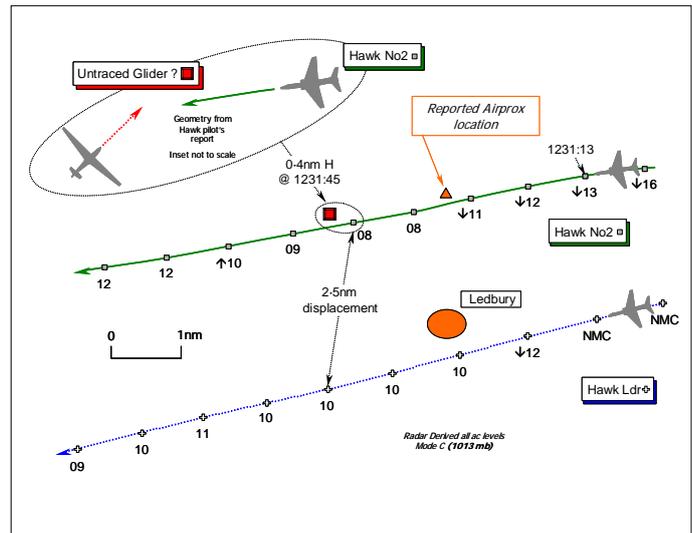
THE BAe HAWK T1 PILOT, a QFI, reports he was the wingman of a pair of Hawks carrying out a dual instructional evasion sortie in LFA 4. They were not in receipt of an ATS but monitoring a discreet frequency. A squawk of A7001 was selected with Mode C on; neither TCAS nor Mode S is fitted. His ac has a black colour-scheme and the white HISLs were on.

Cause: Conflict in Class G airspace resolved by the No2 Hawk pilot.

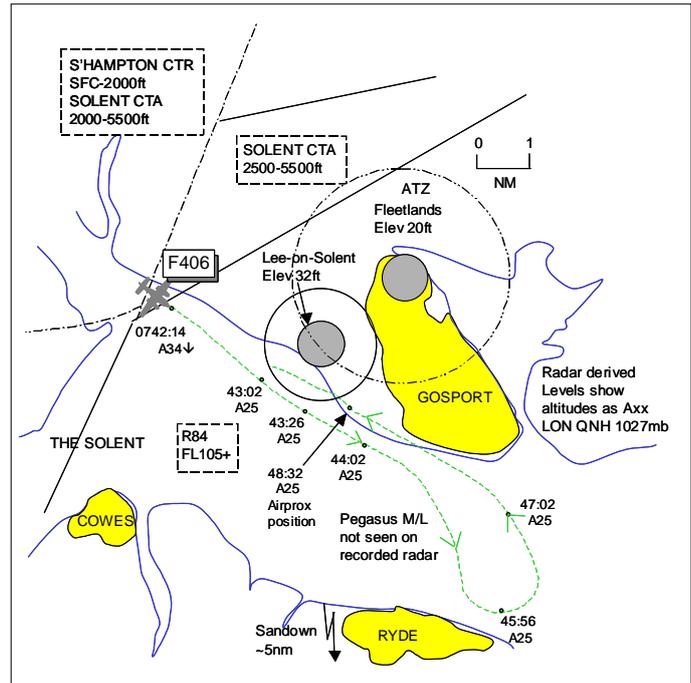
At 0745:51, the Microlight pilot reported approaching the mainland coast at Lee-on-Solent, descending to 2200ft. Solent Radar instructed the pilot to report at New Alresford and to remain outside CAS. No primary contact was seen on the radar recording. However, the Southampton unit investigation report indicated that a primary contact was observed on the Southampton radar recording, approximately 3nm SE of Lee-on-Solent. At 0745:56 the radar recording shows the F406, 5-9nm SE of Lee-on-Solent at 2400ft commencing a L turn onto a NW'ly track.

Cause: Effectively a non-sighting by the Pegasus Microlight pilot and a late sighting by the F406 pilot.

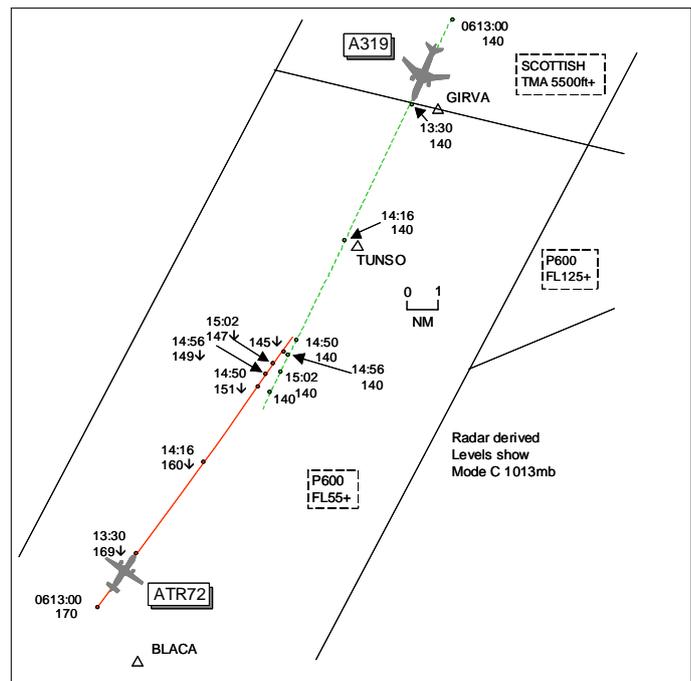
THE A319 PILOT reports cruising at FL140 en-route to Belfast IFR and in receipt of a RCS from ScACC on 123-775MHz, squawking with Modes S and C. ATC advised them of opposite direction traffic that had been cleared to descend to FL150; visual contact was made with an ATR 15nm ahead. A TCAS TA occurred as the ATR passed O/H as it had descended to +800ft of their level, before a TCAS RA 'monitor v/s' was received before 'clear of conflict' soon followed with no level deviation. Their TCAS showed the ATR to be behind them when it stopped its descent +400ft above their level. ATC checked with the ATR crew for their cleared level and told them of their 'level bust'. ATC was informed of their TCAS RA and they replied that a report had been filed. Visual contact was maintained continuously until the ATR passed O/H and he assessed the risk as high.

Cause: The ATR72 crew descended below their cleared level and into conflict with the A319.

The unit report also recommends the review of airspace 'hot spots', where similar occurrences might be likely. This has been accepted by unit management and the ATSD En-Route Inspectorate will monitor the progress of the recommendation as required.

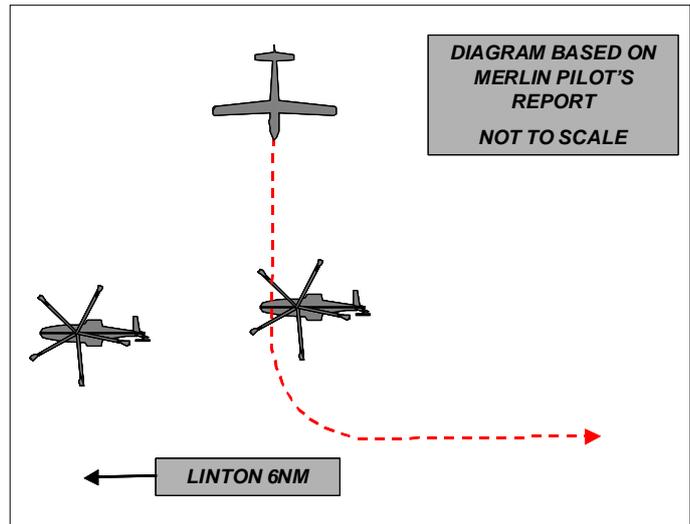
THE MERLIN HC3 PILOT reports that he was flying as No2 in a pair of green helicopters on recovery to Linton on Ouse, squawking 7000 with Mode C but, although the ac was fully lit, TCAS was not fitted. They were listening out on Linton APP, heading 270° at 2000ft agl and flying at 120kt, when the crewman observed a glider 100m away, pass approximately 100 ft above their ac and 150m to their right. The glider was tracking from N to S and turned onto E just after the ac crossed. They were unable to take any avoiding action as the ac had crossed before there was time to react but reported the incident immediately to Linton APP and their ac was recovered with no further incident.

Cause: Effectively a non-sighting by the Merlin crew and a possible non-sighting by the glider pilot.

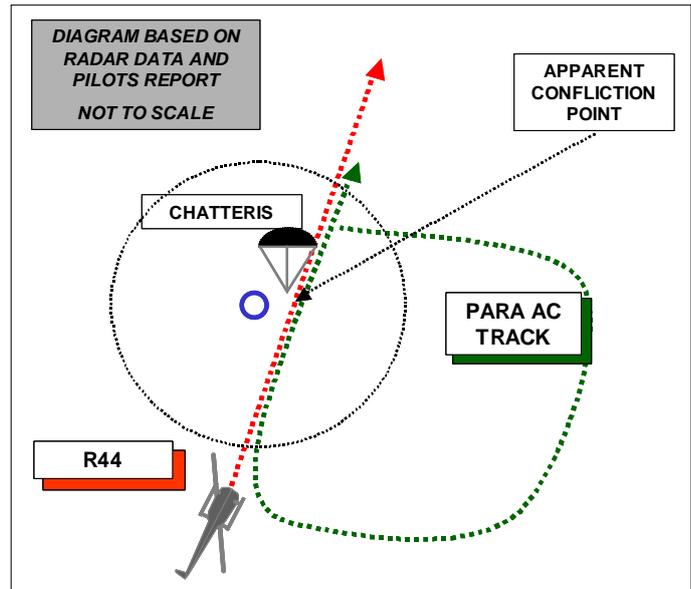
THE SKYDIVER reports that he is the CFI of North London Skydiving Centre and jumped from their Twin Otter ac at 5000ft agl following an AFF (Accelerated Free-Fall) student who deployed his main canopy 7sec after exit. He then deployed his multi coloured canopy which opened at 3000ft and had a fully operational parachute at 2500ft when he 'released his brakes' and looked to his right, immediately seeing a helicopter coming straight towards him. His immediate reaction was to pull down on both brakes, which had the effect of slowing his descent rate and the black helicopter, which looked like an R44, passed directly below him. It was difficult to tell the helicopter's exact height but the parachutist could clearly see the single helicopter occupant wearing a pink shirt, with blue trousers and he had brown hair. As the helicopter went away from him he tried to see the registration, but due to the angle he was unable to see the markings. He landed as soon as possible and immediately spoke to the DZ controller who was in RT contact with their ac and was talking to RAF Lakenheath Radar who reported that they had tracked the helicopter.

Cause: The R44 pilot flew into a notified and active Free-Fall DZ and into conflict with a Skydiver.

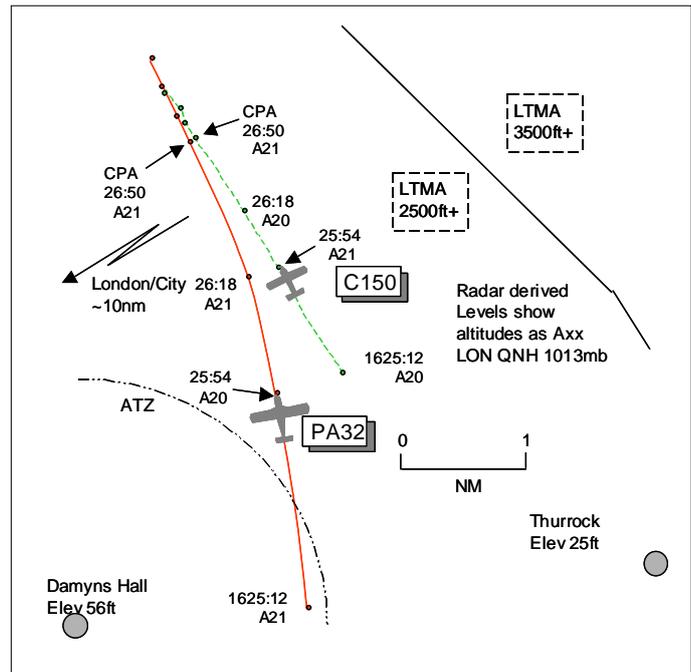
THE C150 PILOT reports flying an instructional sortie inbound to Elstree VFR and in receipt of a BS from Farnborough N, squawking an assigned code with Mode C. The visibility was >10km in VMC and the ac was coloured red/white/blue with anti-collision light switched on. After hearing TI passed to another flight he realised that they were conflicting traffic to it and that it was catching them up. Owing to their high-wing configuration, he couldn't see the other ac, which was behind them and to their L (7 o'clock) and reported to be 100ft above. Heading 330° at 85kt and 2000ft QNH they wanted to climb to overfly the Stapleford ATZ so he asked Farnborough if it was clear for them to do so, thinking the other ac may not be a factor any longer. They were told that there was no reason why they couldn't climb and just as the student advanced the throttle the other ac, a PA32, was seen to pass about 40ft above and 20-30m clear to their L.

Cause: The PA32 pilot flew close enough to the C150 to cause its pilot concern.

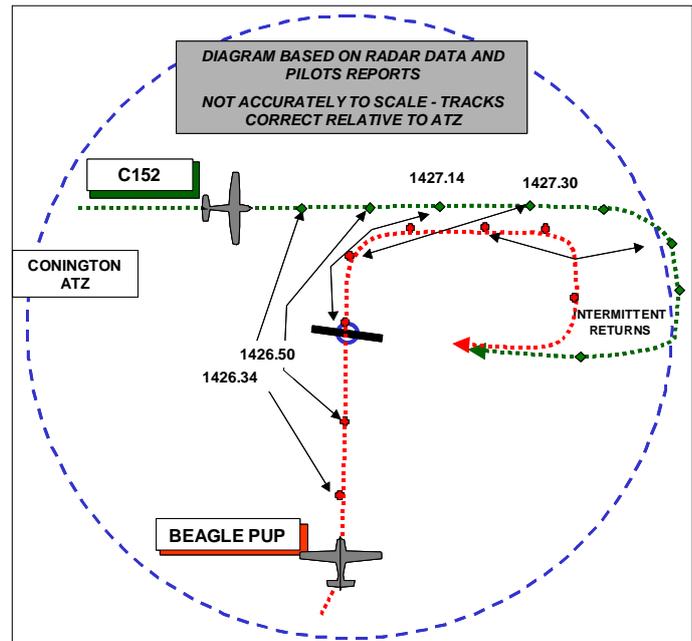
After take-off on RW28 he initiated a simulated engine failure from 700ft in order to demonstrate the relevant drills and recovery. As the subsequent recovery took their ac slightly outside the ATZ and he was aware that another ac had recently reported that it was descending deadside, prior to joining the downwind leg of the cct, he made a radio call "C/S rejoining downwind from the West". As they rejoined the downwind leg from the W, looking out of sun, he saw a Beagle Pup in their 2 o'clock on the deadside at the same level. Abeam the threshold of RW10, his student made a radio call "C/S downwind". He was still visual with the Beagle Pup, which was now in their 3 o'clock deadside, tracking North at the same level.

Cause: The Beagle Pup pilot did not establish visual contact with the C152 in order to integrate into the circuit.

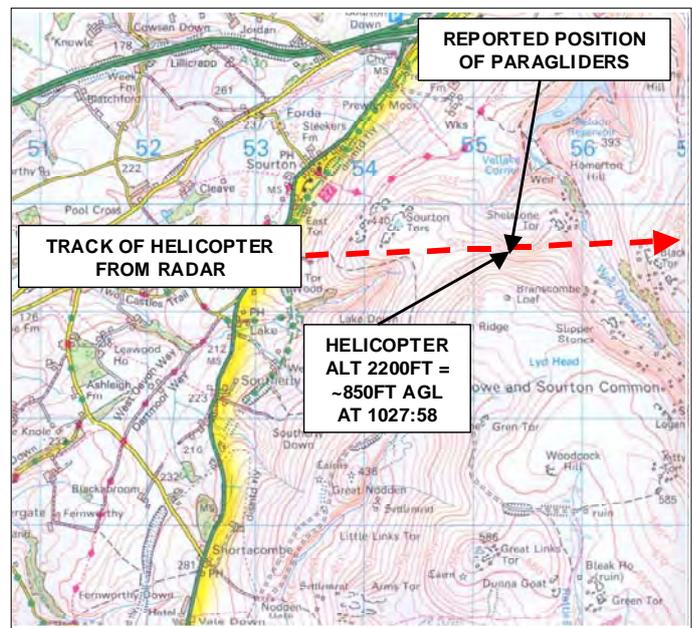
THE PARAGLIDER PILOT reported (2 reports were received but 3 paragliders were involved) that he was flying a multi-coloured paraglider at a local flying site with 2 other paraglider pilots. One had climbed to around 500ft above the hill [ground] and 200ft out from the ridge, another was around 100ft behind at a similar height and the third was 300ft to the W also at a similar height; all were ridge soaring at about 12kt. The first and second pilots both saw a blue and yellow police helicopter about 1nm away to the SW at about 700ft agl (i.e. 200ft above them) coming towards them. The helicopter continued on a straight and level course directly towards them and passed directly over them about 200ft above. The first pilot made large hand gestures to the helicopter pilot while the second made large turns, to show their position, but the helicopter took no evasive action or make any attempt to give them wider separation. The helicopter continued on his track towards Exeter without changing heading.

Cause: The EC145 pilot flew close enough to cause concern to a group of paragliders, some of which he may not have seen.

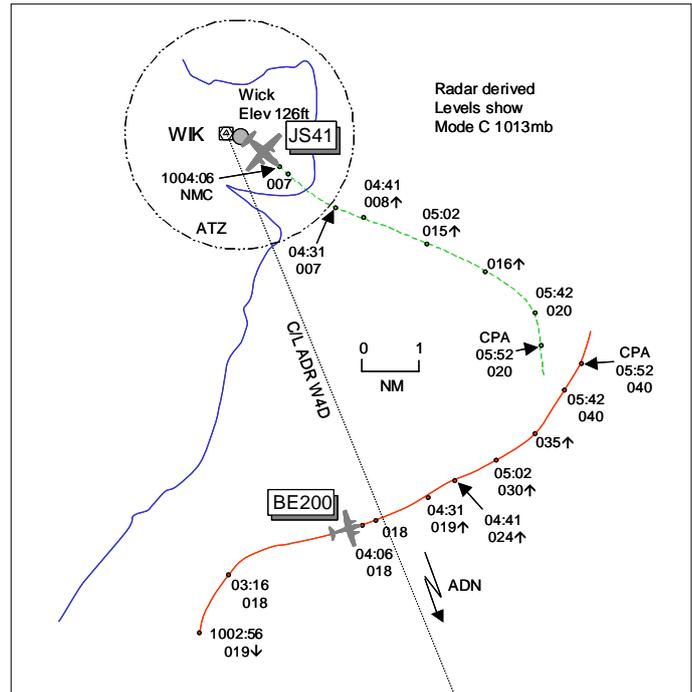
THE JS41 PILOT reports outbound from WICK IFR and in receipt of a PS from Wick squawking an assigned code with Modes S and C. On line-up RW13 they were given a local restriction on departure to climb and maintain altitude 3000ft owing to a BE200 inbound from the SE, which they believed had been cleared for the RW13 procedure maintaining 4000ft. On rotation he, the Capt PNF, noticed a TCAS contact 6-7nm ahead 1700ft above their ac. He confirmed this geometry with the PF and agreed to dial 1000ft into the ALT SEL window whilst the PF flew manually at 160kt and reduced the ROC until they had 'cleaned up' the ac. He requested ATC to confirm the level of the inbound ac to which they replied altitude 4000ft. He advised the controller that this did not agree with their TCAS display so ATC interrogated the BE200 crew and found that the flight was at 1800ft. The controller then instructed the BE200 pilot to climb immediately to 4000ft before they were instructed to climb and maintain altitude 2000ft. It appears that the BE200 crew was under the impression that they were cleared to descend with the RW13 arrival as 1800ft is the platform altitude. He assessed the risk as low.

Cause: APP cleared the BE200 into conflict with the JS41.
