ASSESSMENT SUMMARY SHEET FOR UKAB MEETING ON 21 July 2010

AIRPROX REPORT No 2010004

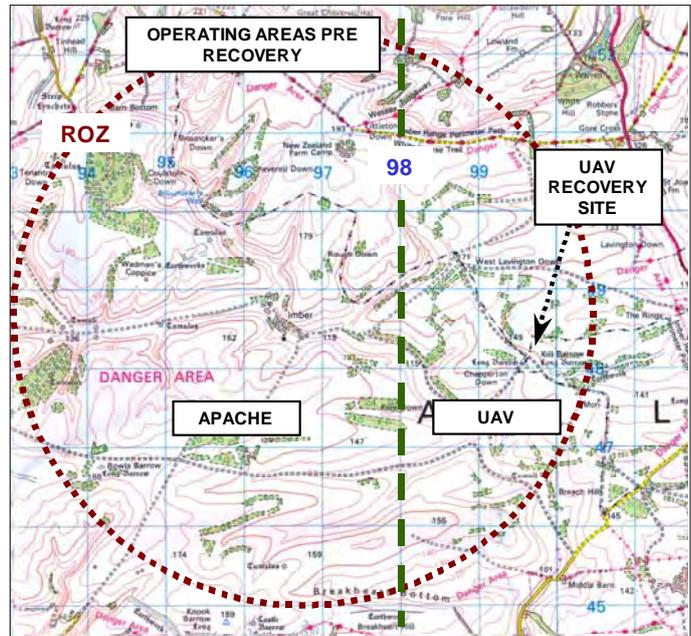
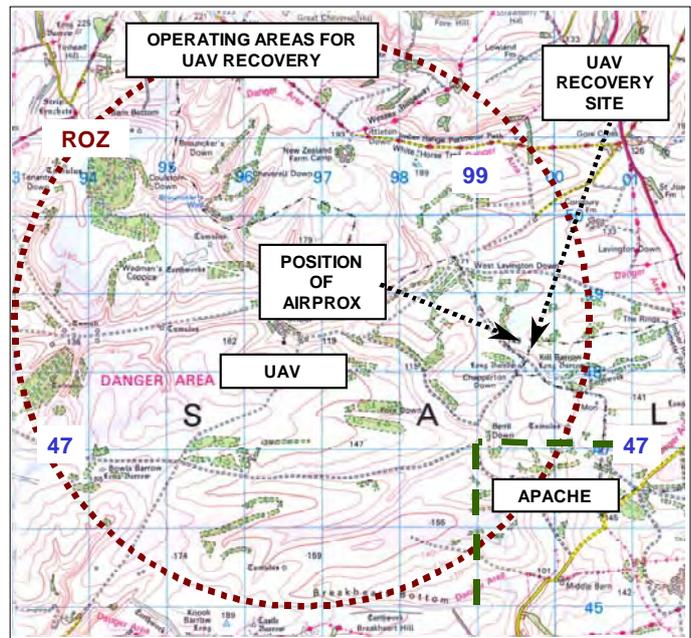
THE DH3 UAV PILOT reports that he was operating a small, non-SSR or TCAS equipped UAV in an exercise ROZ [Restricted Operating Zone], 2nm in radius from 0-1500ft amsl centred on 5114N 00203W (see diagram). Meanwhile an Apache was cleared to operate in the ROZ and was being deconflicted geographically by the Tactical Air Control Party (TACP). He understood that the Apache was cleared to operate W of the 98E 'line' and his UAV was to operate to the E.

The Tactical Commander (TAC) informed the TACP that the DH3 needed to recover due to low battery endurance, and it was planned to recover to a point at ST 997481 (see diagram); he also informed the TACP that a new de-confliction plan would have to be implemented. They agreed that the Apache would have to operate E of the 99E and S of the 47N and informed its pilot. The TACP asked the Apache pilot to confirm when he was S of the 47N deconfliction line; he replied that he was already to the S and they passed this on to the DH3 TAC.

The Apache then moved to the N and the DH3 FSO (Flight Safety Officer) reported to TAC that it was breaching the deconfliction line. The TACP again asked the Apache pilot to confirm that he was S of the 47N, and he verified that he was. At this point the Apache was identified by the DH3 FSO to be at Grid ST 995479 [just under 1km N of the line and very close to the DH3 recovery point] at about 300ft agl (radar verified with Salisbury Air Ops). At this time the DH3 was in its landing pattern at 300ft agl, 300m from the Apache and on a collision course with it. The DH3 FSO instructed the UAV operator to initiate an immediate orbit to prevent collision and it was then commanded to fly to the NW, away from the Apache.

Cause: Conflict in a ROZ resolved by the UAV operator.

Recommendation: The MoD ensures that FACs are instructed in Airprox reporting and investigation procedures.

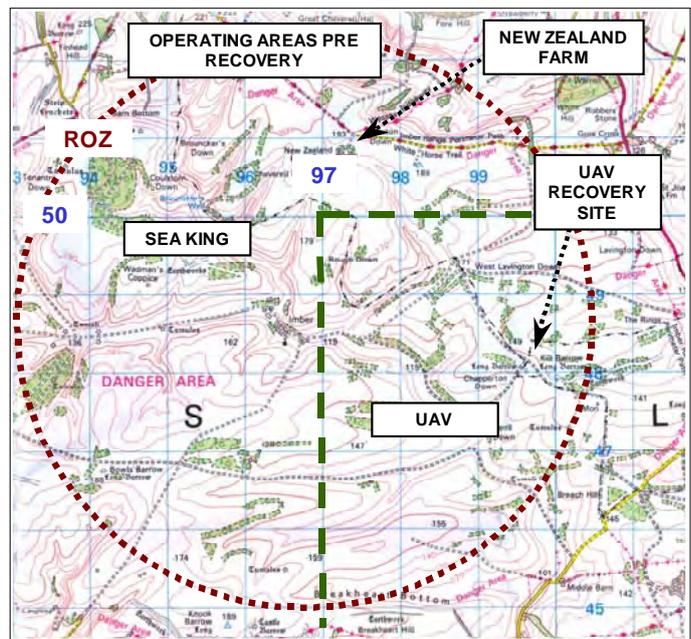
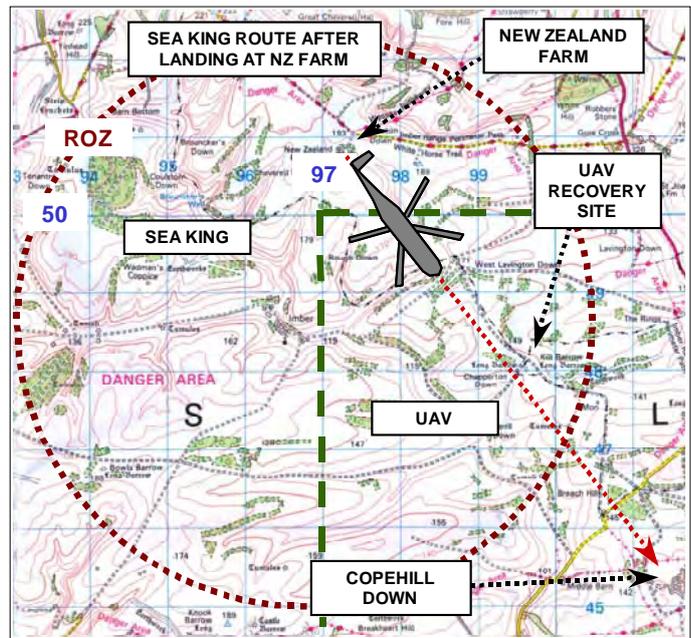
After taking off from the FOB a short time later the Sea King routed direct from the FOB to Copehill Down (2nm SSE of the landing site) at low level. This routing took them through the airspace reserved for the DH3.

At this point the DH3 was turning left and descending, 300m out in its final landing pattern, flying at 32kt, when the Flight Safety Officer (FSO) saw the Sea King approaching 700m away. He carried out the immediate action drill, sending the UAV into an emergency orbit away from the flight path of the Sea King. The helicopter came within 300m of the UAV with both ac at the same alt. This was a very close encounter and had the FSO not reacted so quickly a mid air collision could have occurred. Since the Sea King was flying so low it was not seen by the air sentries and gave the Detachment little time to react; it was also too low for RT contact with the TACP.

The Officer Commending the exercise investigated the incident and it was found that a breakdown in communications between the Sea King and the JTAC (Joint Tactical Air Commander) led to it flying through UAV segregated airspace.

Cause: Conflict in a ROZ resolved by the UAV operator.

Recommendation: (See Airprox 2010004)

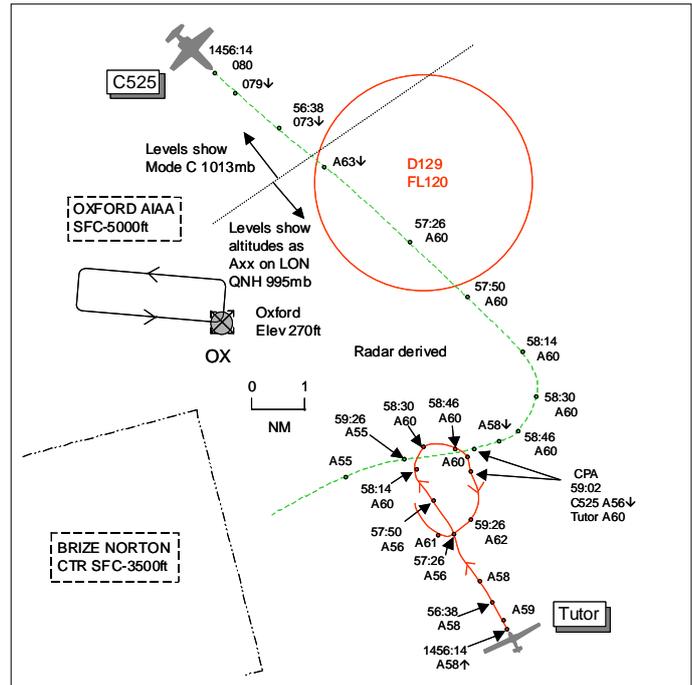
THE C525 PILOT reports flying solo inbound to Oxford IFR routing from PEPUL [33nm NW OX] on a very late handover to Oxford ATC from London when only 5nm from the OX NDB, descending to FL65. After an introductory call to Oxford he was already at the OX and he requested further instructions. ATC told him to either orbit or join the hold at FL65 and he elected to join the hold. He turned R and entered the hold and almost immediately TCAS commanded a 'dive'. He saw the traffic, a single-engine ac, flying amongst the cloud tops and heading straight towards him. He initiated a rapid dive and immediately entered cloud becoming fully IMC, estimating the CPA as 0.5nm at the same level. He informed ATC of their actions and was cautioned on other traffic in the hold at FL35. He stopped descent at FL55, he thought [actually FL60], and the other traffic in the hold was identified on the TCAS screen. Meanwhile a new target entered the hold area from the NE heading directly towards them, which led to a second TCAS RA 'descend'; he turned sharp L to avoid the traffic. He descended to FL35 and by now his ac was S of the hold. He informed ATC who told him the Wx was clearer to the NW and recommended further descent in this area. After turning onto a NW'ly heading he found a 'wall' of ac targets, so many that despite a TCAS range of 5nm he was unable to read many of their heights owing to 1 target covering the altitude numbers of others. He turned W to try and find a gap in the traffic and a way through. Eventually he headed N in clear air and descended to 2000ft QNH. He then realised that after flying at FL35 he had entered the Brize CTR by descent whilst looking for a way N. He later rang Brize Supervisor to apologise and he also spoke to Oxford ATC who was unaware of the conflicting traffic. At no time was his IFR status officially cancelled. He considered that his ac was at great risk on several occasions and the situation of a protected environment whilst IFR and IMC should be considered.

Cause: Conflict in Class G airspace resolved by the C525 pilot using TCAS.

Recommendations. RAF Brize Norton will continue to provide TS to Tutor ac until RAF Benson recovers its Watchman radar. RAF Brize Norton has a long standing LoA with Oxford Kidlington ATC

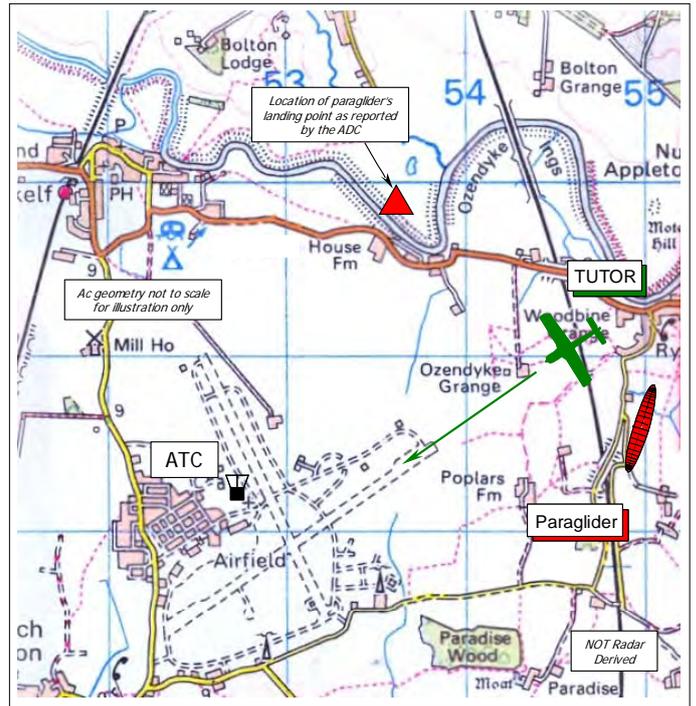
It was unfortunate that the paramotor pilot could not be traced since, in the absence of a report from him, the Board recognised that the details of this Airprox were far from complete. Whilst it was feasible the paramotor pilot might have got into difficulty whilst airborne and had to make an emergency landing, Members believed it would have been wise to have contacted Church Fenton ATC afterwards to advise them what had occurred. A radio failure was feasible, but that would not absolve the paramotor pilot from compliance with the Rules of the Air. However, that was all conjecture; the ATZ should be a known traffic environment with all ac operating within it either pre-notified to the ADC or in communication with TOWER on the RT. It was plain to the Board that the paramotor pilot had not contacted the ADC to allow entry into the ATZ beforehand, or called TOWER on RT to obtain permission from the controller, which is contrary to Rule 45 of the Rules of the Air. This Airprox was a reminder to all pilots of what can occur with an unannounced intrusion into the ATZ, and more significantly, through the cct and final approach area where it might least be expected. Members agreed unanimously that in the absence of any known extenuating circumstance the Cause of this Airprox was that, contrary to Rule 45 of the Rules of the Air, the Paramotor pilot entered the Church Fenton ATZ without permission, resulting in a conflict with the Grob Tutor on final.

Cause: Contrary to Rule 45 of the Rules of the Air, the Paramotor pilot entered the Church Fenton ATZ without permission, resulting in a conflict with the Grob Tutor on final.

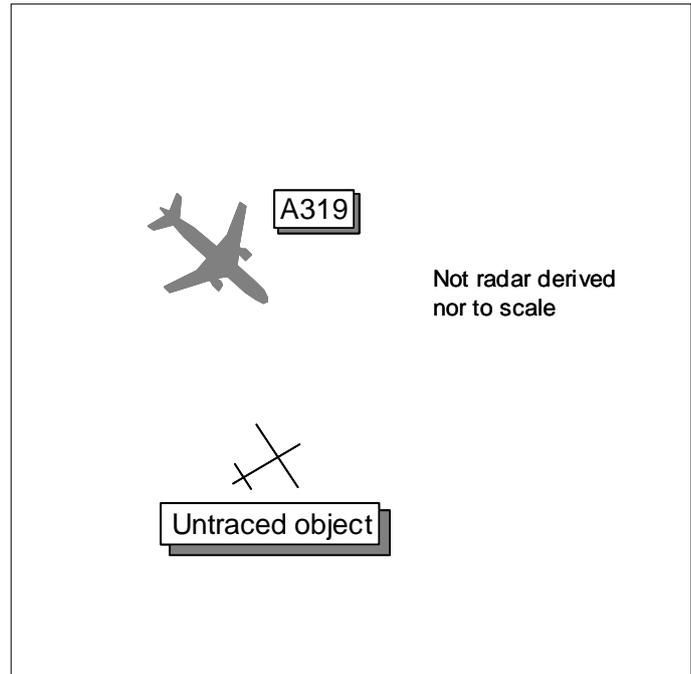
THE A319 PILOT reports inbound to Bristol IFR and receipt of a RCS from Bristol, squawking an assigned code with Modes S and C. Whilst descending to 6000ft on radar heading 140° at 220kt, the FO pointed out an object in their 12 o'clock position at roughly the same level. He, the Capt PF, looked out and saw the object fly under the ac's nose; its level was difficult to judge but he thought it was between 50-100ft below. The FO described the object as ac shaped coloured white with a red stripe, in an apparent bank to its R and he, the Capt, having only seen it for 3-4sec confirmed the colour and shape. The radar controller was asked for any TI or possible contacts but nothing was seen on radar.

Although the crew reported sighting an ac shaped object, the radar recording did not show any target in the location that could be correlated with an ac type radar return. The primary only return in conflict captured on the Bristol radar was moving in the direction of and at the speed of the reported wind. Had this target been a balloon or possibly a bundle of balloons, it/they would have appeared to the crew to pass them very quickly owing to the high speed differential. Members thought it unlikely for it to have been a glider owing to the high level of the encounter, the Wx conditions at the time and the closeness to sunset. With the tracing action ruling out breakaway balloons, notified balloon releases and no ac identification possible, Members could offer no explanation as to the identity of the reported object. Members reluctantly agreed that, on the limited information available, this encounter would be classified as a conflict within Class D airspace with an untraced object but it was not possible to assess the risk of collision.

Cause: Conflict in Class D airspace with an untraced object.

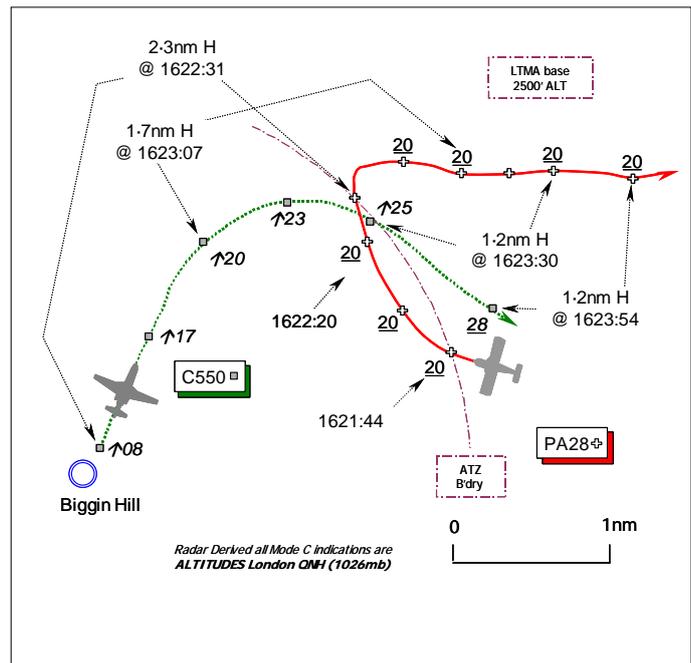
PA28 was turned out of the way promptly and by swiftly passing TI to both flights. It was plain that the PA28 pilot had inadvertently entered the Biggin Hill ATZ without permission, which Members agreed unanimously was the Cause of this Airprox.

Cause: The PA28 pilot inadvertently entered the Biggin Hill ATZ without permission.

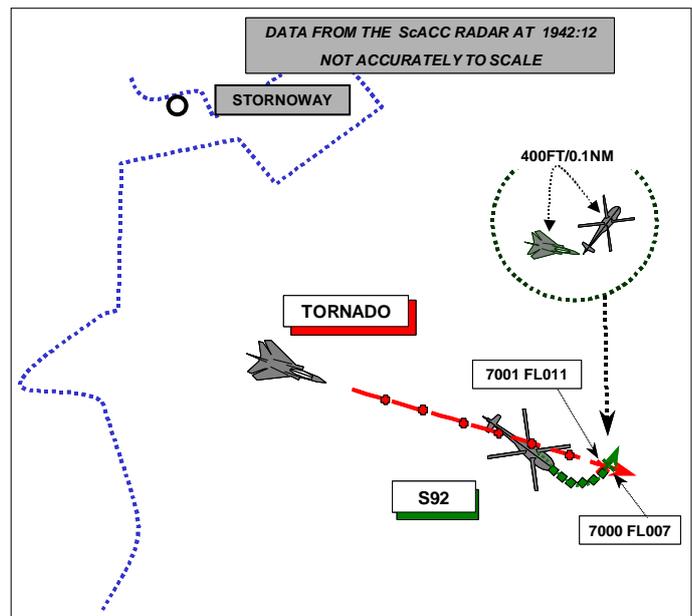
THE S92A PILOT reports that they departed Stornoway Airport at 1933Z on a SAR training exercise, under IFR, in a TCAS(1) equipped ac, squawking 7000 with Modes C and S; nav lights and upper and lower red and white strobes were switched on. The sortie was planned to work with a surface vessel 23nm to the SE of Stornoway. They climbed to 1500ft on the Stornoway QNH of 1034mb and tracked 140° at 80kt towards the vessel. When they were about 10nm out from Stornoway they cleared from Stornoway APP since it was due to close and advised them that they would continue with Scottish Info on 127.275 as they would be clear of the Stornoway area (If they had been operating in the Stornoway area, they would have remained on Stornoway and transmitted blind calls even when ATC is closed). Prior to calling Scottish, they heard a Tornado on the APP frequency and heard ATC passing the Tornado crew details of their approximate height and position and suggesting that they (the Tornado) call Scottish for further information.

THE TORNADO GR4 PILOT reports flying a basic night low level TFR night training sortie in Night LFA 1BE/W, squawking 7001 with Mode C; night area 1BW was an RAF Lossiemouth allocated night flying area. At 1942 when they were about 22nm SE of Stornoway at 1500ft, heading 105° at 420kt, they came close to a Coastguard helicopter in Class G airspace over the sea. The pilot was not wearing NVGs but at the time of the incident the navigator was.

The Board observed that although this was a serious incident, it could easily have been avoided. Had the Tornado crew been aware of the pre-planned training flight of the S92 it is probable that they would have given it a wide berth. Members were surprised that there was no interaction between the Coastguard operators and the Military (specifically the Low Flying Booking Cell); they were also surprised when they were informed that RAF Lossiemouth crews, the prime users of that part of the night low-flying system, were not aware of the Stornoway Coastguard activities. They considered this to be a significant breakdown in communication and agreed that the onus was on the Coastguard operators to inform the Military rather than the Military to seek the information. Far from being a quiet area, the NW of Scotland is widely used by Military ac at night. Members noted that, although the Military Low Flying Handbook Sect 3 (Night) warned of several SAR Helicopter Night Training Areas and night SAR procedures, Stornoway was not mentioned. The Board therefore recommended that this be reviewed. One Member also suggested that the CANP procedure (AIC Y028/2010 refers) could be extended to include Coastguard training flights.

Cause: Conflict in Class G airspace resolved by both crews.

1. The MoD is recommended to amend the Low Flying Handbook to provide more comprehensive guidance on SAR training flights.
2. The Maritime Coastguard Agency considers using existing CANP procedures to notify military crews about Coastguard training flights.

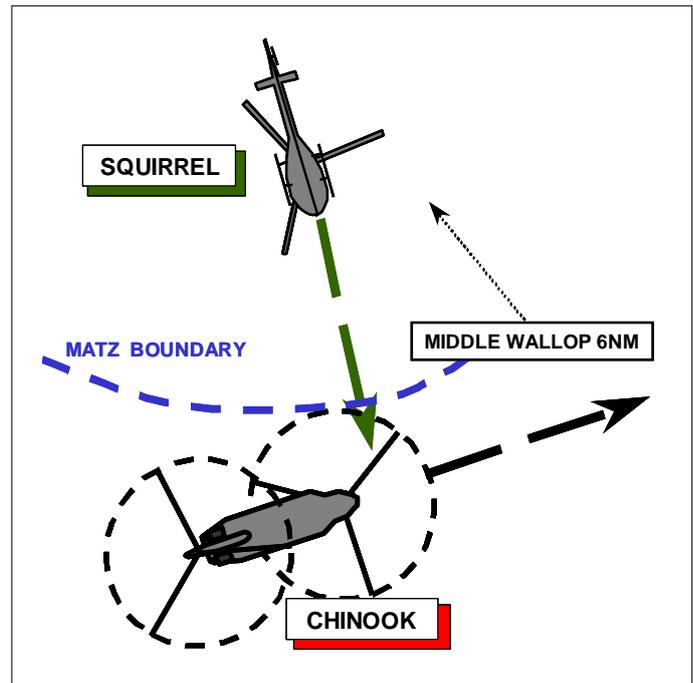
THE SQUIRREL PILOT reports that they were flying a standard night departure from Middle Wallop, in receipt of a BS from TWR and squawking with Mode C. When they were approaching the southern MATZ boundary, heading 170° at 90kt, having cleared with TWR, they commenced a descent to 200ft agl and while in the descent a Chinook passed through their 12 o'clock flying from right to left, about 100ft lower than them and about 300m ahead. He assessed the risk as being high.

The Board was unable to determine positively why the night flying notification procedures had not worked as designed; it seemed, however, that there might have been a breakdown of the communication chain in RAF Odiham Ops centre. One Member also observed that, although his report was minimal and very late, the Chinook pilot also appeared to be unaware that the Squirrel was entering the LFA to the S of Middle Wallop at the time they passed through the area.

Cause: Non-sighting by the Chinook crew and late sighting by the Squirrel crew.

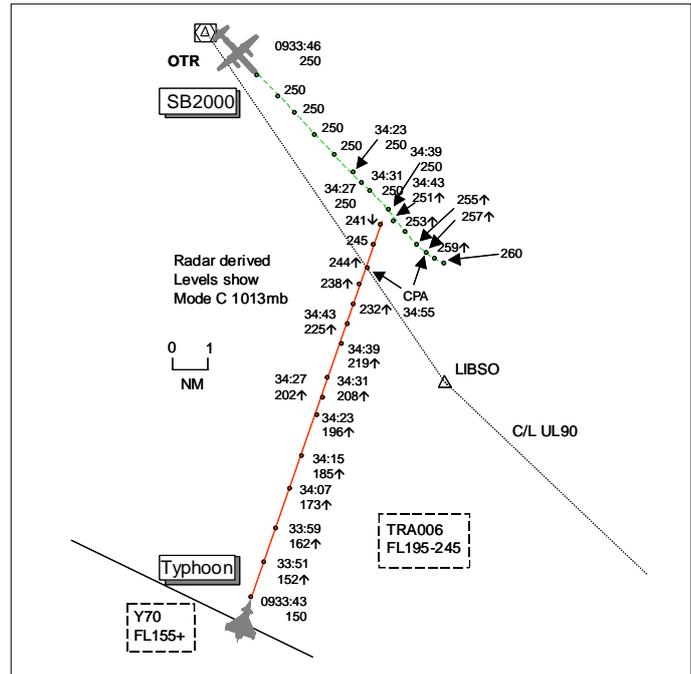
THE SCACC E SECTOR RADAR CONTROLLER reports that the SB2000 was inbound to Norwich in the area of OTR at FL250. A military squawk [the subject Typhoon] was seen crossing under airway Y70 NE'bound at FL150 and then it commenced a climb at a high rate so he asked the Planner to call London Mil Console 15 to coordinate. The Console 15 controller said that he would stop-off the Typhoon at a lower level but as the Typhoon was passing FL200 the SB2000 crew received a TCAS RA and climbed to FL260. As the crew were already responding to the RA and the Typhoon's track was taking it behind the SB2000 it was deemed unnecessary to give avoiding action. Instead he gave TI to assist the crew in locating the traffic. The Typhoon continued with its high ROC and was observed at FL246 with 1.6nm lateral separation against the SB2000. He commented that this had been the 3rd time a civil ac under his control had had to respond to a TCAS RA against fast climbing military traffic.

The SB2000 passed OTR at 0933:32 having attained its new cleared level of FL250. At this time a Typhoon under the control of London Military E (Console 15) was 20nm S of OTR and tracking N at FL150 underneath airway Y70 in uncontrolled airspace. As the Typhoon passed the N edge of Y70 it was observed to commence a steep climb. The SB2000 was 14nm N of the Typhoon.

In determining the cause of the Airprox, Members considered the inducement of the TCAS RA and the 'level-bust'. Although the RA on its own might have resulted in the declaration of an Airprox, the 'level-bust' would have put the Typhoon within 400ft and 1.7nm of the Saab, had the latter not followed its TCAS RA demand and climbed to FL257 at the CPA. As it was, the SB2000 crew had been given the 'heads-up' with a TCAS TA and had then reacted promptly to the RA, flying the avoidance manoeuvre until 'clear of conflict' had been received. The Typhoon crew had been issued with TI on the SB2000, located it on radar and then seen it pass above and to their R whilst attempting to level-off. Therefore the Board agreed that the combined actions taken by all parties had ensured that safety margins had not been eroded even though the Typhoon crew climbed above their assigned level, the cause of the Airprox.

Cause: The Typhoon crew climbed above their assigned level.

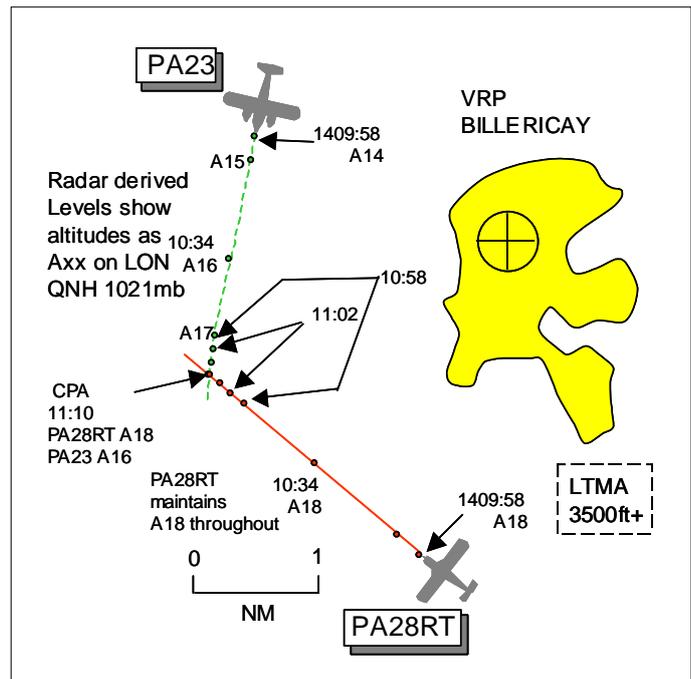
THE PA23 PILOT reports enroute to Redhill, VFR and in receipt of a BS from Farnborough on 132.8MHz, squawking 5031 with Modes S and C; PCAS was fitted. The visibility was 20nm CAVOK VMC and the ac was coloured white/blue/red. Heading 200° at 1900ft QNH 1021mb and 130kt, the pilot seated in RH seat saw, identified and pointed out to him fast-moving traffic, a bronze coloured single-engine low-wing T-tailed ac in his 9 o'clock at the same height. He immediately initiated a dive estimating the other ac passed 50ft above and 100m clear ahead, appearing to continue W'y uninterrupted. No TA alert was received during the encounter and he assessed the risk as high.

the cause of the Airprox. The PA23 pilot was alerted to the approaching PA28RT by a warning from Farnborough LARS N, a good call, which facilitated his visual acquisition, albeit late, which was the other part of the cause. The opportunity for the pilots to see each other's ac was there for some time prior to the Airprox; however, with the ac approaching on a constant bearing, the conflicting ac would appear as a stationary object within the pilot's field of view making detection more difficult. Moving one's head in the cockpit or altering the ac's flightpath by turning breaks the situation, creating relative movement between ac and an improved opportunity for visual acquisition. There was little time between the ATC warning and the CPA but the PA23 pilot reacted quickly and dived his ac below the PA28RT, which passed 50ft above and 100m ahead. The Board believed that this action had been just enough to remove the actual collision risk but that safety had not been assured as they passed.

Cause: Non-sighting by the PA28RT pilot and a late sighting by the PA23 pilot.

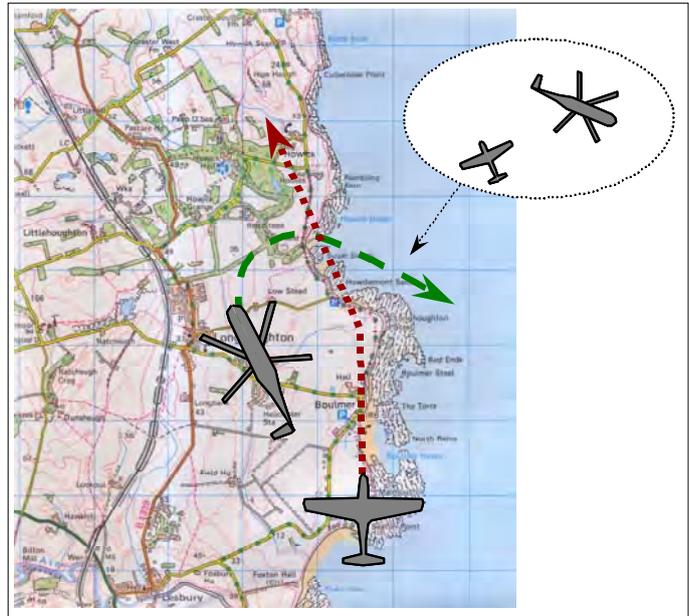
THE SEA KING PILOT reports flying a yellow helicopter on a local S&R training flight squawking 7000 with Mode C in contact with Boulmer Radio. Whilst completing the finals turn of a drum winching circuit, in a period of high workload, in a 30° aob right turn onto 120° at 50kt and descending from 150ft AMSL towards 100ft, the winchman, who was primarily concentrating his attention on remaining visual with the simulated survivor through the right-hand bubble window, called “ac 2 o’clock high”. The reported ac was a red and white Chipmunk, initially 300m away, which passed 125m to the right and 50ft above. The winchman continued to observe the ac and call its position as it descended northwards along the coast passing behind them. He did not take any further avoiding action as he was already in a descending turn to 50ft asl. The ac was last seen behind them on the coast where it was then obscured by the terrain. At a time interval of 90sec after the CPA, the winchman judged that the ac appeared to be flying at 100ft agl, based on the height of the Sea King and the backdrop with the horizon.

Although unable to resolve the differences positively, Members agreed that the Chipmunk was probably further from the Sea King than its crew estimated, but considerably closer than the Chipmunk pilot estimated; by flying close to the Sea King at a critical time in their winching circuit the Chipmunk pilot had caused the Sea King crew concern.

Cause: The Chipmunk flew close enough to the Sea King to cause its crew concern.

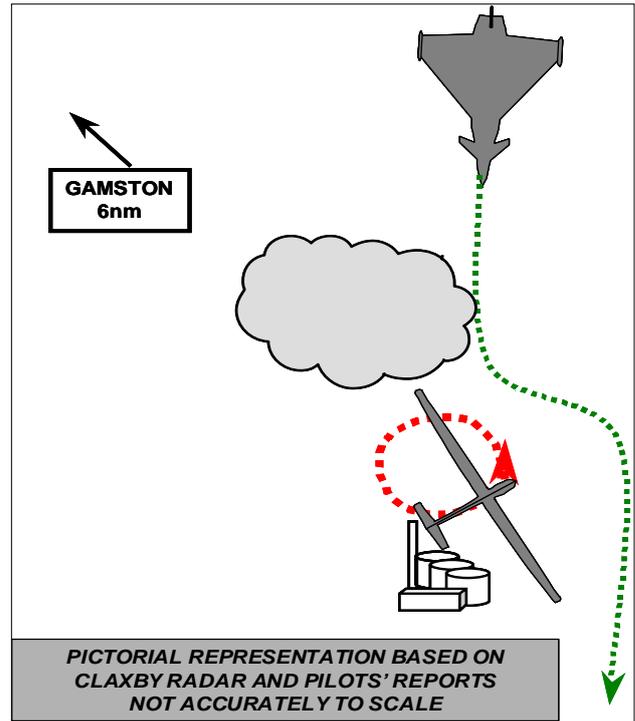
THE TYPHOON PILOT reports flying a grey ac with HISLs and nav lights switched on, on a dual training flight from Coningsby, squawking 7001 with Mode C but not in receipt of an ATS; TCAS was not fitted. While heading 180° at 360kt and at 2300ft on the RPS, a mid wing, unpowered glider was seen about 2nm ahead in a left turn, at the same alt, but to the right of the nose. Initially he did not consider it necessary to take avoiding action, as the glider appeared to be moving away to the right, so his unaltered flight path would take him safely behind the glider without alarming its pilot. As they closed however, he observed that the glider's high turn rate and low turn radius was such that it had performed a level left hand turn through about 120° and was then converging from right to left and significantly reducing the separation distance. He therefore broke left to give the greatest spacing possible and generated a lateral miss-distance of about 500ft thus ensuring that there was no risk of collision.

The GA Member opined that the Typhoon pilot did well to see the small cross-section, white glider early enough to assess its flightpath and avoid it when it made an unexpected turn towards him. The HQ Air Member noted the glider pilot's comment regarding thermals over power-stations and the increased probability of encountering gliders there, but thought that many military aircrew would not be aware of this; he thought it most informative and worthy of publicising.

Cause: Conflict in Class G airspace resolved by the Typhoon pilot.

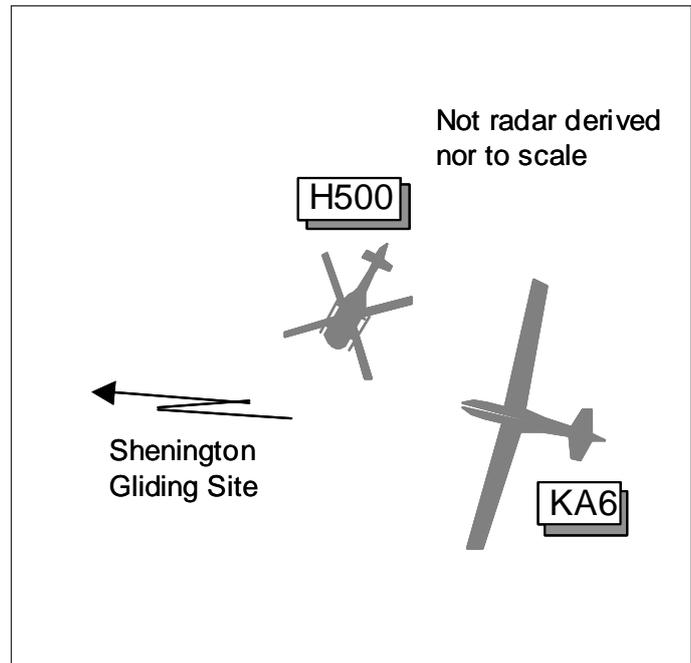
THE KA6 PILOT reports returning to Edge Hill from a 5hr 20min Silver endurance flight and in communication with Shenington Radio on 129.975MHz. The Wx was VMC and the ac was coloured white/green. After turning on to the approach at 600ft heading 280° at 55kt a helicopter took off from a field between the perimeter fence and the school, and then flew directly across his approach path. As he descended through 500ft on his approach, the helicopter passed just ahead and then about 200ft below him. At the time the strong wind and turbulent thermals precluded a go-around and gain of height from his position on the final approach. Also, an avoidance L or R turn was not possible owing to a lack of suitable landing fields. He was also concerned that the rotor wash could have potentially caused loss of control at this critical phase of flight. He assessed the risk of collision as none.

Cause: The H500 pilot took off from a site in the vicinity of the approach to Edge Hill/Shenington and into conflict with the KA6, which he did not see.

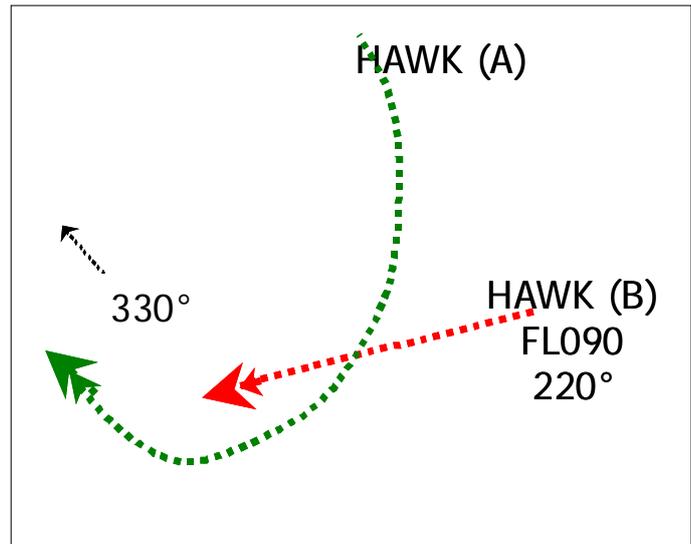
THE HAWK PILOT (A) reports flying a black ac on an aerobatics training sortie with HISLs and the nose light switched on, listening on the Valley VHF deconfliction frequency and squawking 7005 [aerobatics]; TCAS was not fitted. While pulling to level at base alt of 7000ft (RPS), during the final quarter of a looping manoeuvre above scattered cloud 3nm East of Lake Bala, using the valley as a reference (track of 150°/330°), another Hawk was seen in their right 4 o'clock about 3000ft above. Shortly after, the other ac [Hawk (B)] made contact with them on the frequency in use to report that they had passed extremely close.

The Board noted that both Hawks had been operating legitimately in Class G airspace and had an equal and shared responsibility to see and avoid other ac. Although, due to RAF Valley local warning procedures, the crew of Hawk (A) knew that Hawk (B) was in the general area, neither crew was aware of the close proximity of the other ac until after they had passed the CPA.

Cause: Effectively non-sightings by both Hawk crews.
