ASSESSMENT SUMMARY SHEET FOR UKAB MEETING ON 20 Jul 2011

AIRPROX REPORT No 2010174

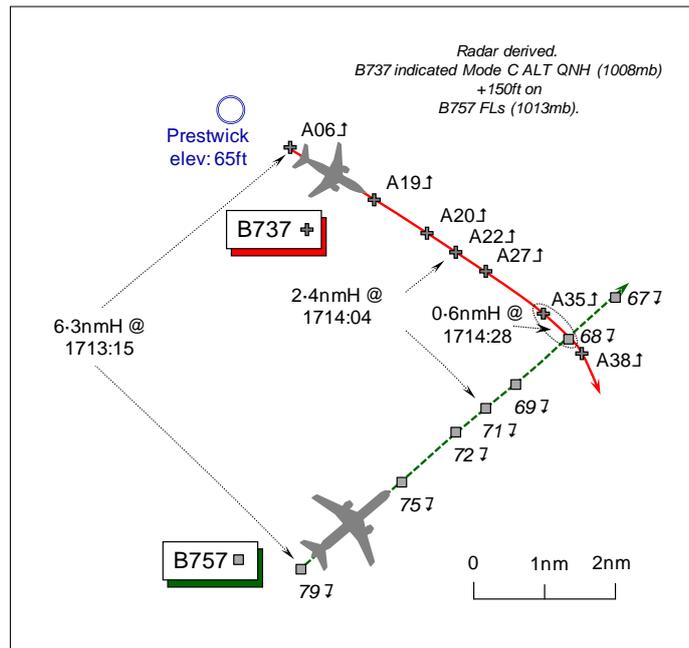
3250ft V @ 0.5nm min H

[UKAB Note (1): The B757 was displayed at FL068 within the Scottish TMA and the B737 at ALT 3700ft (1008mb) within the Prestwick CTR giving vertical separation of about 3250ft at minimum horizontal separation of 0.5nm.]

It is likely that the distraction of the inbound Tornado and the short notice opening of the APR position lead to an incomplete transfer of information between TWR and APR with regard to the traffic situation.

Cause: An incomplete handover of the Approach Control function between TWR/APP and the APR.

Degree of Risk: C.

Subsequent to this Airprox, appropriate remedial actions were completed at Prestwick in co-ordination with the CAA Air Traffic Standards Division's Northern Regional Inspectorate.

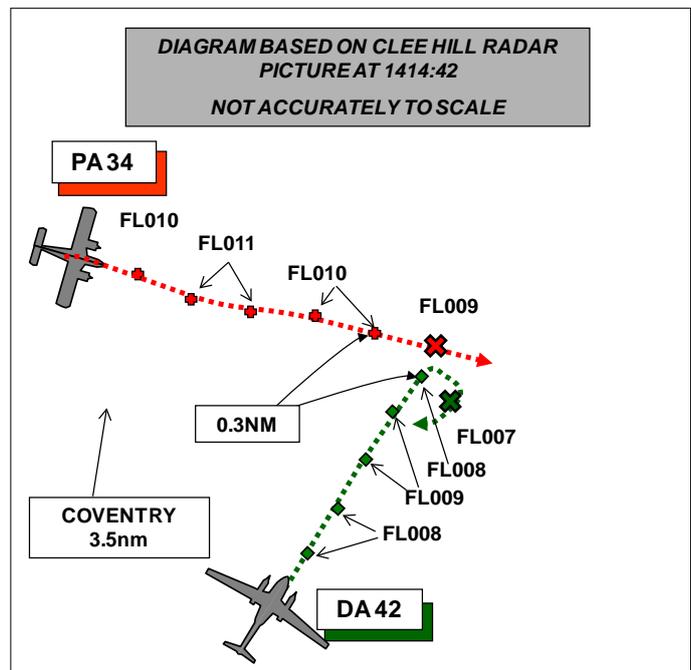
200ft V/0.3nm H

Members observed that this incident could easily have been avoided had the PA34 pilot made a small track alteration soon after he first reported that he was visual with the DA42.

Cause: The PA34 flew close enough to cause the DA42 crew concern.

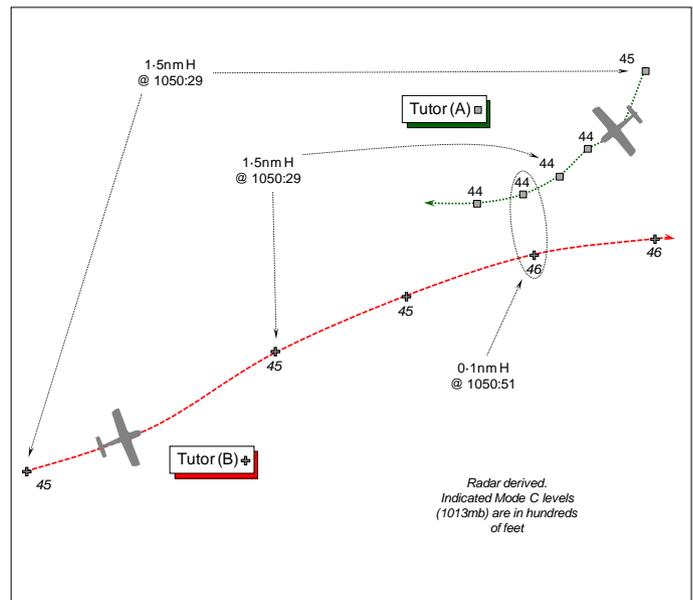
200ft V @ 0.1nm H

Cause: Late sightings by the pilots of both ac.

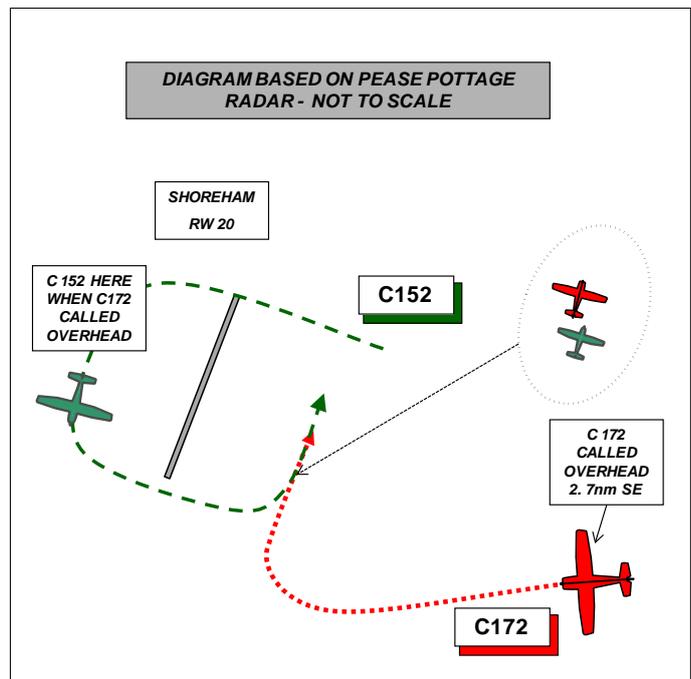
In assessing the risk, Members noted that the C152 did not see the C172 until it appeared 40m away in his 11 o'clock, descending from above; in the absence of any information to the contrary, it was accepted that this estimate of range was accurate. That being the case the C152 pilot was not in a position to take any avoiding action to influence events. Since during the C172's turn onto downwind the C152 would have been obscured by the former's floor then, on rolling out, it would be almost directly below, the C172 pilot did not see the C152 before the CPA.. In these circumstances there was, in the Board's unanimous view, an actual risk that the ac would have collided.

Cause: The C172 pilot did not comply with the ROA or ATC instructions and gave incorrect position reports, flying into conflict with the C152 which he did not see.

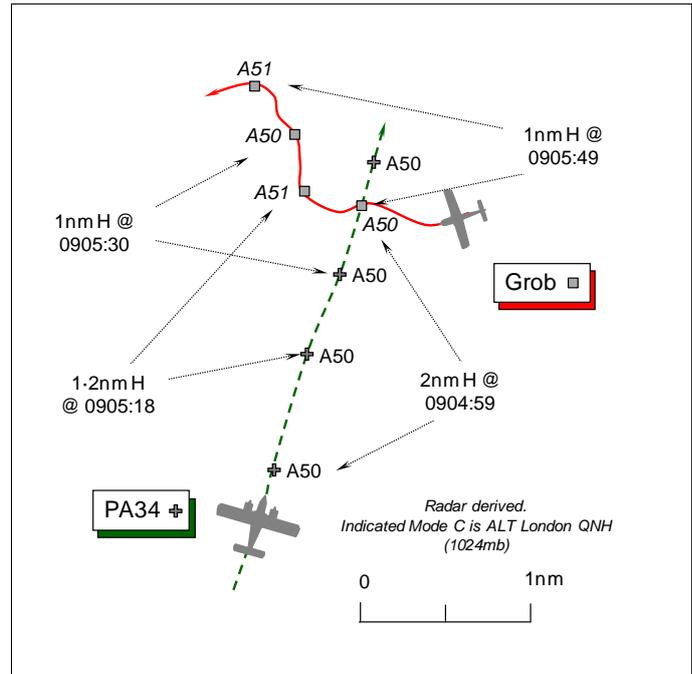
Nil V/1nm H

This Airprox resulted from a late sighting by the PA34 crew, the late provision of TI by RAD and the meteorological conditions hampering their visual acquisition task. It has been impossible to determine conclusively why TI was not passed to the PA34 earlier than 0905:31.

Cause: Sighting Report.

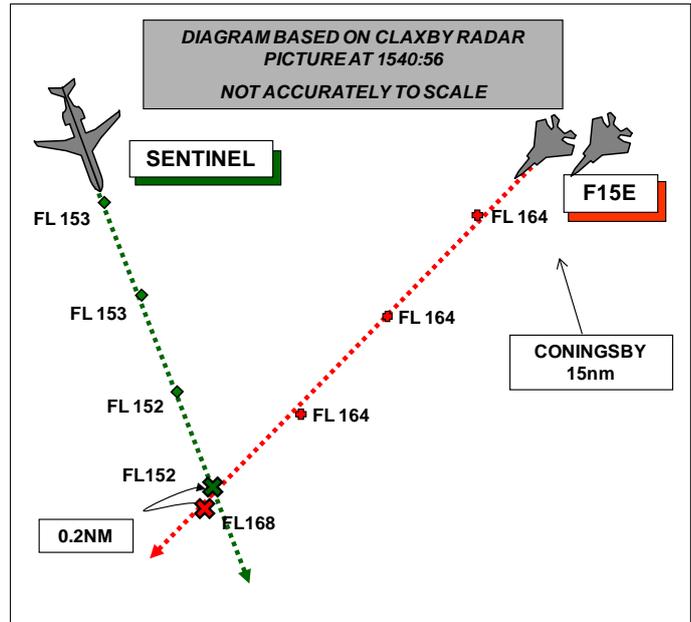
1600ft V/0.2nm H

Cause: A conflict in Class G airspace resolved by the crews of both flights.

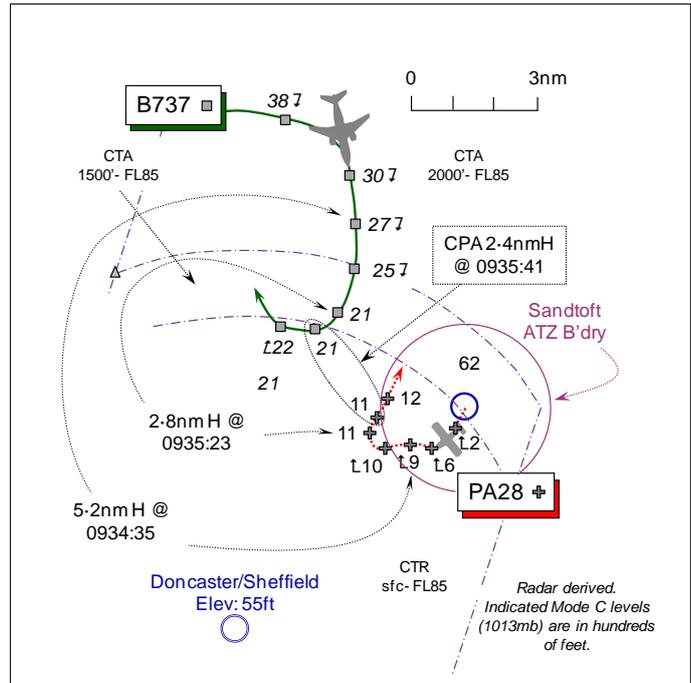
1000ft V/2.4nm H

The PA28 instructor reports he had to take control of his aeroplane, in what were challenging wind conditions for his student. However, the radar recording clearly showed that the PA28 had entered the Doncaster CTR during his Crosswind to Downwind turn. The Board was surprised that the PA28 pilot had not seen the B737 at all. Nevertheless, it was evident that the PA28 pilot's excursion outwith the ATZ was quickly detected on radar by the alert APR who watched it carefully whilst keeping the B737 crew apprised through the transmission of TI. The crew also had the PA28 displayed on their TCAS but it was evident that the controller took positive action at an appropriate stage before TCAS was called upon to act. The Board agreed that the B737 crew had little impact on this Airprox other than that they had complied promptly with the avoiding action instructions issued by the Doncaster APR. Controller Members recognised that the APR had acted correctly and the radar recording reflects that the APR passed these instructions to the B737 crew, turning their ac off the LLZ and back into the pattern, moments after he observed the PA28 penetrating the Class D Doncaster CTR. The Members agreed unanimously that the Cause of this Airprox was that the PA28 pilot entered controlled airspace without clearance and into conflict with the B737 established on the ILS. Furthermore, the APR's prompt action ensured that separation of 1000ft and 2.4nm was preserved, thereby removing entirely any Risk of a collision.

Cause: The PA28 pilot entered controlled airspace without clearance and into conflict with the B737 established on the ILS.

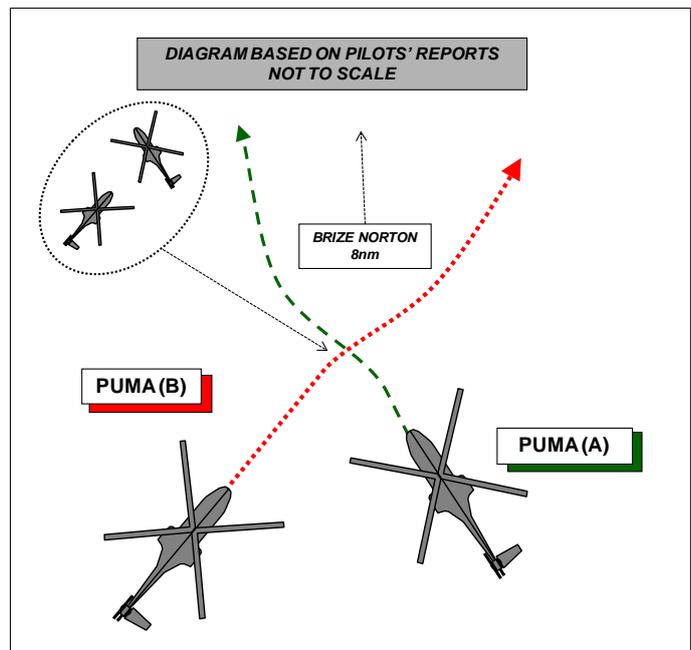
Cause: Effectively a non-sighting by Puma (B) crew and a late appreciation of Puma (B)'s range by Puma (A) crew.

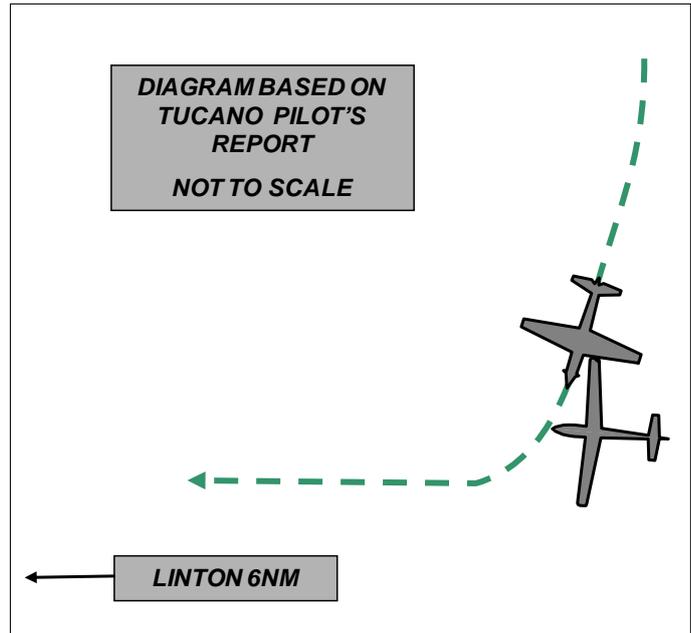
Cause: Possibly a non-sighting by the glider pilot and a late sighting by the Tucano crew.

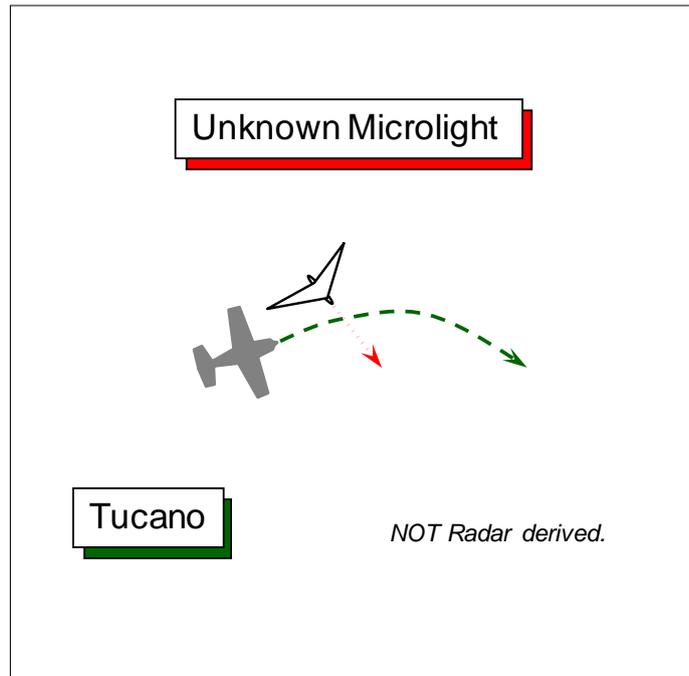
Even without the benefit of this warning from ATC, the Tucano pilot's lookout scan had later detected the group of MLs, enabling him to steer clear before he encountered the reported ML. However, his authorizing officer's account states that he had seen the subject ML at a late stage ½nm away and 50ft above his aeroplane. Nevertheless, pilot Members noted the Tucano pilot had seen it in sufficient time to assess the situation and enter a rapid descent, passing 200ft clear below it, and thereby resolve the conflict. Therefore, the Board agreed that this Airprox had resulted from a conflict in Class G airspace resolved by the Tucano pilot. Moreover, the Tucano pilot's robust avoiding action had, in the Board's view, effectively removed any Risk of a collision.

Cause: Conflict in Class G airspace resolved by the Tucano pilot.
