ASSESSMENT SUMMARY SHEET FOR UKAB MEETING ON 15 Jun 2011

AIRPROX REPORT No 2010169

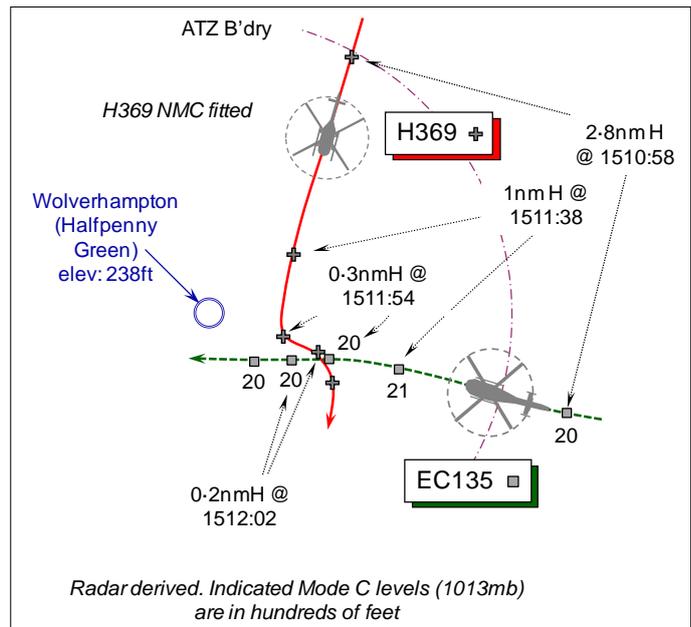
Cause: The H369 pilot did not comply with Rule 45 of the Rules of the Air and flew into conflict with the EC135.

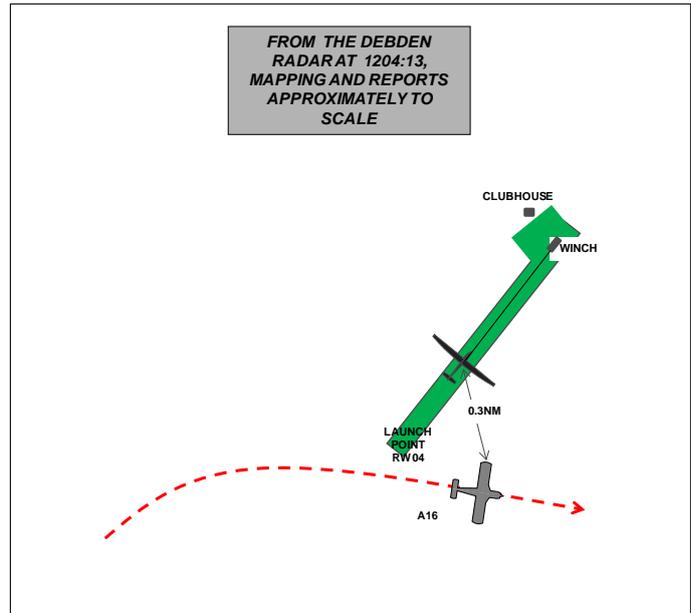
Cause: The PA28 flew close enough to a notified and active Glider Launch Site to cause concern.

CAA ATSI recommends that Cambridge ATSU review the Cambridge UK AIP entry, regarding the promulgated arrangements for the provision of radar services.

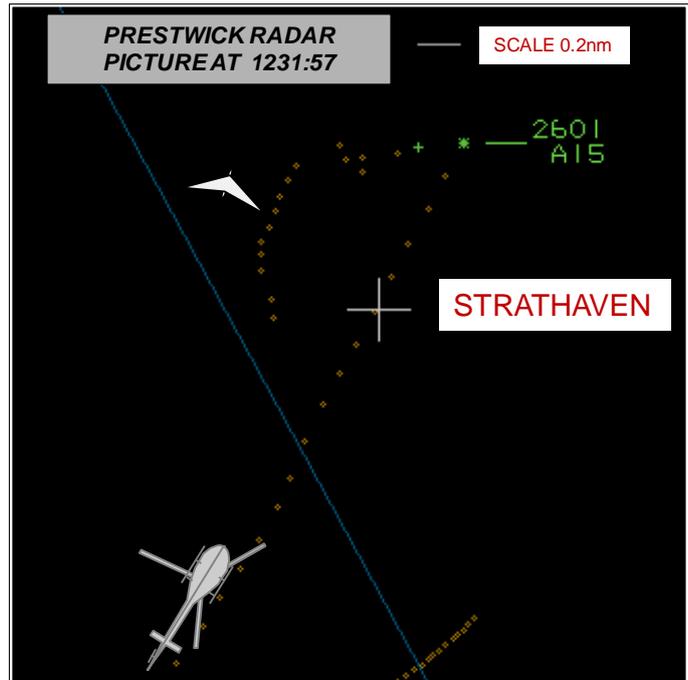
Cause: The AS355 pilot flew through a notified and active Microlight Site and into conflict with the Pegasus Quantum, which he did not see.

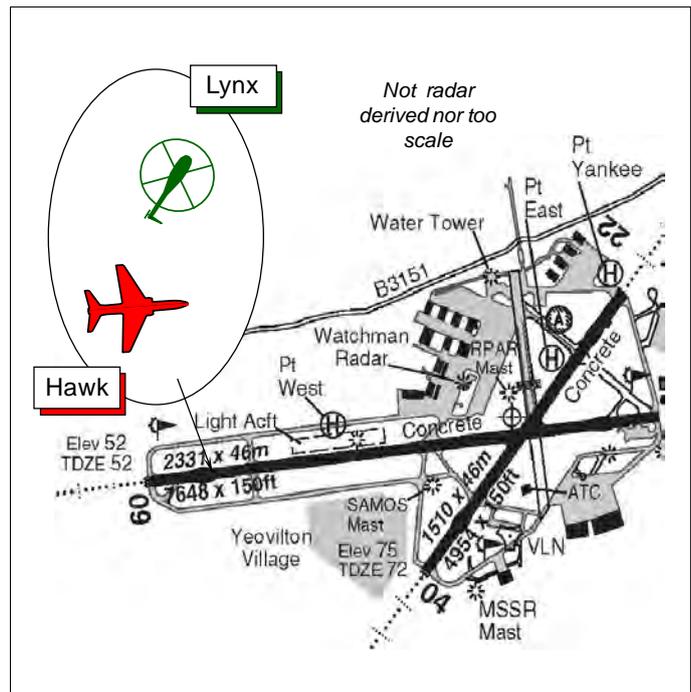
Cause: A perceived conflict by the Lynx crew.

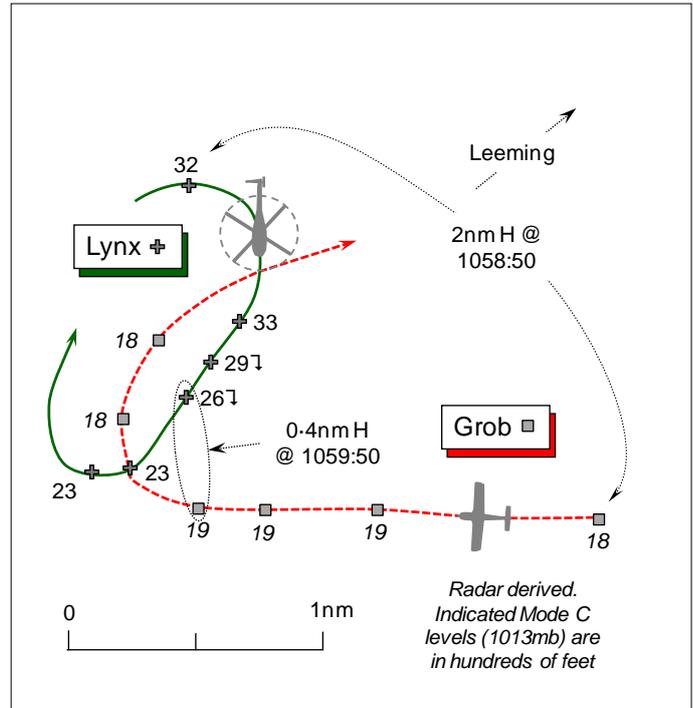
Cause: Conflict in the Vale of York AIAA resolved by the Lynx crew.

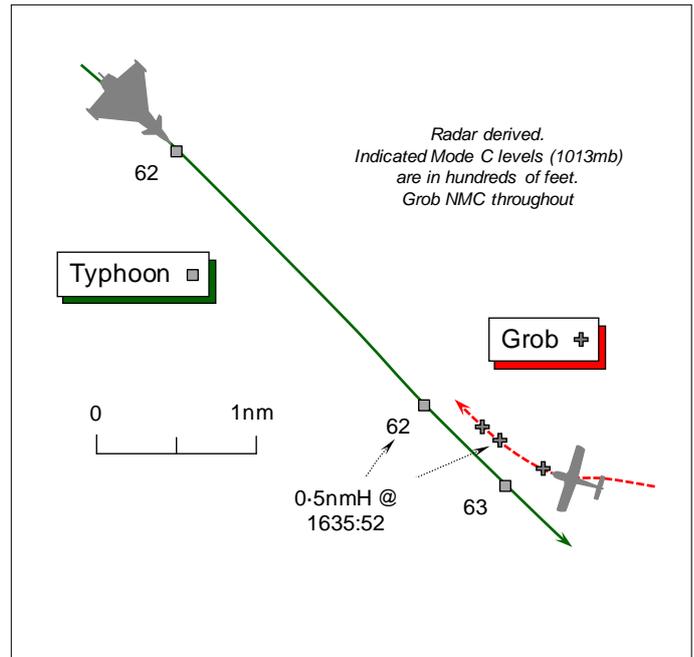
Cause: Sighting Report.

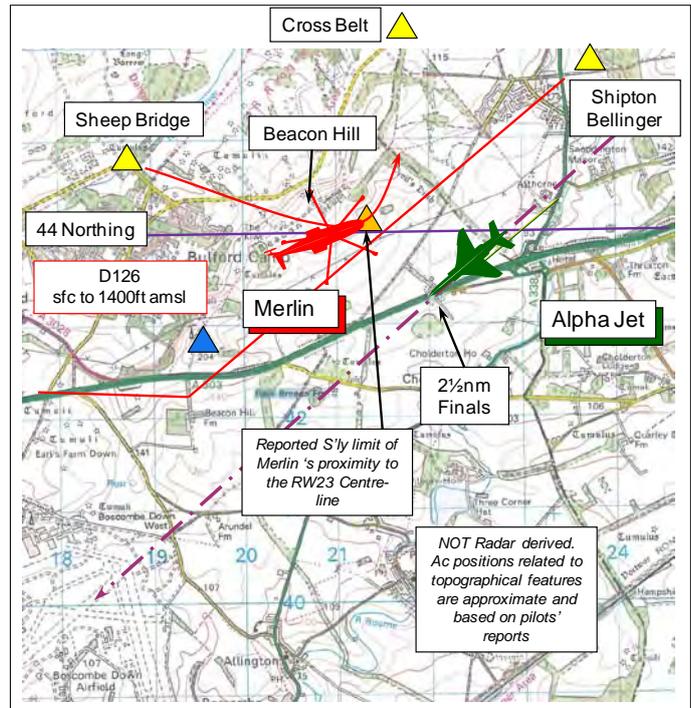
Cause: The Merlin crew flew close enough to cause the Alpha Jet crew concern.

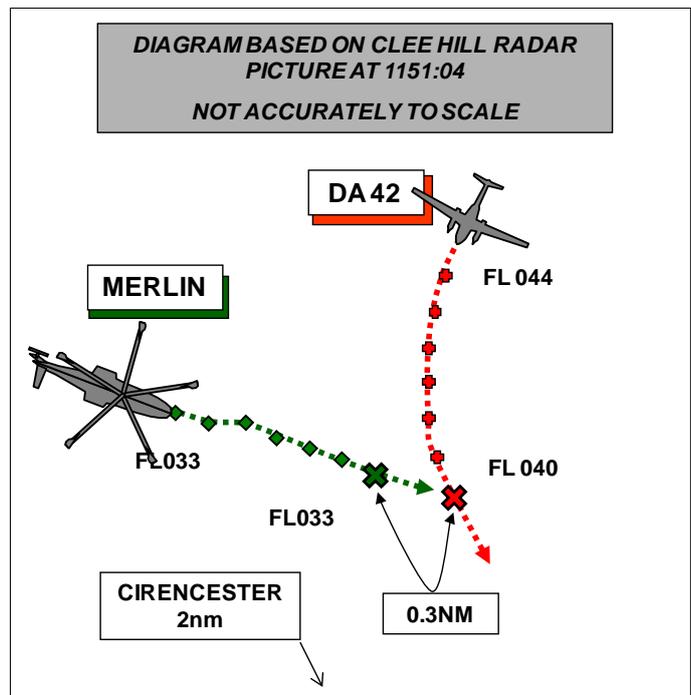
Cause: In the absence of TI, the Merlin crew was concerned by the proximity of the DA42.

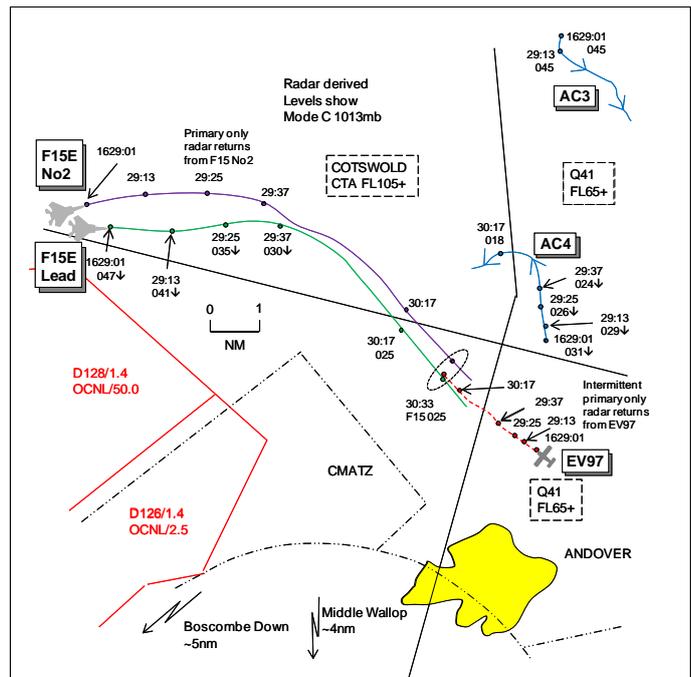
Cause: The F15E crews flew close enough to cause the EV97 pilot concern.

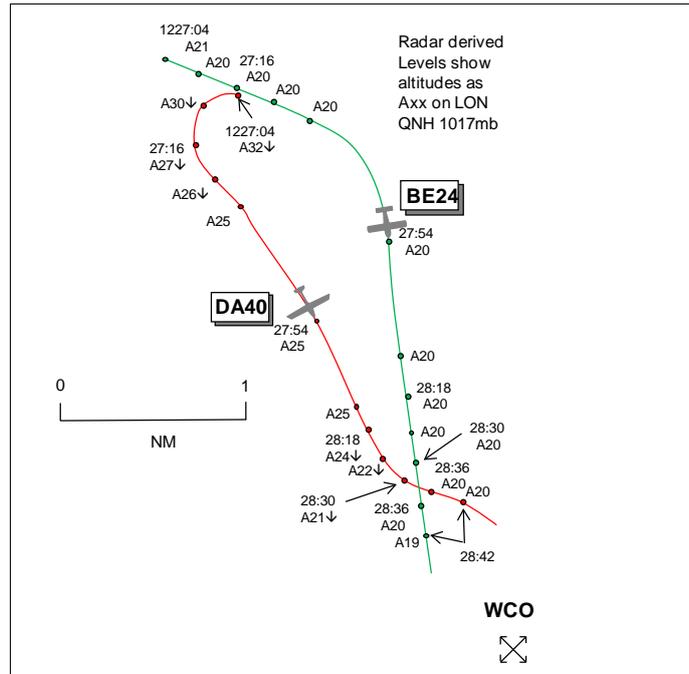
Cause: Effectively, non-sightings by the pilots of both ac.

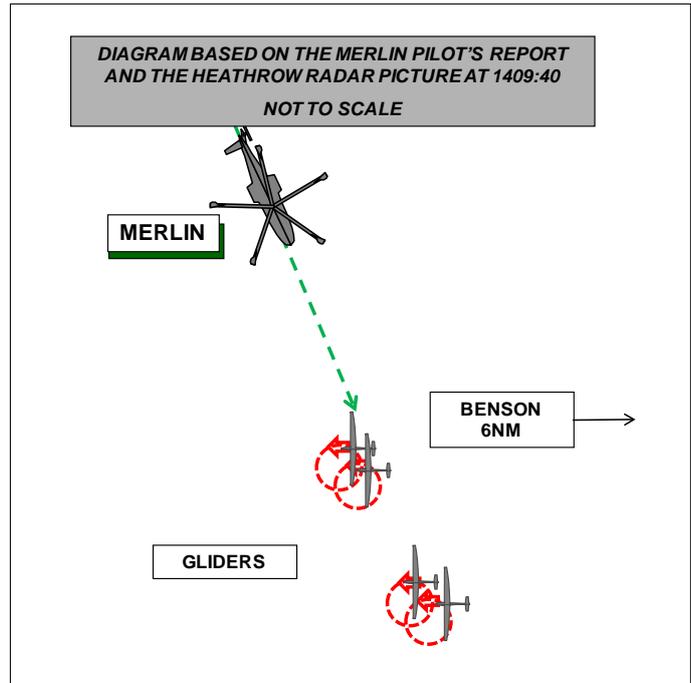
Cause: A conflict in Class G Airspace between the Merlin and an untraced glider.

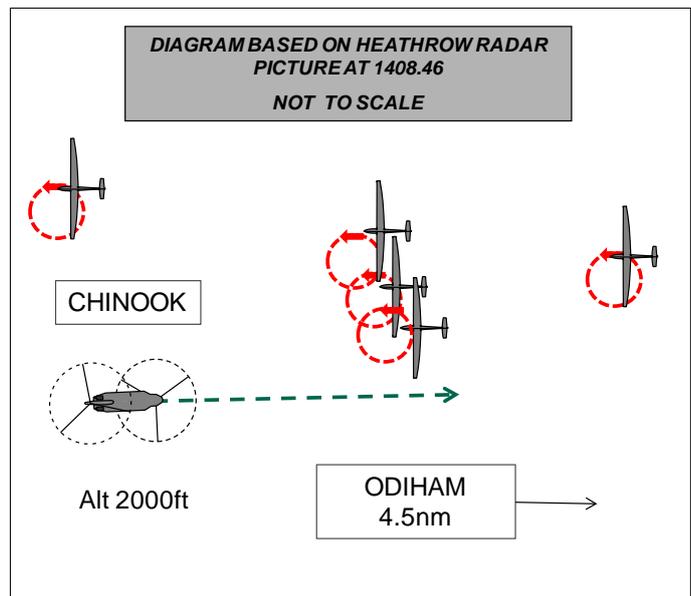
Cause: A conflict on the instrument approach to Odiham.

BM SM Spt recommends that Odiham continue to engage with the local flying community to develop awareness of their operations.

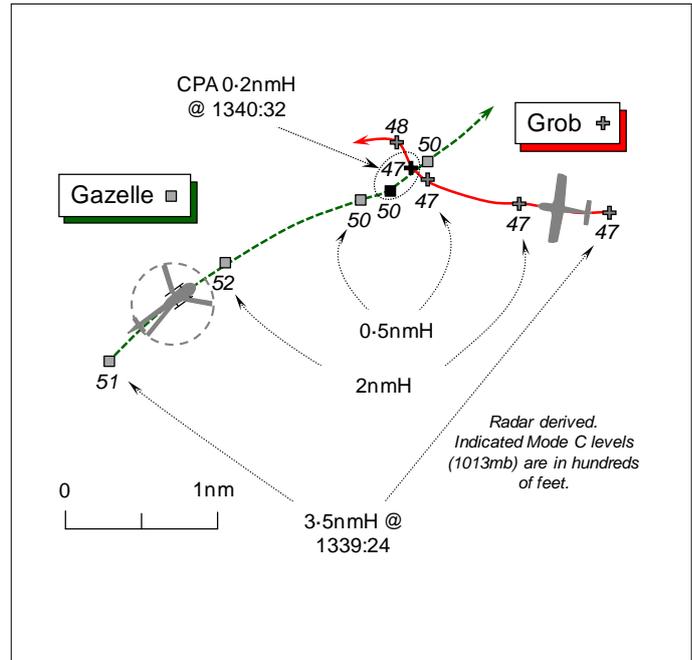
Cause: A non-sighting by the Tutor pilot and a late sighting by the Gazelle crew.
