ASSESSMENT SUMMARY SHEET FOR UKAB MEETING ON 20 JUN 2012

AIRPROX REPORT No 2012009

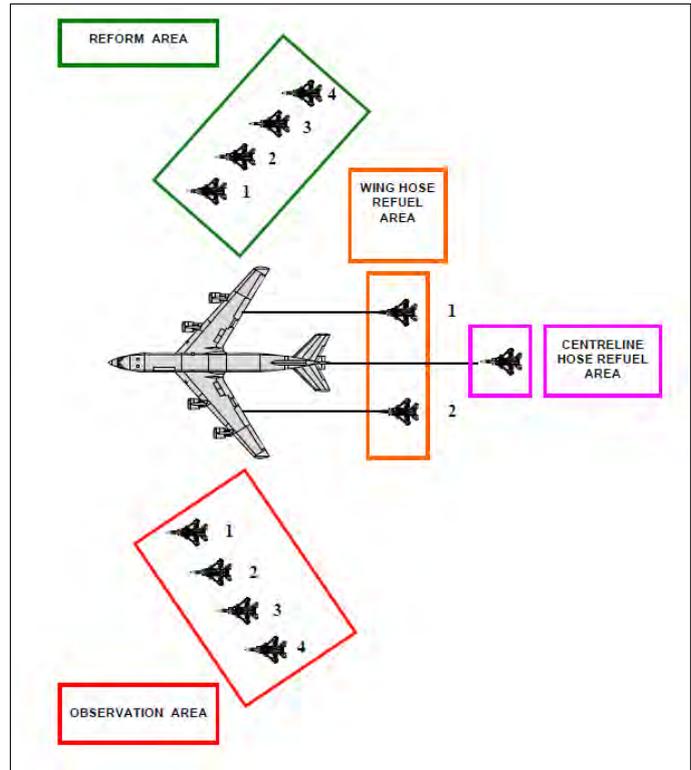
UKAB Note (1): The above is a diagram taken from ATP56 (B), the NATO manual of AAR.

- a. Cause. The Pilot of Typhoon 2 became disorientated as to the left hand side of the VC10 whilst attempting to stow the probe.
- b. Contributory Factor. The pilot of Typhoon 2 assessed that avoiding action was necessary to prevent a collision with the VC10.
- c. Other Factor. The momentary pause in the Tornado's progress towards the observation left position put him in the flight path of Typhoon 2 during the latter's avoidance manoeuvre.

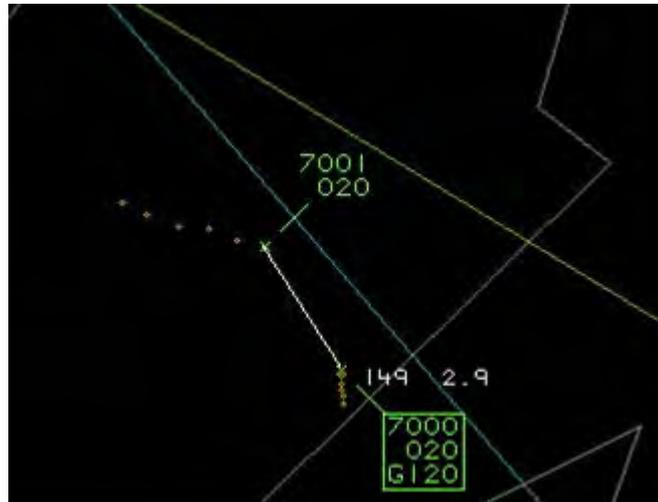
The Scottish controller gave generic traffic information on the Tornado operating to the SSW to the S92 pilot and then passed a warning when the Tornado flew into proximity with the ac.

Figure 1. Scottish Controller passes TI to Coastguard XXX. (2007:40)

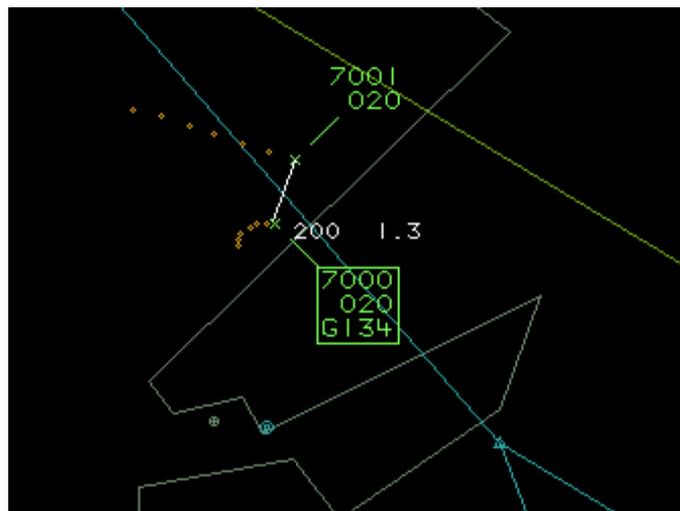
Figure 2. Closest point of approach 1.3nm & 0ft (2008:00)

Although Members considered the separation reasonable (1.3nm H) and they agreed that was no risk of collision, they observed that had there been more effective communication between the ac regarding each other's intentions when they talked on the APP frequency, the incident would most likely have been avoided.

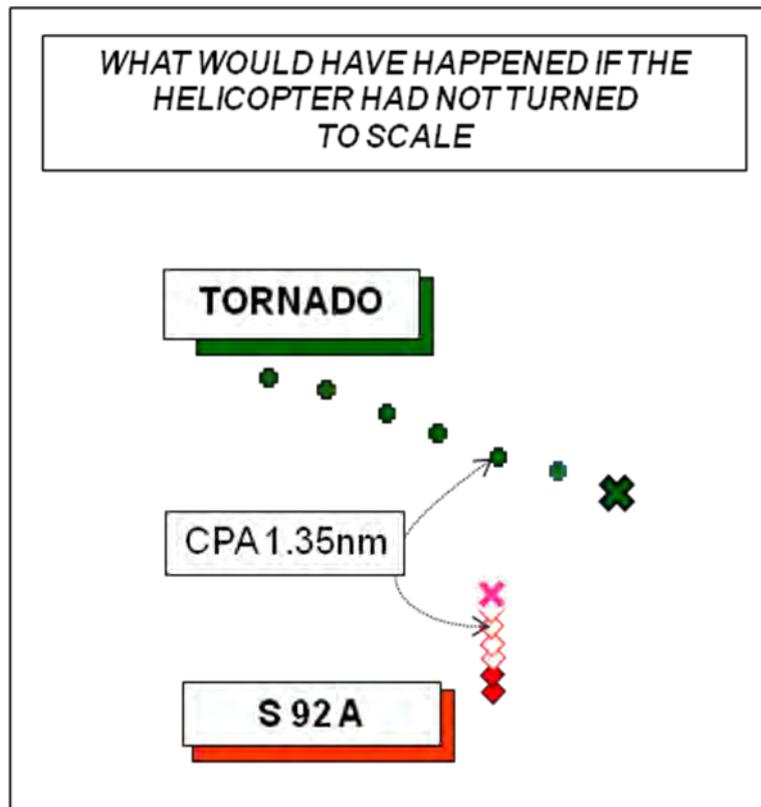
The Board was shown a diagram (below) depicting what would have happened had the S92 not turned to the right (using actual G/S and headings taken from the Stornoway SSR). It showed that the Tornado would have passed from left to right through the S92's 12 o'clock at a distance of 1.3nm at the same alt (2000ft amsl). That being the case Members agreed that the S92's turn had not had the desired effect of increasing the separation between the ac.

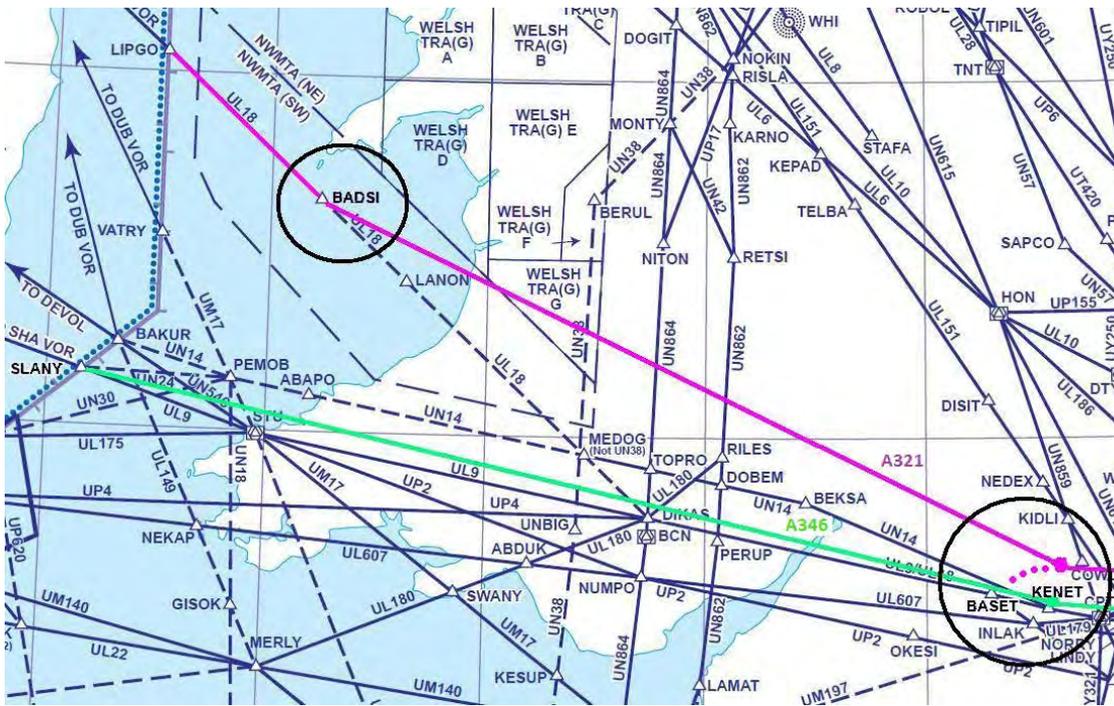
Fig 1

The A321 was operating IFR on a flight from Europe to Dublin and had flight planned to route UAR UL9/UL18 between CPT and DIKAS then UL18 DIKAS to LIPGO (Fig 1). UL18 is classified as a conditional route which was available on the Saturday of the Airprox.

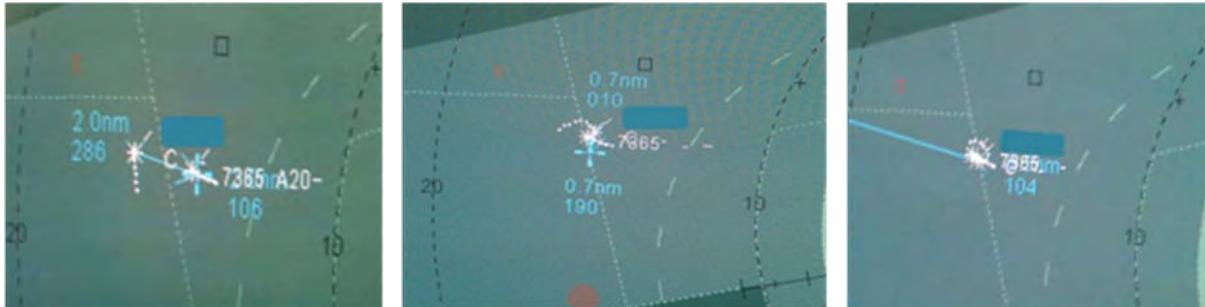
At 1727:50, when the PA28 was 18.7nm WSW of Bournemouth Airport, the controller downgraded the service to a BS due to the radar contact from the PA28 becoming intermittent. At 1742:57, when the PA28 was 14.2nm WNW of Bournemouth, a radar contact squawking A7000 with no Mode C, was shown 2nm WNW of the PA28. The A7000 squawk was identified as the RV-7 using the Bournemouth Radar Mode S function during the replay. Photographs of the Bournemouth Radar data (reproduced below) show the RV-7 turned to the R and orbited about the PA28.

The written report from the pilot of the RV-7 stated that he manoeuvred his ac to arrive 150m on the PA28's port side. The pilot of the RV-7 did not believe that the PA28 crew was visual with his RV-7; he continued past the PA28 and 'when well clear commenced a climbing turn to the R'.

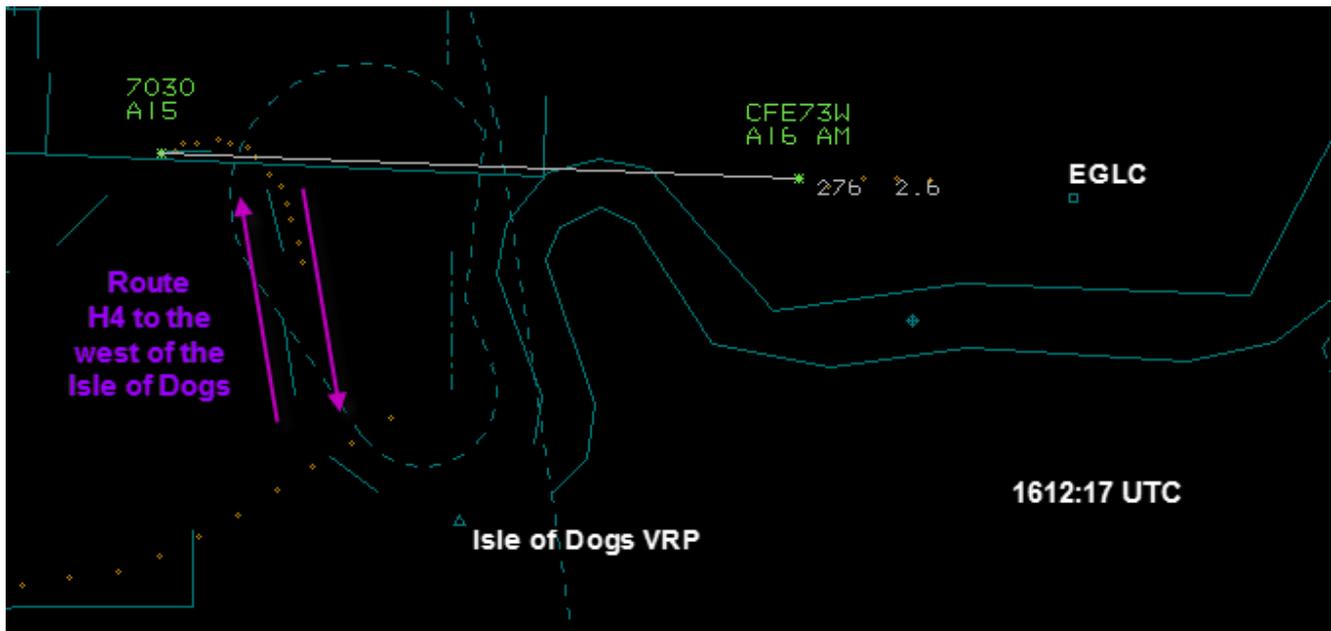
By 1612:17 the EMB190 was passing 1600ft 2.6nm E of the Apache (see screenshot below).

[UKAB Note (3): As the EMB190 climbs through altitude 2500ft at 1612:38, the Apache is 2.2nm ahead and 1000ft below.]
