ASSESSMENT SUMMARY SHEET FOR UKAB MEETING ON 21 MAR 2012

AIRPROX REPORT No 2011147

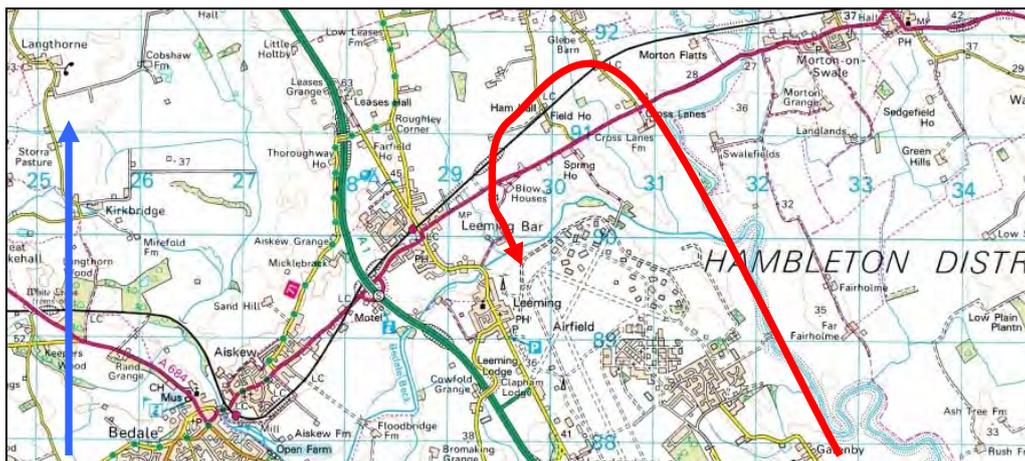
Fig: 1

Based upon the information provided to TWR by Zone at 1457:06, that the MD902 would be routing N from Bedale, TWR had no reason to suspect that the MD902 would conflict with the visual cct; as illustrated at Figure 1.

Moreover, the obstructions to the N and NW of the airfield would have precluded TWR from visually acquiring the MD902 until a late stage. Finally, whilst given their low workload it is reasonable to suggest that TWR could have scanned their Hi-Brite VRD, it is just as reasonable to argue that with nothing to prompt TWR to do this, their visual focus would have remained on the Hawk.

- a. Review RAF ATM Force Orders 100.130 to determine whether paras 100.130.2 and 100.130.3 are applicable to ATCO ICs.
- b. Direct RAF ATM Terminal units to review local orders permitting the use of an ATCO IC, in lieu of a dedicated Sup, in a rostered control position, during core opening hours.
