**ASSESSMENT SUMMARY SHEET FOR UKAB MEETING ON 18 May 2011**

## AIRPROX REPORT No 2010144

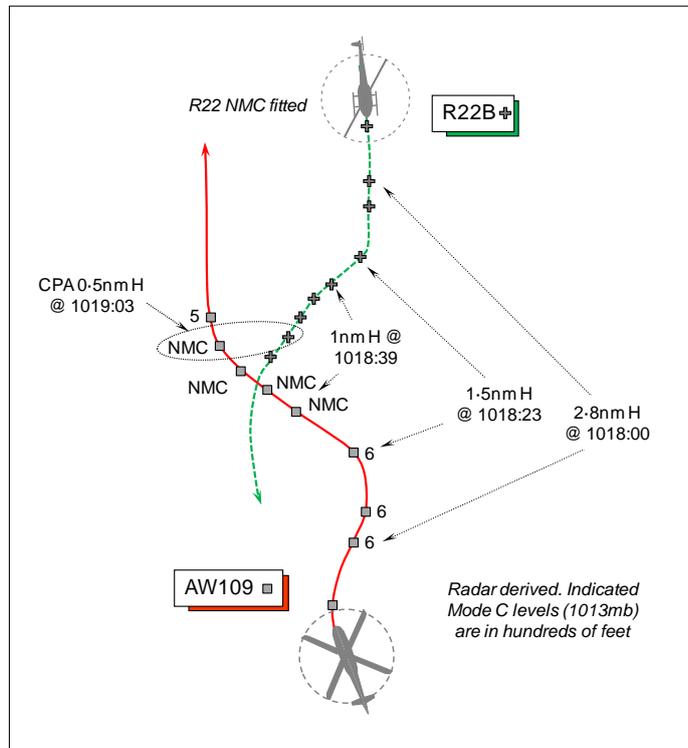
0.5nm Min H

Cause: A conflict in Class G airspace.

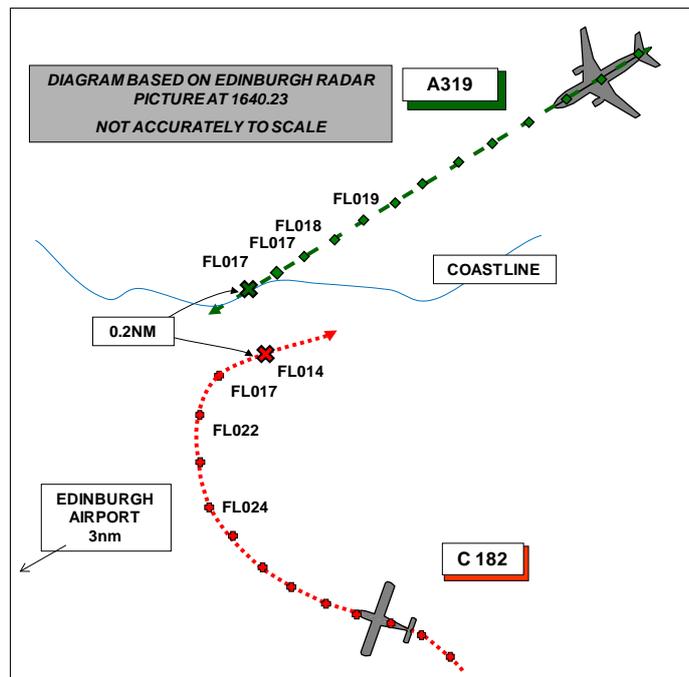
~300ft V/0.2nm H

Cause: In the absence of TI, the C182 pilot flew close enough to cause the A319 crew concern.

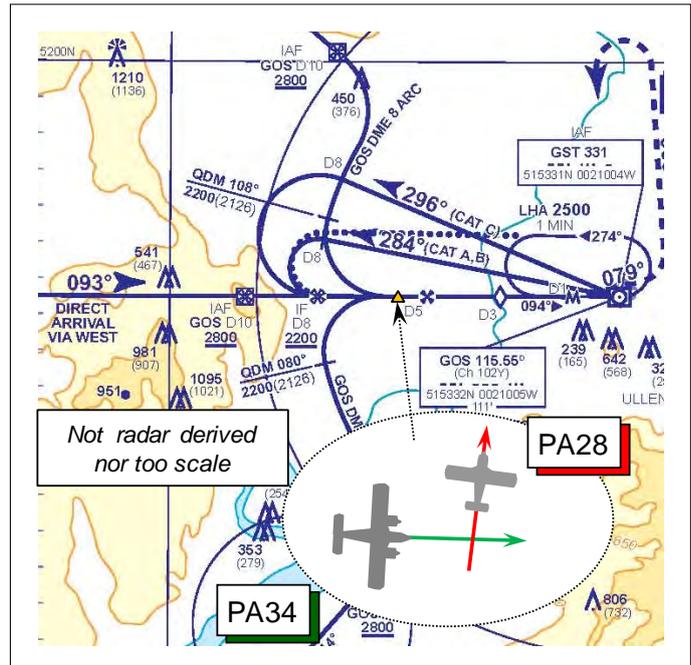
Not recorded

Cause: A controller perceived conflict.

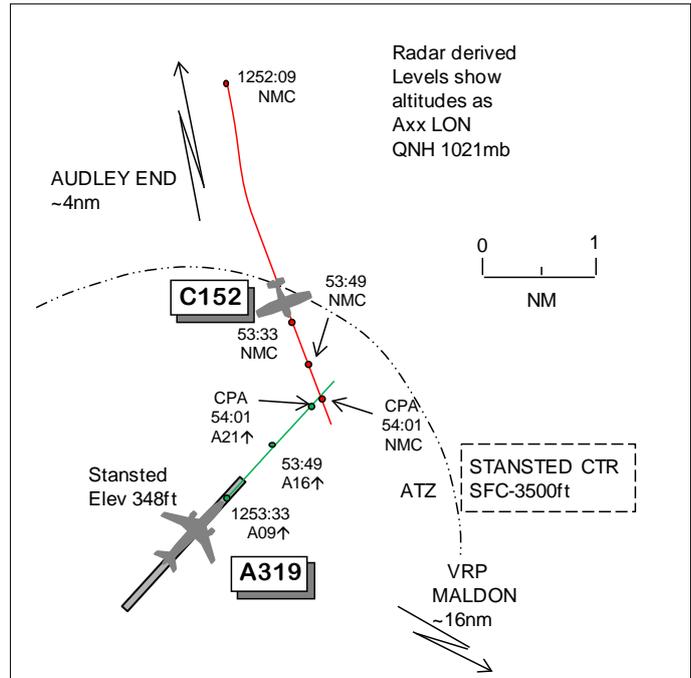
<0.1nm H

Cause: The C152 pilot did not comply with the ATC instruction to route via the RW04 threshold and flew into conflict with the A319.

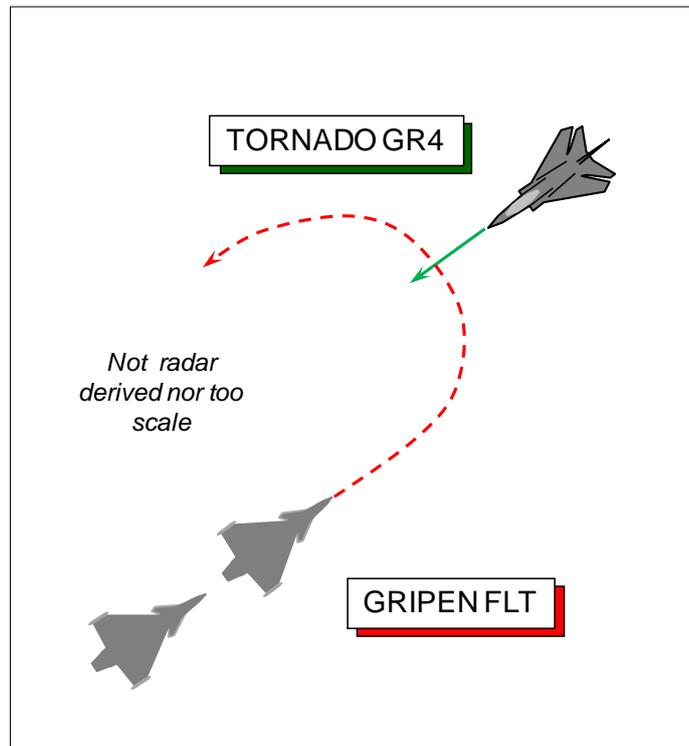
Not recorded

Cause: Visual circuits were permitted in unsuitable weather conditions.

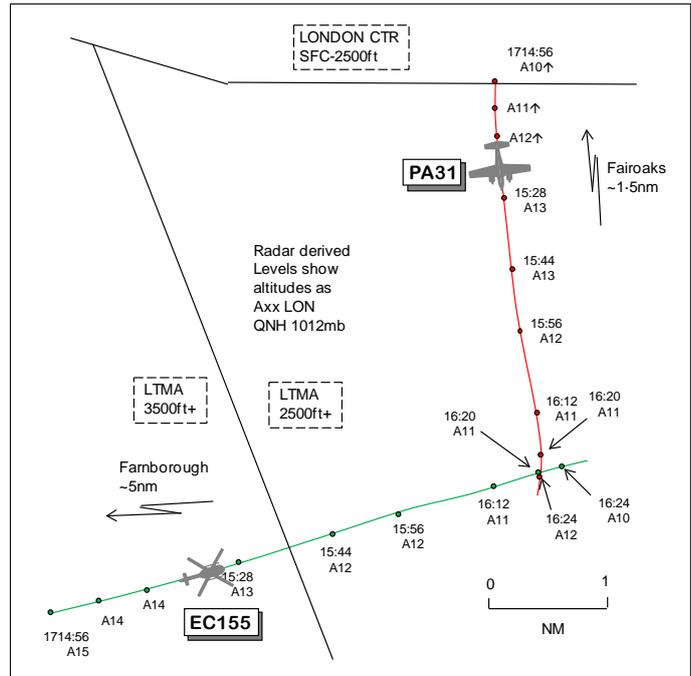
<100ft V/<0.1nm H

Cause: Effectively a non-sighting by the EC155B crew and a late sighting by the PA31 pilot.

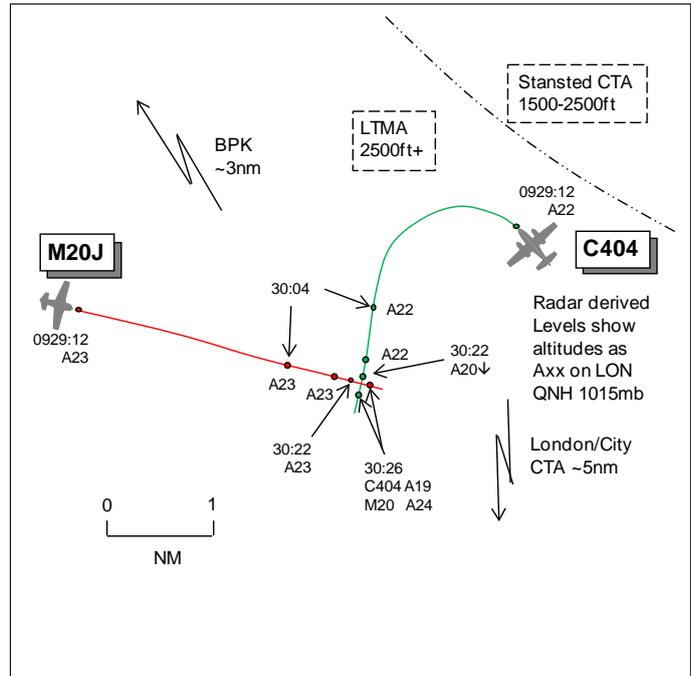
400ft V/Nil H

Cause: A conflict in Class G airspace resolved by the C404 pilot.

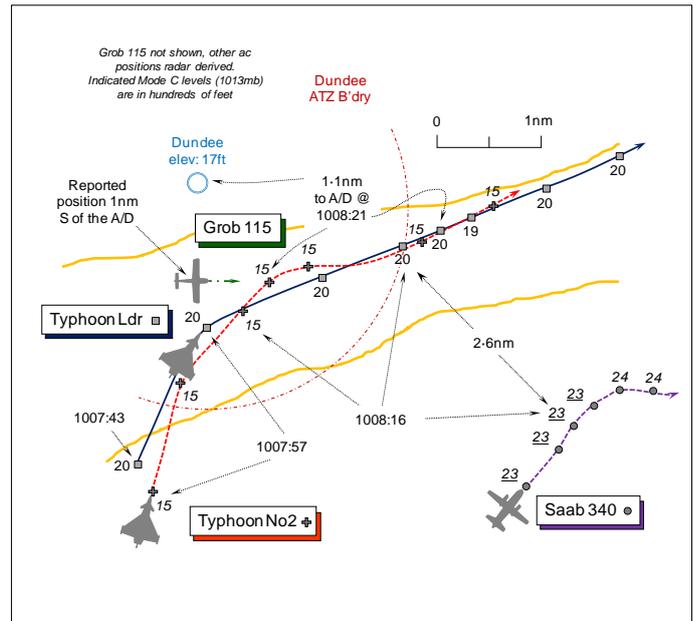
Not Recorded

Cause: Sighting Report.

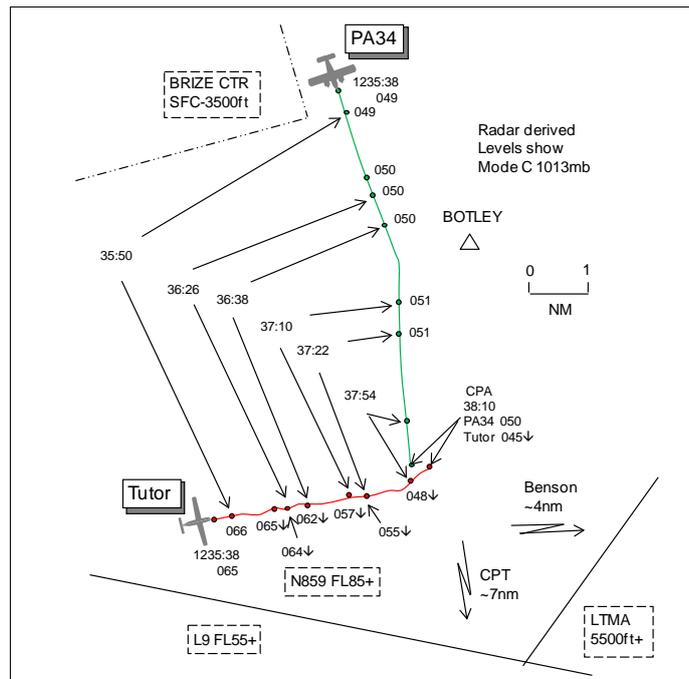
500ft V/0.3nm H

Cause: A controller perceived conflict.
