**ASSESSMENT SUMMARY SHEET FOR UKAB MEETING ON 23 MAY 2012**

## AIRPROX REPORT No 2012012

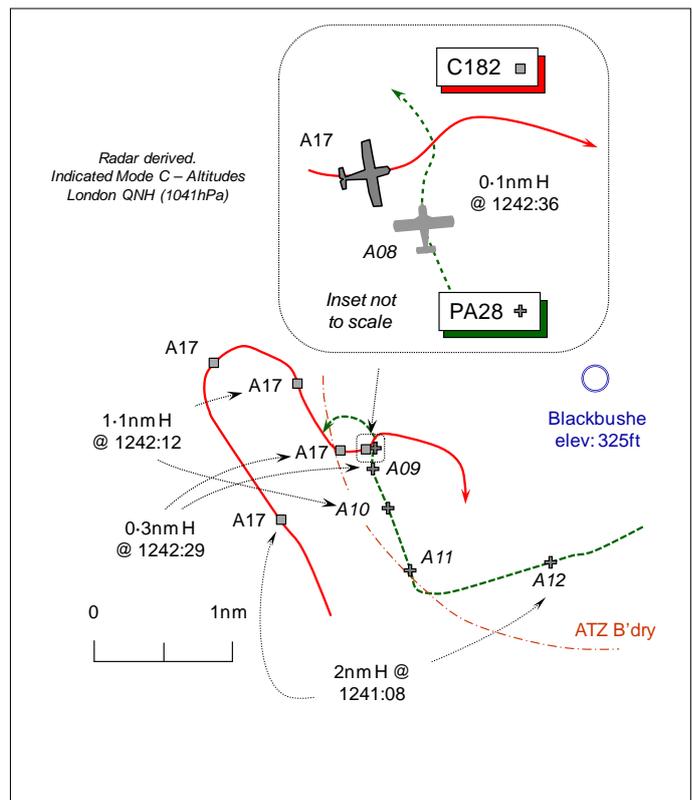
Cause: The C182 pilot did not integrate into the established cct pattern and flew into conflict with the PA28, which he did not see.

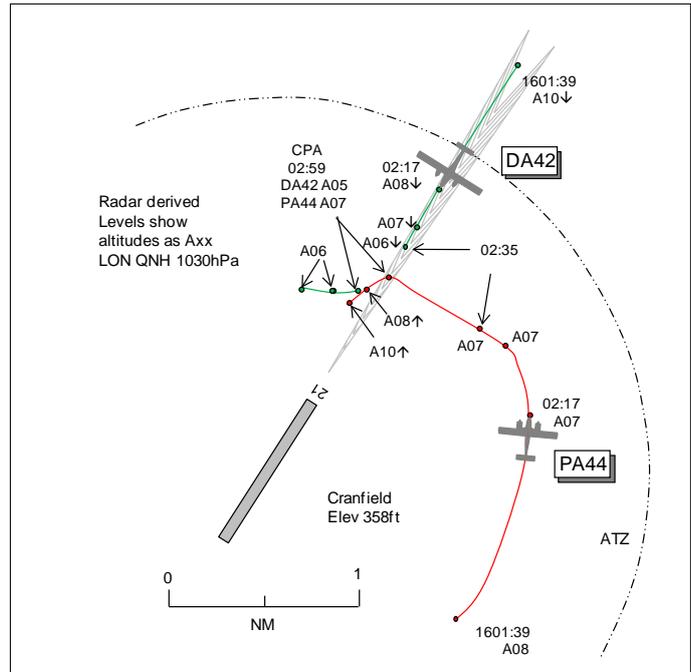
Cause: The PA44 pilot did not comply with the ADC's instruction to position as No 2 and flew into conflict with the DA42 on final, which he had not seen.

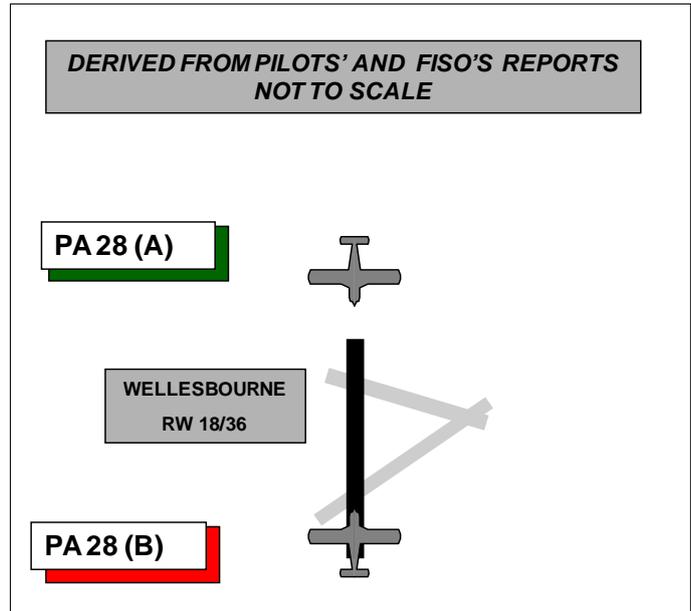
Cause: Unable to make RT contact with Wellesbourne, the pilot of PA28 (B) did not conform to the circuit pattern established by other ac and landed into conflict with PA28 (A).

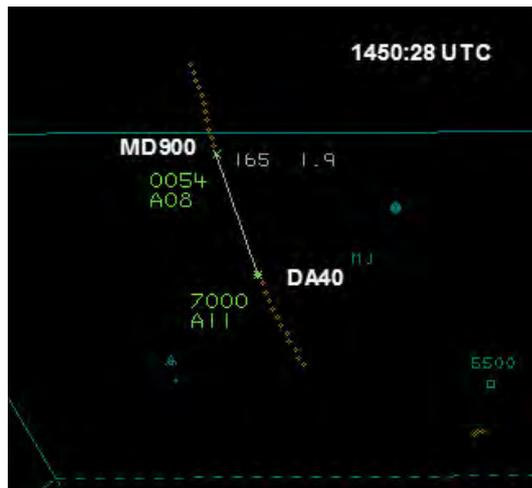
The distance between the two ac continued to decrease as each remained in the other's 12 o'clock on reciprocal tracks as shown below. Note: SSR code 0054 is considered unvalidated and unverified.

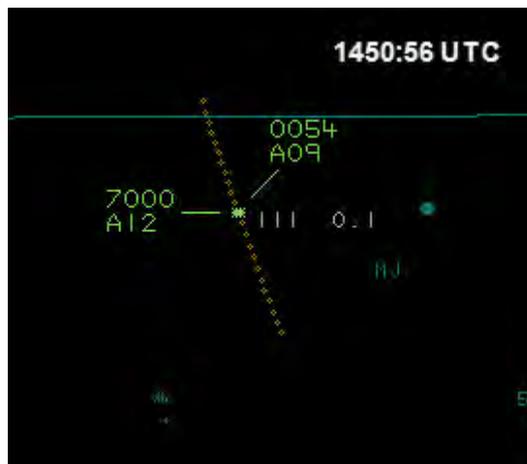
At 1450:56 the position indication symbols of the ac merged on the radar replay with the MD900 at altitude 900ft and the DA40 at altitude 1200ft (as shown below).

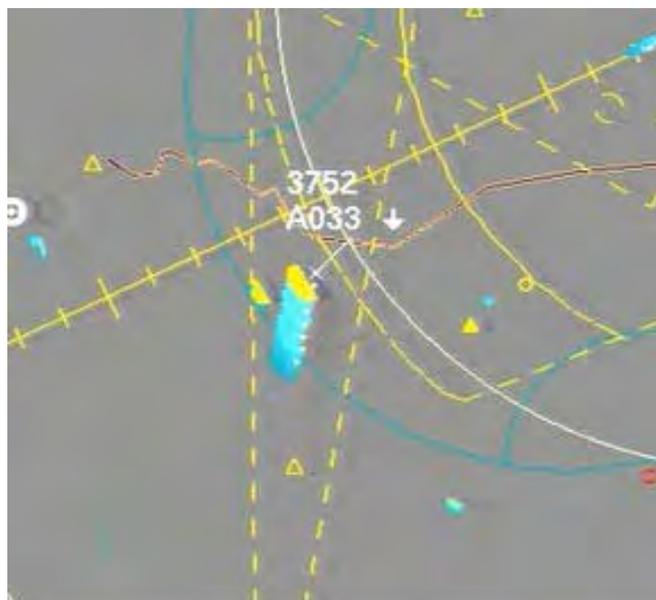
Fig 1. (1646:06)

The Newcastle radar display showed a number of spurious returns, (anomalous propagation) resulting from the high pressure atmospheric conditions; one of these contacts was subsequently believed to be the Hot Air Balloon.
