ASSESSMENT SUMMARY SHEET FOR UKAB MEETING ON 17 Nov 2010

AIRPROX REPORT No 2010033

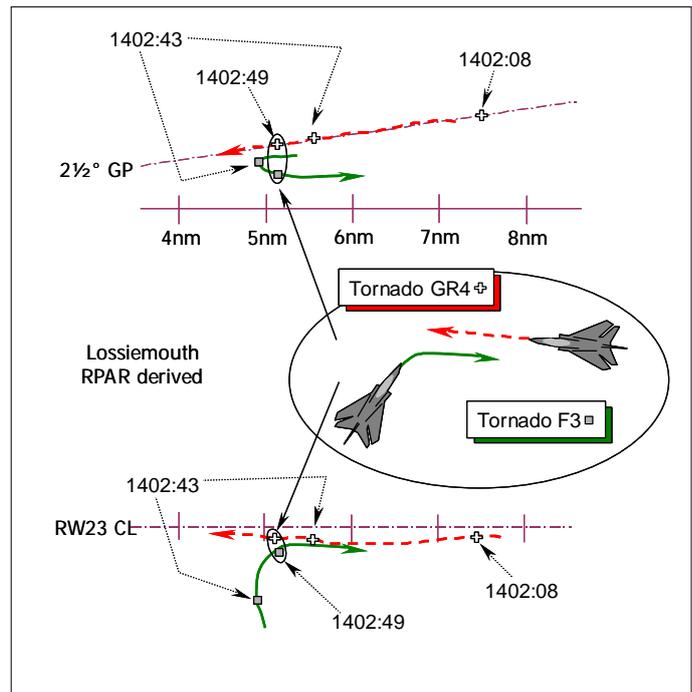
Although requested, no TI was provided by the APPROACH (APP) controller about any other ac recovering before switching to TOWER (TWR) on 279.05MHz. Approaching the extended centreline to RW23 at 8nm, flying level at 1000ft QFE (1017mb), a standard 8nm instrument traffic call was broadcast by TWR, so he manoeuvred off of his westerly heading in an attempt to gain visual contact with the instrument traffic. Whilst in the turn he spotted a Tornado GR4 at close range – crossing from R – L about ½nm away – descending wings level on a 2½° glide-path instrument approach. To avoid the GR4 he initiated a descending RH break at about 3G. The GR4 passed about 500ft ahead with a 'high' Risk, some 400ft above his F3 after he had executed his avoiding action descent. Although the manoeuvre was not extreme he and his navigator believed that the 2 ac were on a collision course beforehand.

advised about a “..visual joiner on your left hand side”. Thus the F3 was not acquired by the GR4 safety pilot in the rear seat until he saw it at 9 o'clock in a RH descending turn belly up to his ac some 500ft away already taking robust avoiding action. Therefore, in the Board's view, the GR4 crew was not able to affect the outcome and did not contribute to the Cause. The F3 pilot reports that when he heard the ADC's broadcast he started to manoeuvre off his westerly heading in an attempt to gain visual contact with the instrument traffic. It was whilst in the turn that he spotted the GR4 for the first time at about ½nm away crossing from R – L. It was clear that that this late sighting by the F3 crew was the other important element. Following a comprehensive debate the Board agreed that the lack of TI led to a late sighting by the F3 crew and that was the Cause of this Airprox.

Cause: Lack of TI led to late sighting by the F3 crew.

This occurrence highlights the criticality of visual monitoring of all ac within the visual cct environment and the utility of the Highbrite VRD in aiding IFR/VFR integration. HQ Air BM ATM recommended that Lossiemouth ATC conduct a safety survey of visual joining procedures and IFR/VFR integration.

Subsequent to this Airprox Lossiemouth ATC initiated a review of visual joining procedures and IFR/VFR integration, which found that there was mixed understanding amongst ATC personnel and aircrew of visual joining procedures. It was recommended that more definitive guidance be placed within ATC and aircrew orders. As a result, a change of operating procedures proposal was raised, which has defined the visual and radar-visual approach procedures and provides clear instruction on the provision of TI by ATC to ac recovering visually.

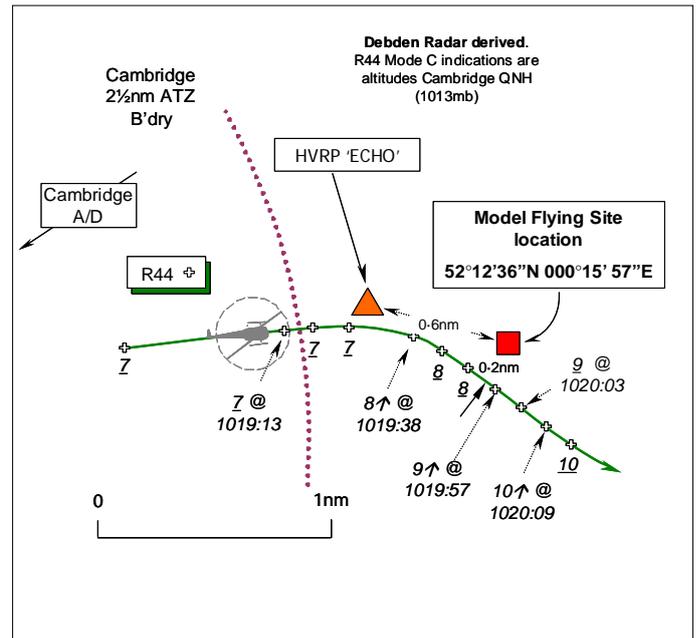
In either case a Risk of collision cannot be ruled out in future encounters. This would almost certainly cause major damage to the helicopter, possibly catastrophic. He thought that a model flying club site is located almost directly underneath the eastern Helicopter VFRP (HVRP) known as point 'Echo'.

Radar recordings show the helicopter departing the cct and leaving the ATZ to the E. No other radar returns are observed in the vicinity of the reported Airprox location. It is probable that the size of the model ac did not provide a sufficient reflective surface for an acceptable radar return.

Cause: Conflict with an untraced model ac.

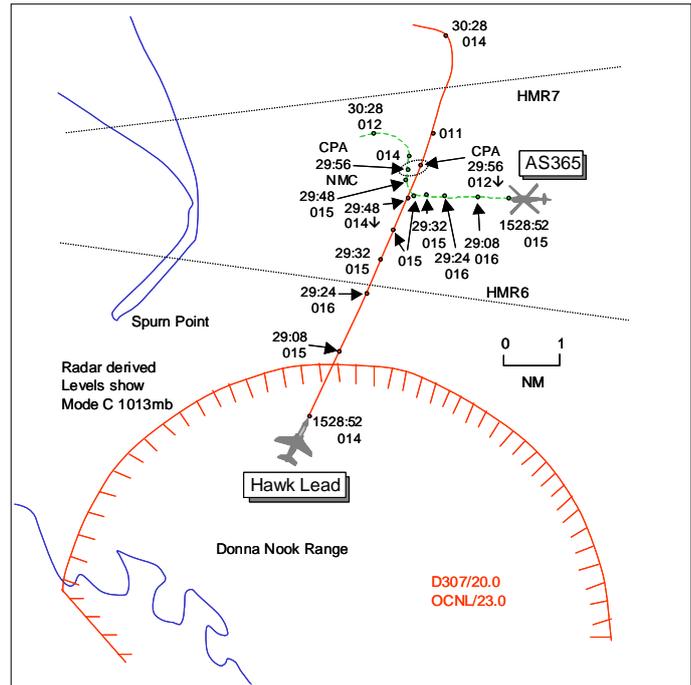
Although there had been a good exchange of information between Anglia and the AS365 flight, which gave the crew early warning of the Hawks presence on the AWR, a combination of the helicopter's planned track (3-4nm N of the range boundary) and the Hawk's rapid departure N'bound from the range led Members to agree that the time available to resolve the conflict was minimal. Anglia had passed updated TI at 1528:48, when the controller noticed Hawk Lead tracking N'ly, and had then immediately given a further updated TI and an avoiding action R turn of 20°; the Board noted that, although it did not affect the outcome, the controller did not use the term "avoiding action". One controller Member thought that Anglia, whilst providing an Offshore DS, was late in giving avoiding action and that it should have been passed during the first updated TI transmission when separation had already reduced to 4nm. Another Member believed that the service should have been limited owing to the helicopter's planned track passing less than 5nm from the Danger Area with known activity inside it as Anglia was endeavouring to provide Deconfliction minima. However, in the end Members agreed that owing to the short time period available Anglia, who was unaware of the Hawk pair's intentions, had discharged his responsibilities and when the AS365 crew reported that they were happy to carry on after sighting the Hawk, they then became responsible for maintaining their own separation from it. The AS365 crew had then become concerned about the Hawk Lead's flightpath and elected to turn hard R whilst they were trying to establish RT contact with Donna Nook. The RSO had done well in the limited time available and informed the Hawk Lead pilot that there was a helicopter on the HMR as the formation reported departing the range. Hawk Lead had seen the AS365 and had taken adequate visual separation on the helicopter as he passed clear to its R and below. The Hawk had become unsighted to the AS365 crew as they turned away until they re-sighted it passing on their RHS, understandably uncomfortable, as its proximity was closer than they expected. In the end Members agreed that all parties had acted appropriately during this rapidly unfolding evolution. This allowed the Board to conclude that the incident had been a conflict in the Class G airspace where the Hawk Lead's visual sighting and action had ensured that any risk of collision was removed. Although there is no compunction to do so, both flights could mitigate similar risks in future: the helicopter crew by adjusting their routeing and/or making an earlier call to the Range, and the Hawk crews by flying over or under the normal operating levels of the HMR.

Cause: Conflict in Class G airspace.

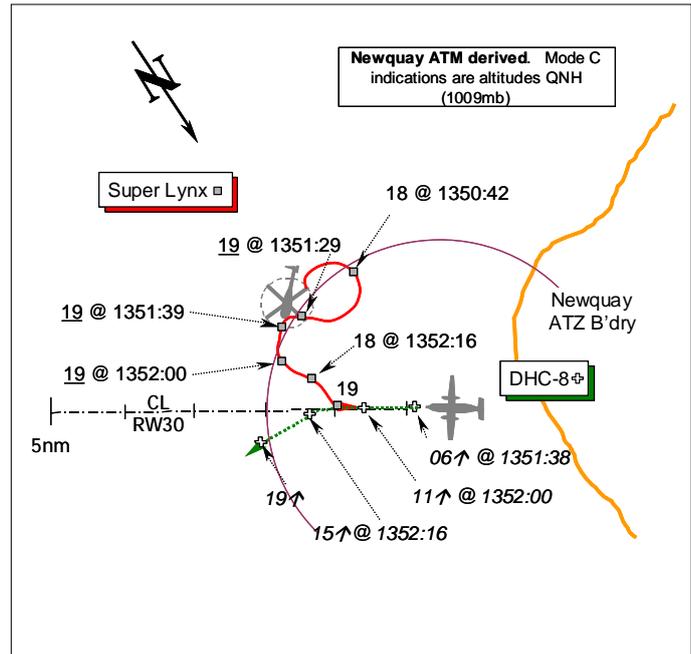
the radar recording shows the DHC-8 commencing a L turn to the E indicating 1500ft ALT, with the Lynx 0.5nm S of the centreline indicating 1800ft ALT at the CPA. It was noted that the DHC-8 pilot's use of the wrong callsign was probably a slip due to the urgency of the transmission and this was repeated by TOWER. The DHC-8 was transferred to the radar frequency immediately after the L turn was approved and before the Lynx had passed abeam. Because the DHC-8 was no longer following noise abatement the ADC considered it important to transfer the flight early so that the APR could deal with the non-standard turn. This was co-ordinated with the APR, the ADC being satisfied at this stage that the Lynx would pass S of the DHC-8.

The use of the opposite runway for departures when ac are circuiting to the RW in use can cause significant problems and requires additional positive steps by ATC to ensure that all the pilots concerned know what is happening. Here it was evident from ATSI's comprehensive report that the ADC was permitted by local procedures to allow departures from the opposite RW if they could be accommodated safely. Moreover the controller had a sound plan to deal with the two helicopters operating VFR in the visual cct to RW30, whilst still allowing the IFR DHC-8 to depart expeditiously from RW12. By placing the two helicopters in orbits on the downwind leg the ADC effectively removed any potential for a conflict with the DHC-8, until the point that he allowed the Lynx to leave the orbit too early without telling the departing DHC-8 crew what was happening. It was clear to Members that the Lynx crew was entirely cognisant of the presence of the DHC-8 and had kept track of it throughout its take-off and departure. Moreover, the ADC had confirmed this before he instructed the Lynx crew to *"..give way to the Dash 8 and report final...3-0"*, which the Lynx crew read-back. Whilst it was evident from his account that the DHC-8 crew heard some of these exchanges too, no TI was actually transmitted to them about the helicopter turning in towards final for RW30. CAT pilot Members understood why the DHC-8 Captain was concerned especially when a TCAS RA was subsequently triggered. A pilot Member suggested that the Lynx crew should have been more aware of the impact they could have on the departing IFR flight and whilst they were undoubtedly 'giving way', the perceived proximity of their helicopter without prior notification caused the DHC-8 pilot to take evasive action by turning L off the RW heading early. It may be that the DHC-8 Captain had assessed the separation from his TCAS display – he reported the helicopter was only 500m away – whereas the radar recording shows the Lynx at twice that range and no closer than 0.5nm at the CPA. In the Board's view, the VFR Lynx pilot was plainly 'giving way' to the IFR departure but without any visual separation criteria specified between IFR CAT ac and VFR flights, once they have been informed about the other ac, it is the VFR pilot's responsibility to afford appropriate separation. CAT pilot Members stressed that the DHC-8 crew has no option but to obey TCAS RA commands, which would undoubtedly have influenced the Captains views about raising a report, and the importance of affording TCAS equipped ac as wider berth as feasible. The helicopter pilot Member considered the separation here was entirely reasonable. Nevertheless, the Lynx Captain might have been more considerate over his positioning and this Airprox illustrated that allowing your ac's flight vector to sweep through the other ac's projected flight path will routinely result in a TCAS RA.

Cause: In the absence of TI, the DHC-8 crew was concerned by the proximity of the Super Lynx.

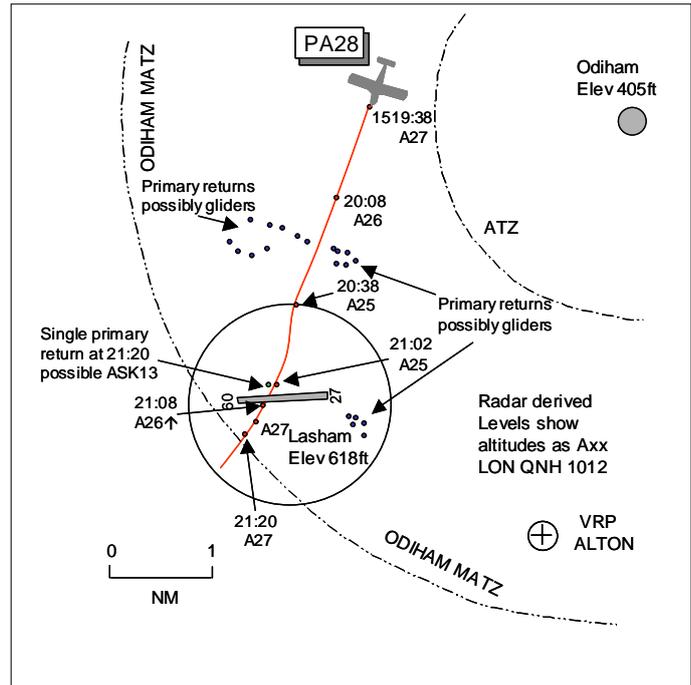
UKAB Note (3): The radar recording does not capture the Airprox. The PA28 is seen at 1519:38 3nm NNE of Lasham tracking 200° and indicating altitude 2700ft London QNH 1012mb. The PA28 continues on a steady track towards Lasham passing close to intermittent primary returns, believed to be gliders, 1.5nm to the N and NE of the glider site. At 1520:38, as the PA28 reaches a position 1nm N of Lasham, its Mode C indicates the ac level at 2500ft QNH and a slight L turn onto a more S'ly heading is then observed. Twenty four seconds later at 1521:02 the PA28 is again tracking 200° and

Cause: The PA28 pilot flew O/H a notified and active glider launching site below the promulgated winch cable release height and into conflict with the ASK13 glider, which he did not see.

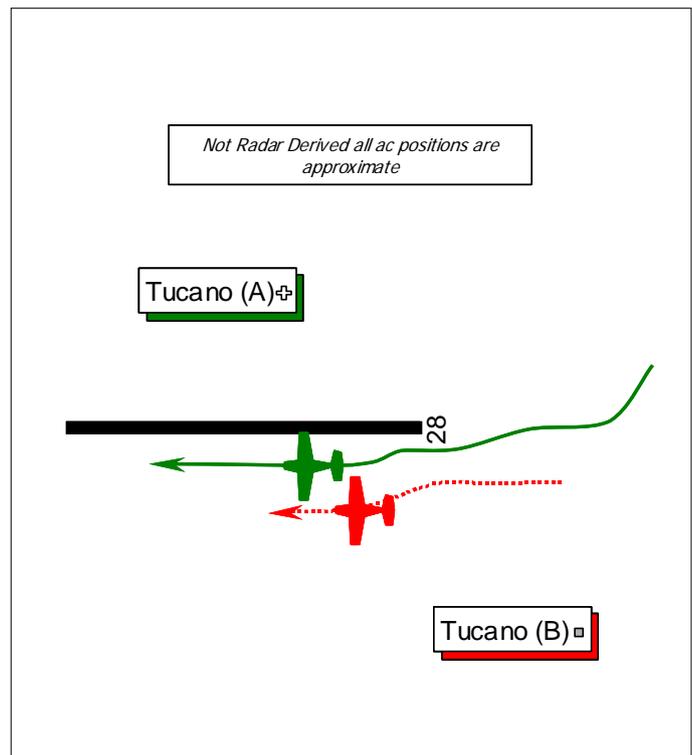
Cause: Erroneous TI from the ADC, resulted in a late sighting by the crew of Tucano (B).

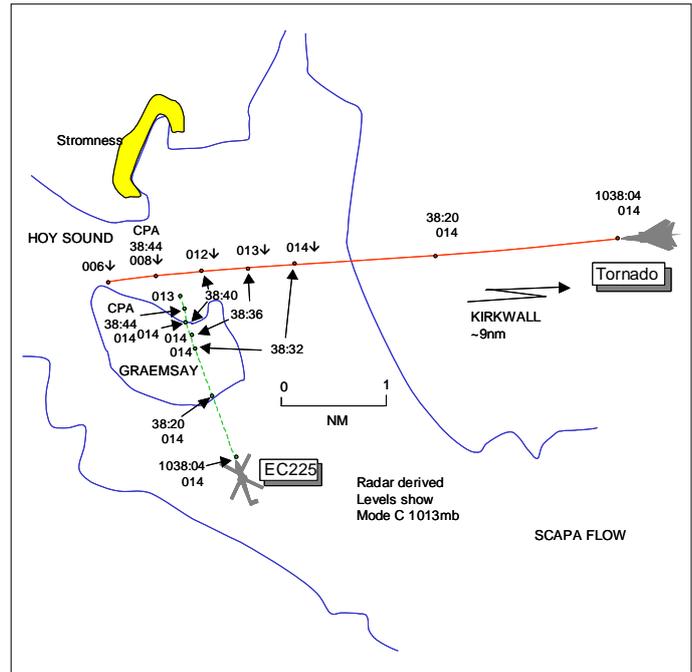
Cause: The Tornado crew flew close enough to cause the EC225 crew concern.

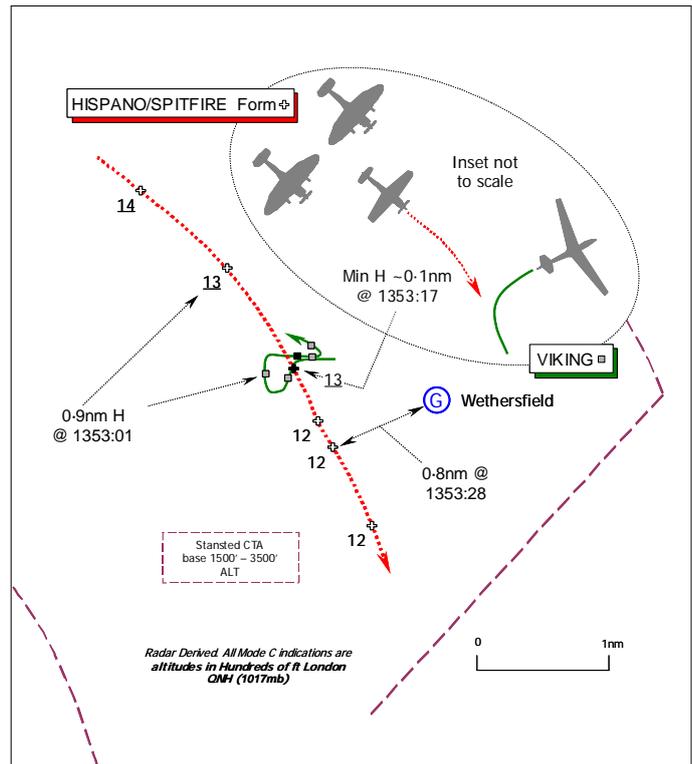
Cause: Conflict in the vicinity of the Wethersfield glider launching site resolved by the pilots involved.

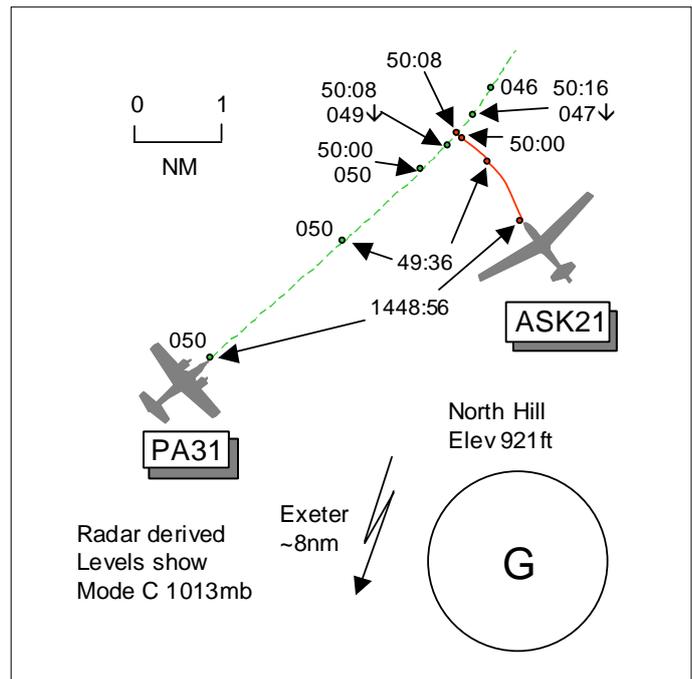
A gliding Member advised that it was not unusual to find gliders at such height, flying below but up to the cloud base, during the summer months. Given that this encounter occurred in Class G airspace, both pilots had equal responsibilities for maintaining their own separation from other ac through see and avoid. Exeter Approach gave good TI to the PA31 pilot, which supplemented his lookout, and it facilitated him acquiring the subject ASK21, albeit late, a part cause of the Airprox. This was possibly owing to the glider initially blending into the cloud backdrop but may have been exacerbated by obscuration by the ac's structure, which the pilot alluded to. Members concurred with the pilot's 'lesson learnt' of moving ones head to mitigate the risk from known blind spots. The ASK21 pilot only saw the PA31, as it appeared just ahead, below and diverging, having already passed, which was effectively a non-sighting, another part of the cause. Although the PA31 pilot's sighting had been

Cause: Effectively a non-sighting by the ASK21 pilot and a late sighting by the PA31 pilot.

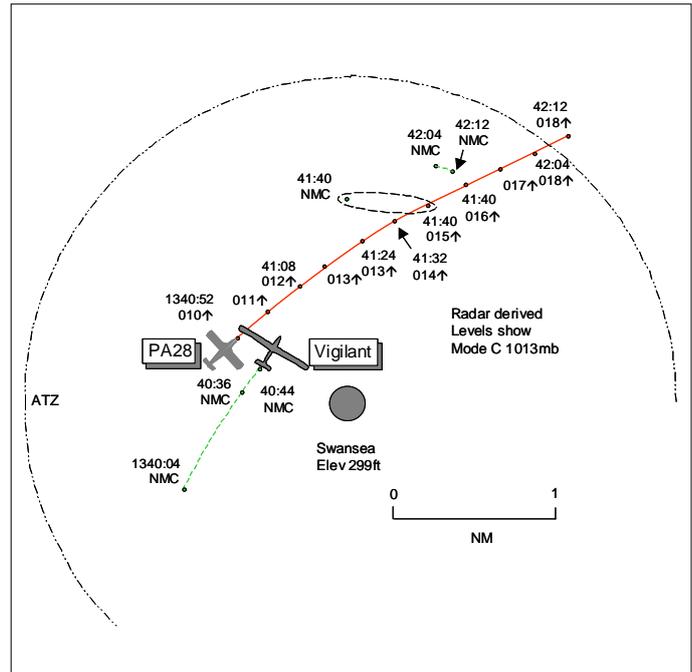
AGCS operator later confirmed that he thought that this was consistent with what he had observed. The view from the control room to the RW22 RH cct is unobstructed. It appeared to him that the PA28 passed behind the subject Vigilant and then turned R to pass O/H it in the late downwind position. In view of the very basic service provided by an AGCS, the operator did well to try and establish whether the PA28 was visual with the subject Vigilant downwind.

Cause: The PA28 pilot flew close enough to cause the Vigilant pilot concern.

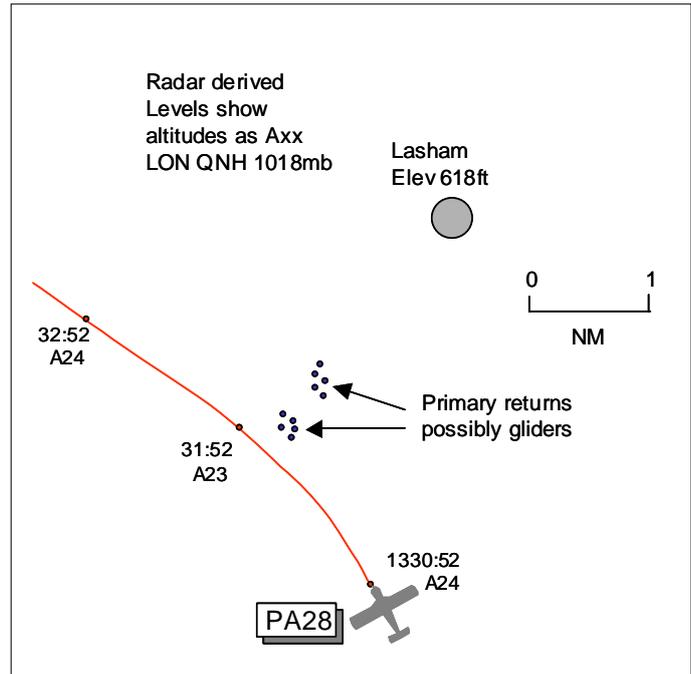
Both pilots had equal responsibility for collision avoidance within this Class G airspace by maintaining a thorough lookout scan and taking appropriate action if necessary. It was clear that the PA28 pilot had avoided the Lasham O/H and had received a warning from LARS W of the gliding activity, and although he saw gliders in the immediate area he did not see the DR400 combination, which was a part cause of the Airprox. The DR400 tug pilot reported seeing the approaching PA28 0.5nm away, which Members thought was a late sighting and another part cause. The opportunity for both pilots to see each other’s ac was there for some time prior to the Airprox. The DR400 would have been approaching from below but within the PA28 pilot’s field of view, although the dark coloured DR400 may have blended into the dark background of the surrounding countryside. Conversely the PA28 would have been sky-lined throughout the DR400 combination’s climb-out. The Board understood the dilemma facing the DR400 pilot and agreed that his sighting and subsequent action of reducing his ROC whilst maintaining visual contact with the PA28 had been most effective in removing any risk of collision.

Cause: Non-sighting by the PA28 pilot and a late sighting by the DR400 pilot.

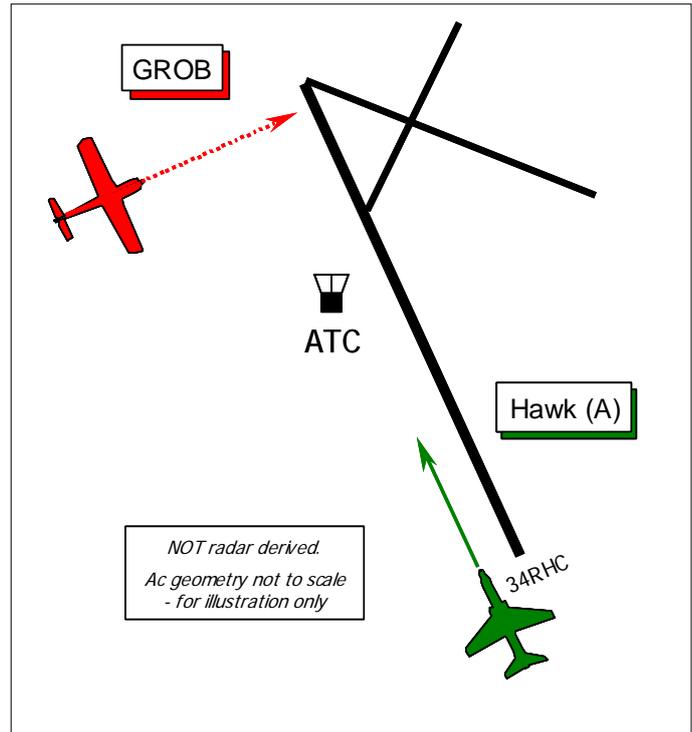
OC Ops Wg states that although the overhead join procedure was rarely practised, it was acknowledged as a Leeming procedure yet did not appear in the FOB. This lack of information relating to overhead joins and specifically how to route from Deadside to Liveside, forced the Grob pilot to adopt a course of action that he considered best. This included a further descent to 500ft QFE, arguably to mirror the height of the solo Tutor student who had been restricted by TWR to 500ft because of the imminent arrival of the next recovering Hawk (C). However, the arrival of Hawk (C) caused the pilot of Hawk (A) to remain at 500ft QFE on the Deadside to provide vertical de-confliction, which, having executed a go-around from his approach, placed the Hawk in confliction with the subject Grob crossing at the upwind threshold.

The use of an overhead join can be viewed as a system induced violation, where the ADC was placed in a situation where the controller was expected to provide a service to ac joining through the overhead, yet the procedure itself had not been integrated into the wider visual cct operation. Furthermore, SATCO Leeming confirmed that the Controllers' Order Book contained no reference to overhead joins or how to manage an ac transitioning from Deadside to Liveside, nor were there any specific training objectives related to such.

This occurrence is a classic example of a series of latent failures awaiting an active trigger – the acceptance by the ADC of the 4th ac into the cct – Hawk (C).

Cause: Late sightings by the crews of both aircraft.

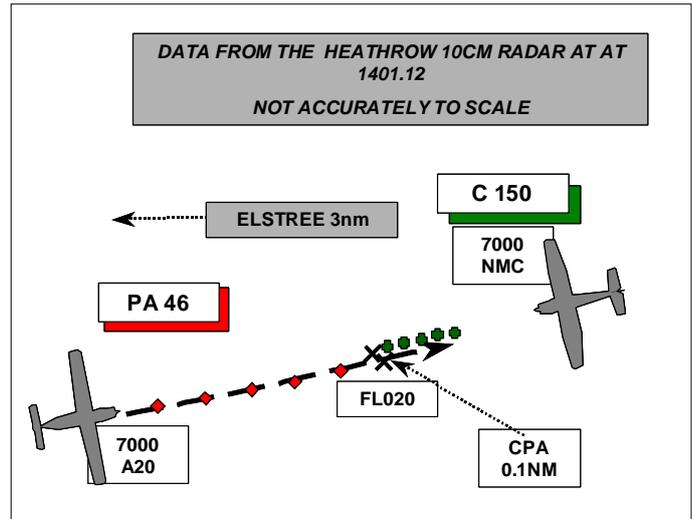
The incident took place in an area of slightly reduced VMC conditions in Class G airspace where 'see and avoid' pertains. Despite the conditions the C150 pilot had first seen the PA46's lighting 600m away. Notwithstanding that he was surprised by its presence, he opted not to take any avoidance, indicating to Members that despite having time to react he considered that no risk of collision existed. The Board thought that the PA46 (solo) pilot had not seen the C150 possibly because it was obscured slightly below the nose of his ac.

Cause: Non-sighting by the PA46 pilot and a late sighting by the C150 pilot.

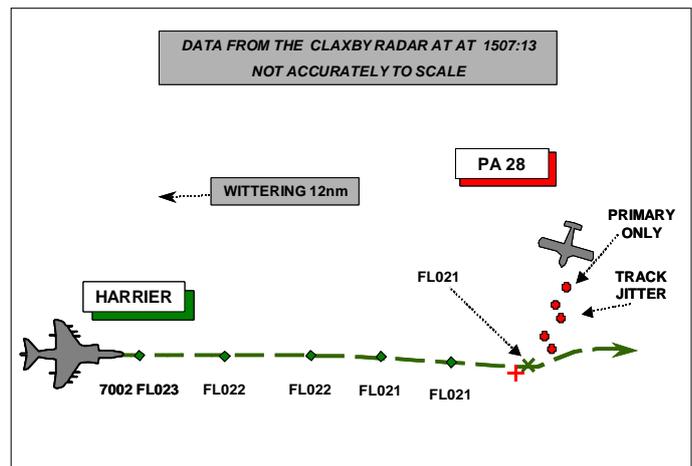
Since the incident took place while the PA28 was not squawking and some time after the Harrier left the Wittering APP frequency, Members thought it reasonable that the that the controller did not warn the Harrier crew of the primary contact (the PA28) on leaving the frequency for Holbeach Range. A military pilot Member also suggested that at the time the crew might have been engaged in pre-range checks or instruction and allowed their lookout to have become degraded. The crew did, however, see the PA28, albeit at a distance they estimated as 100m. Had it actually been 100m away and the closing speed was, as reported, 420kt (215 m/sec) the Board agreed that the avoidance 'break' would not have had time to take effect before the ac crossed, as shown on the radar recording. That being the case, Members agreed unanimously that there had been a degradation of normally accepted safety standards.

Cause: Non-sighting by the PA28 pilot and a late sighting by the Harrier crew.

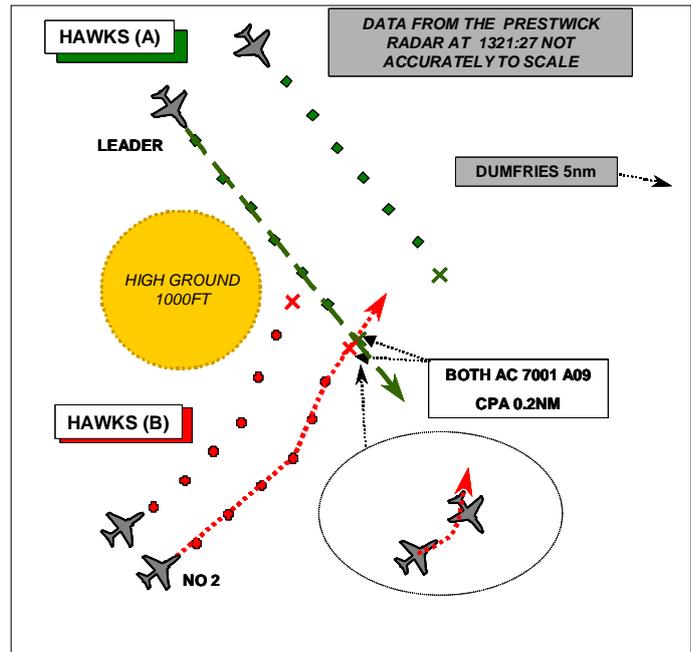
The Board noted that both pairs of ac had been operating legitimately in the UKDLFS but, being from different units, when 'booking out' they would only have been warned of 'mixed traffic' in the LFA and therefore there had been no route deconfliction.

Cause: Conflict in the UKDLFS resolved by Hawk (A) Leader.

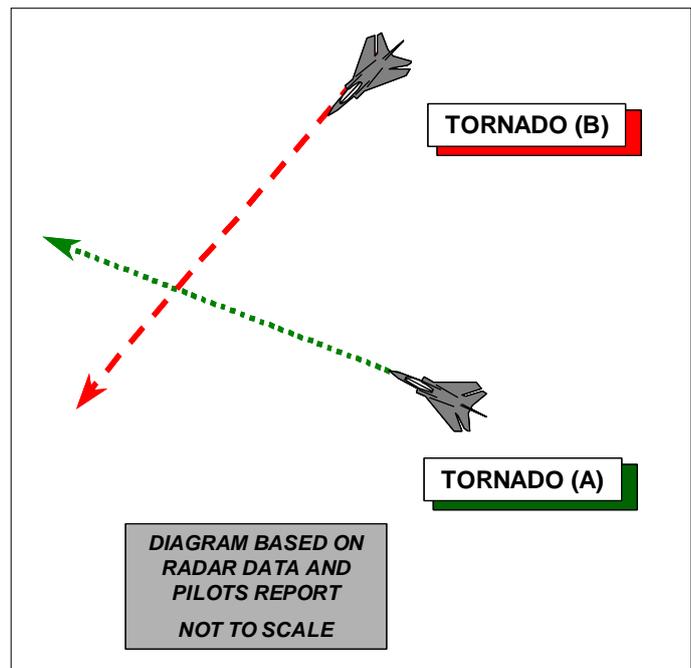
That being the case, the Board agreed unanimously that the UKNLFS [outside the Highlands Restricted Area] is Class G airspace where 'see and avoid' pertains. In this case, despite that the ac had been appropriately lit, the weather below cloud was good and terrain imagery showed that the ac had most likely not been obscured by the terrain, neither crew had seen the conflicting ac and this, Members agreed unanimously, had been the prime cause of the incident.

In light of this information, Members agreed that the crew of Tornado B had not complied with the Deconfliction Plan and this was also part of the cause of the Airprox.

- Cause:
1. Non-sightings by the crews of both aircraft.
 2. The crew of Tornado (B) did not adhere to the deconfliction plan.
