ASSESSMENT SUMMARY SHEET FOR UKAB MEETING ON 16 NOV 2011

AIRPROX REPORT No 2011053

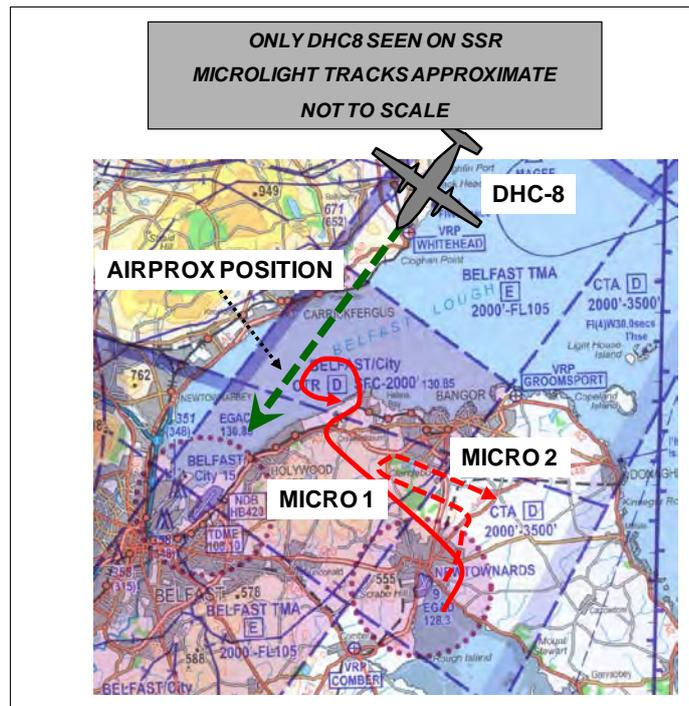
NR V/0.5nm H

Cause: Microlight (1) pilot did not follow the amended clearance and flew into conflict with the DHC-8 on the final approach.

CAA ATSI recommends that the Belfast City ATSU review procedures and phraseology for the transit of formation VFR ac, with a view to obtaining the full details of the ac concerned, with specific mention of the routeing and term 'formation' as part of the clearance provided.

CAA ATSI recommends that the ATSU include this scenario in their unusual emergency (TRUCE) training programme, with elements covering, ac not identified, not displayed on radar, lost ac, tactical and avoiding action considerations.

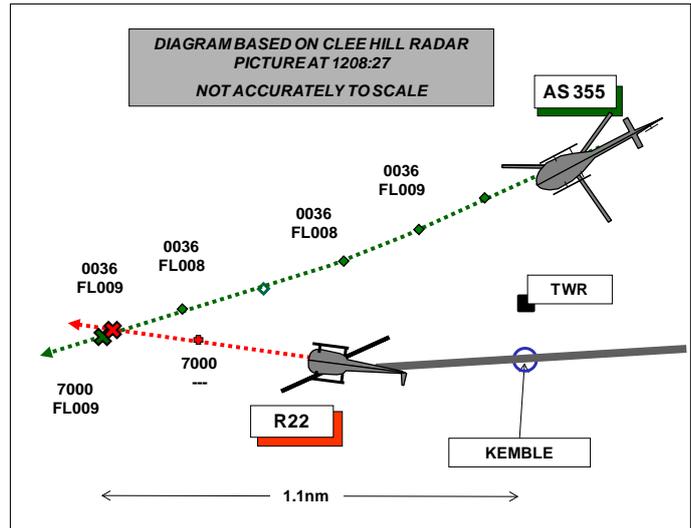
0 V/ <0.1nm H

Cause: In the absence of TI, effectively non-sightings by the pilots of both ac.

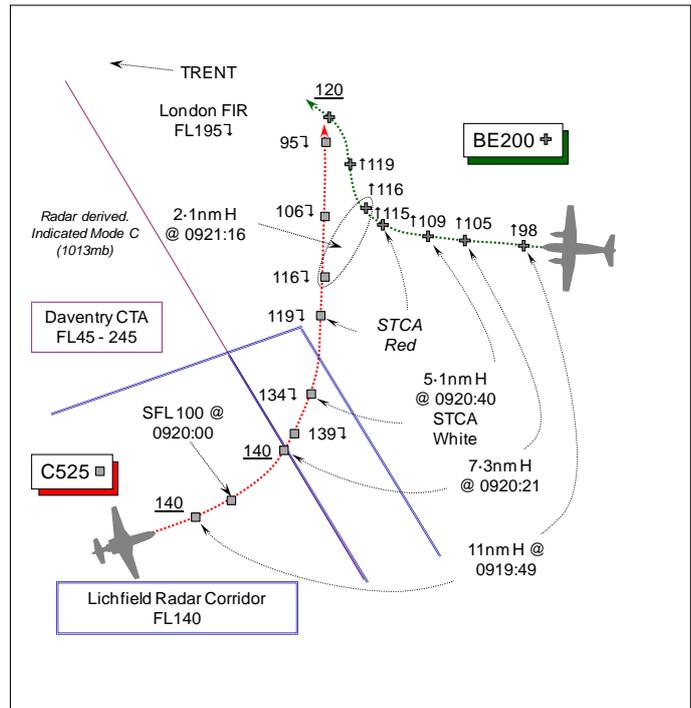
0.3nm Min H @ 2900ft V

Cause: The C525's flight path caused the SAC SE RAD controller concern.

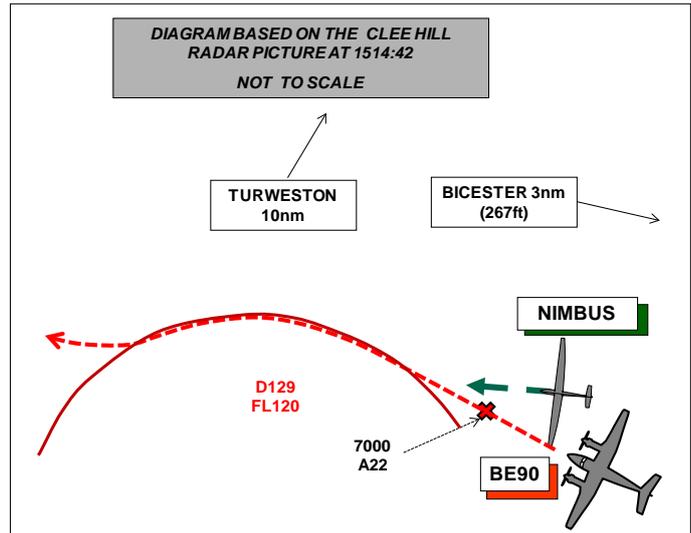
NR

Cause: Probably a non-sighting by the BE90 pilot and effectively a non-sighting by the Nimbus pilot.

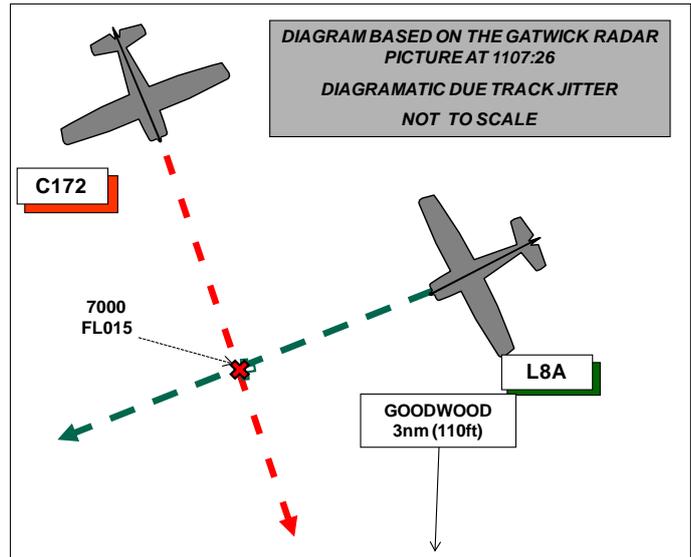
NR V/0 H

Cause: A non-sighting by the C172 pilot and effectively a non-sighting by the Luscombe 8A pilot.

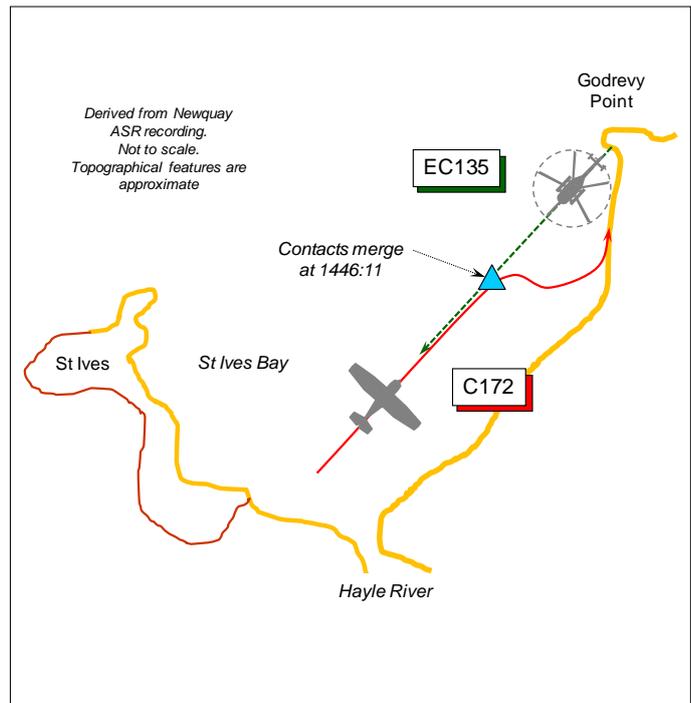
100ft V/contacts merged

Cause: A conflict in Class G airspace resolved by the C172 pilot.

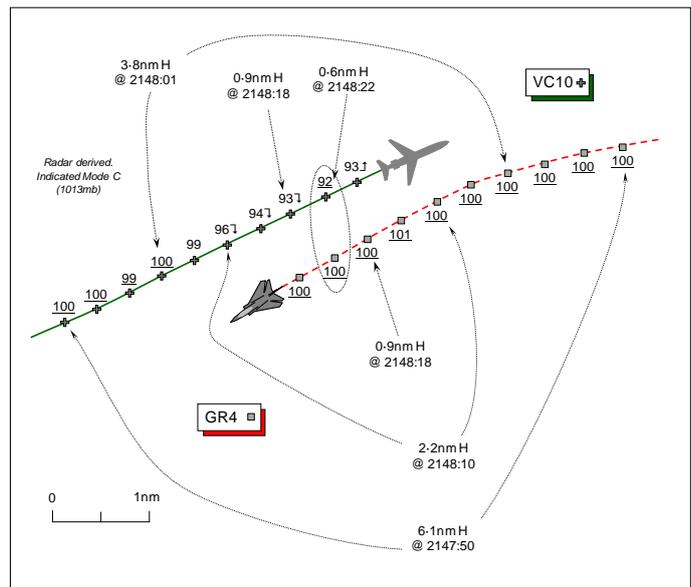
800ft @ 0.6nm Min H

Cause: A conflict in Class G airspace resolved by both crews.

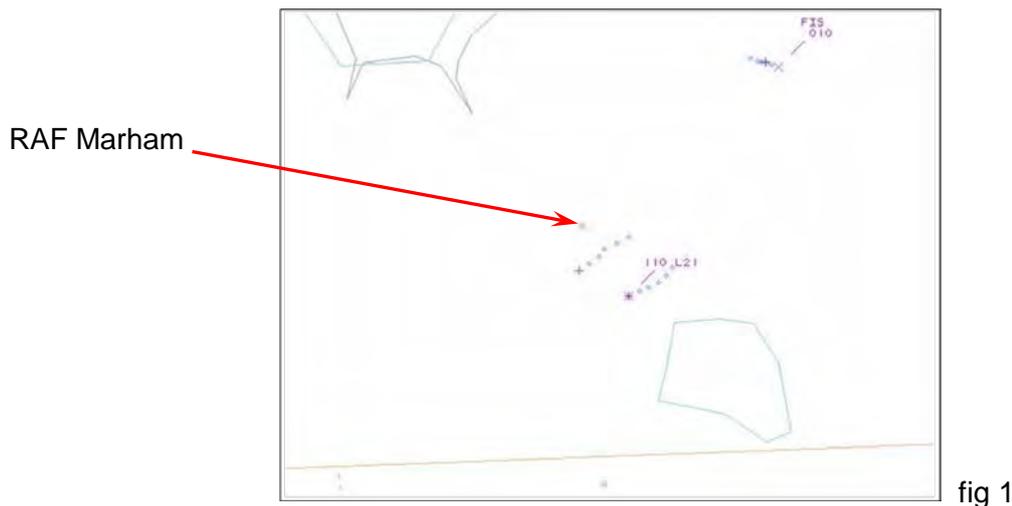
At 2144:42 LJAO EAST passed TI to what they believed to be Tornado (A), stating, "*traffic believed to be your number 1 west 1 mile tracking southwest no height information.*" Given this TI and subsequent events, LJAO EAST believed that Tornado (A) was the south-easterly of the two ac and the ac that had retained the SSR Mode 3A. In reality, as depicted in fig 1 below, Tornado (A) was

the north-westerly PSR-only contact S of Marham, whilst Tornado (B) was the combined (SSR & PSR) contact SE of Marham. The TI issued was acknowledged by the crew of Tornado (A).

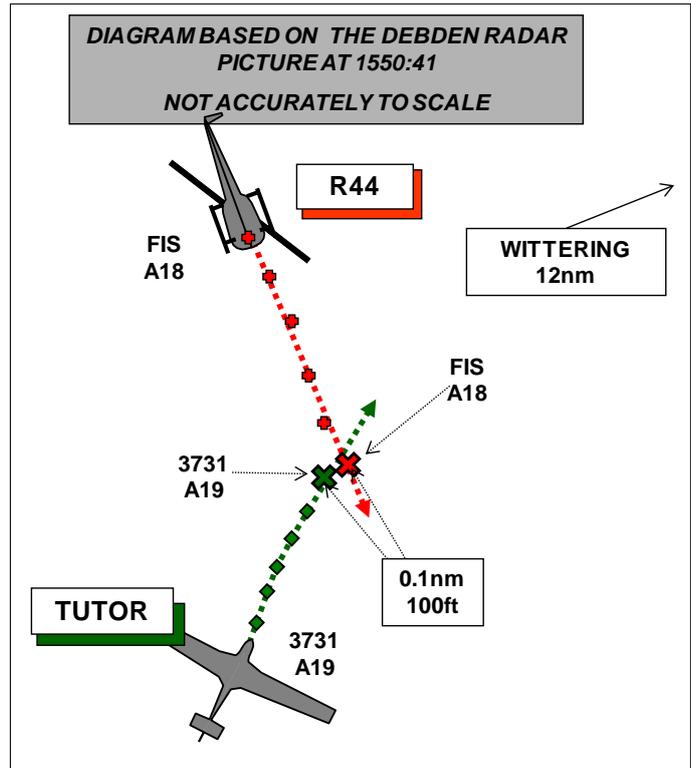
100ft V/ 0.1nm H

Cause: A non-sighting by the R44 pilot and a late sighting by the Tutor instructor.

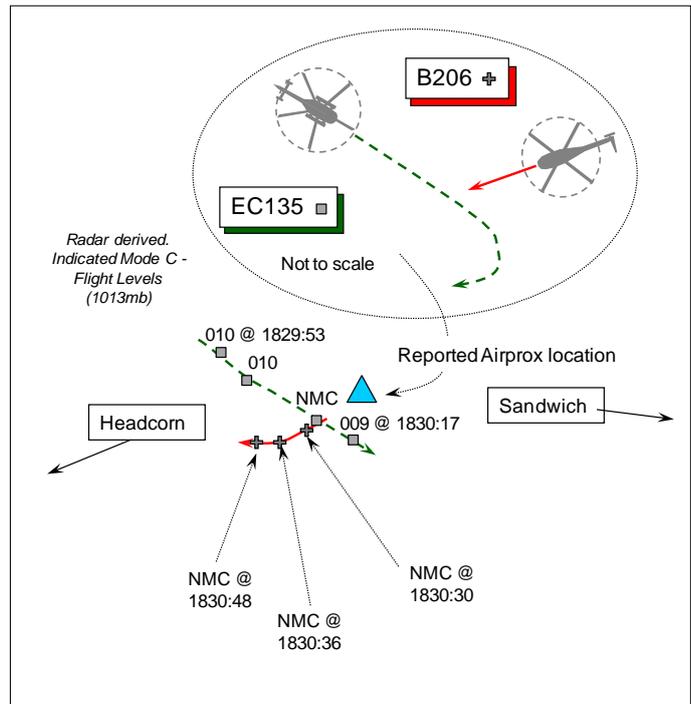
Not recorded

Cause: A conflict in Class G airspace resolved by the EC135 pilot.

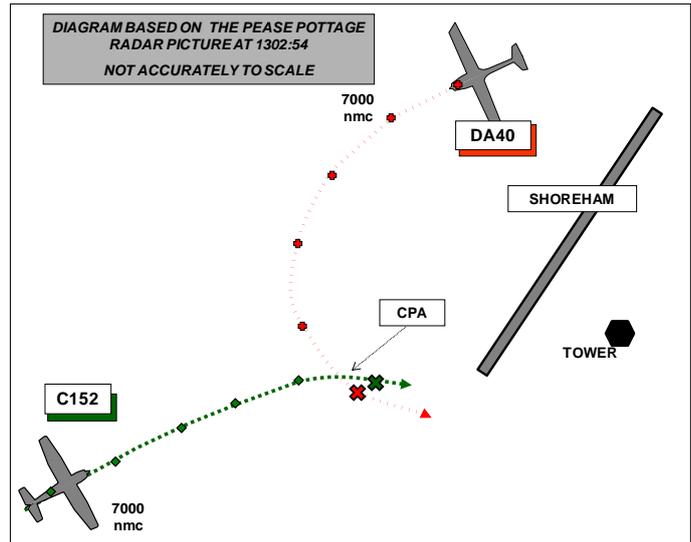
NR V/ est 0 H (between sweeps)

Cause: The DA40 pilot did not follow the Shoreham joining procedure and descended into conflict with the C152, which he did not see.

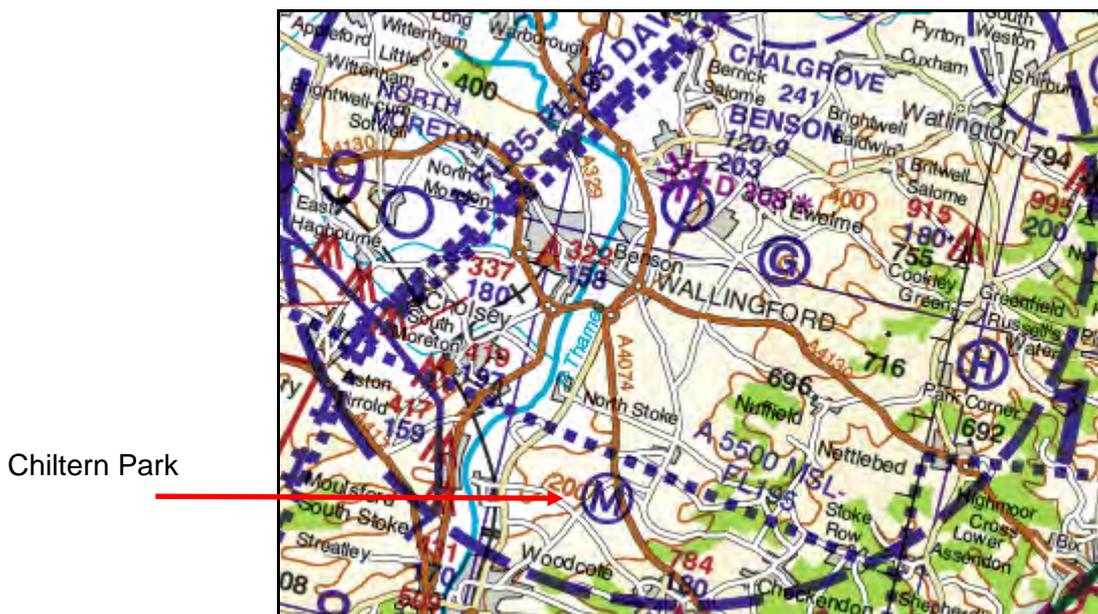
Figure 1: RAF Benson Local Area

Chiltern Park is situated 3.5nm S of RAF Benson and slightly to the E of the extended C/L to RW01 RH (see Figure 1 below), with a visual cct height of 700ft QFE. Published within the AIP as a microlight site, there is no avoidance criteria associated with the site. Chiltern Park and RAF Benson are signatories to a LoA which states that ac wishing to depart above the Chiltern Park cct height of 700ft are advised to contact Benson Zone prior to leaving the cct; it is not a mandatory requirement. The Ikarus flight did not contact Zone in this instance. In the Ikarus pilot's written report, he stated that the Airprox occurred at 800ft QNH, whereas during their later report of the Airprox to Zone on frequency at 1452:23, he stated that they "we're climbing through approximately a thousand or ish seven hundred feet QNH."
