ASSESSMENT SUMMARY SHEET FOR UKAB MEETING 22 September 2010

AIRPROX REPORT No 2010001

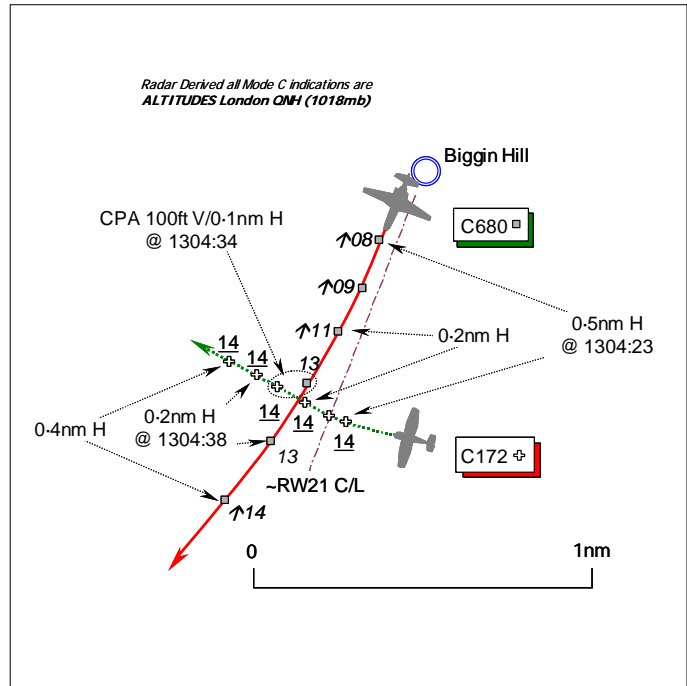
Cause: The ADC cleared the C680 for take off without giving appropriate TI and it flew into conflict with the C172 joining the circuit.

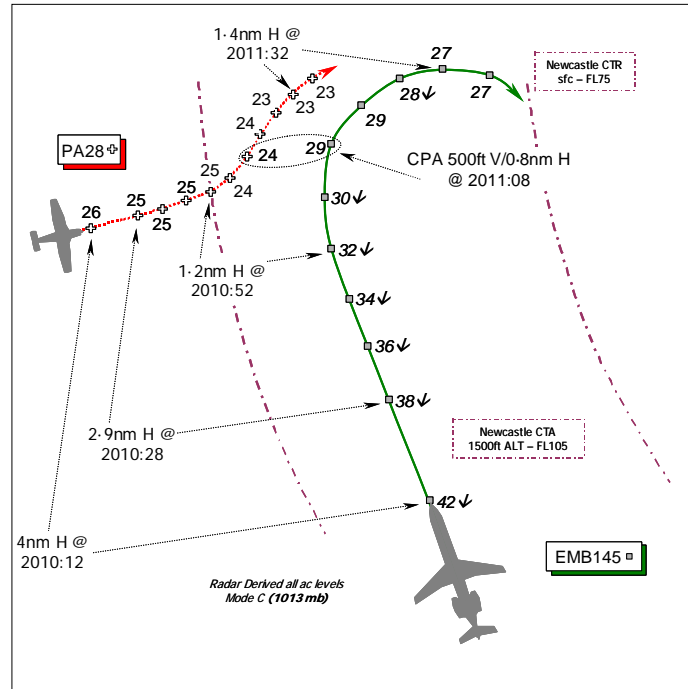
Cause: The PA28 pilot entered the Class D Newcastle CTA without clearance.

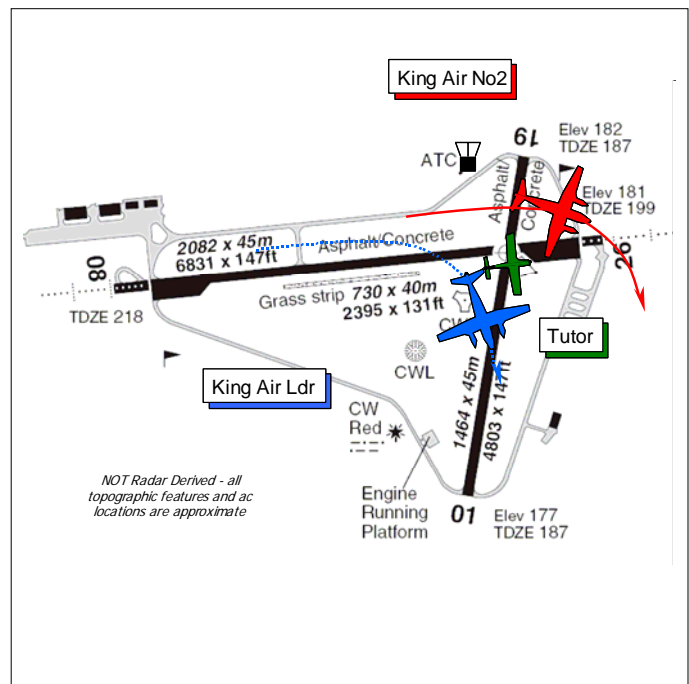
Cause: The King Air formation leader did not integrate his formation into the circuit safely.

Air Cmd ATM Safety Management Support recommended a review of the Run-in and Break procedure at Cranwell, in particular the interaction between the break point within the cct and the grass runway.

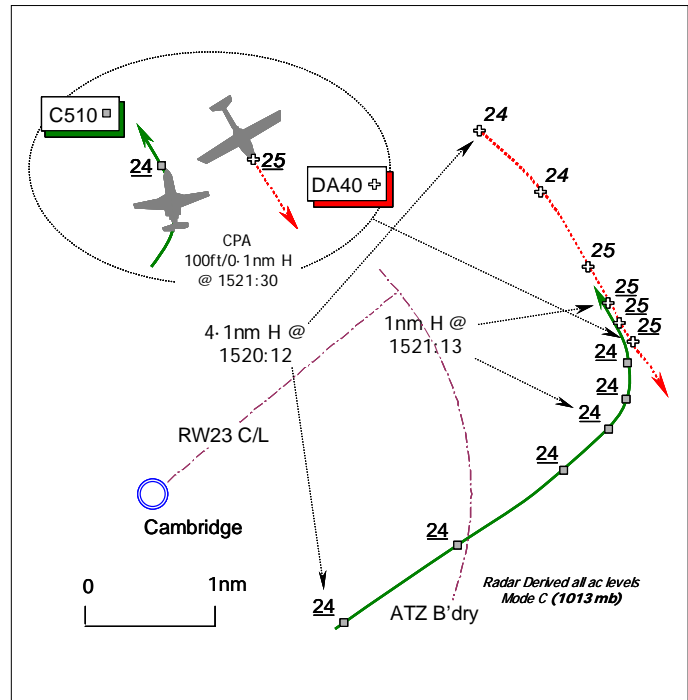
Cause: A non-sighting by the DA40 pilot and a late sighting by the C510 pilots.

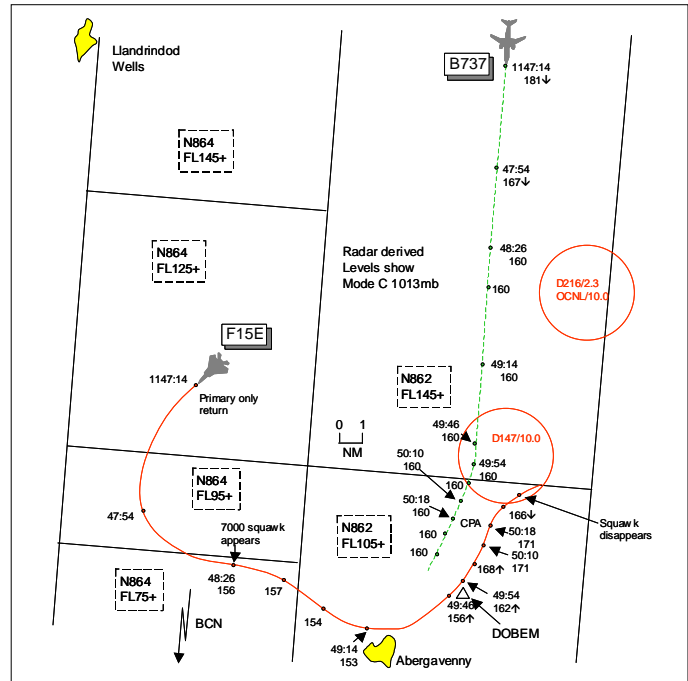
Cause: The F15E pilot entered CAS without clearance and flew into conflict with the B737.

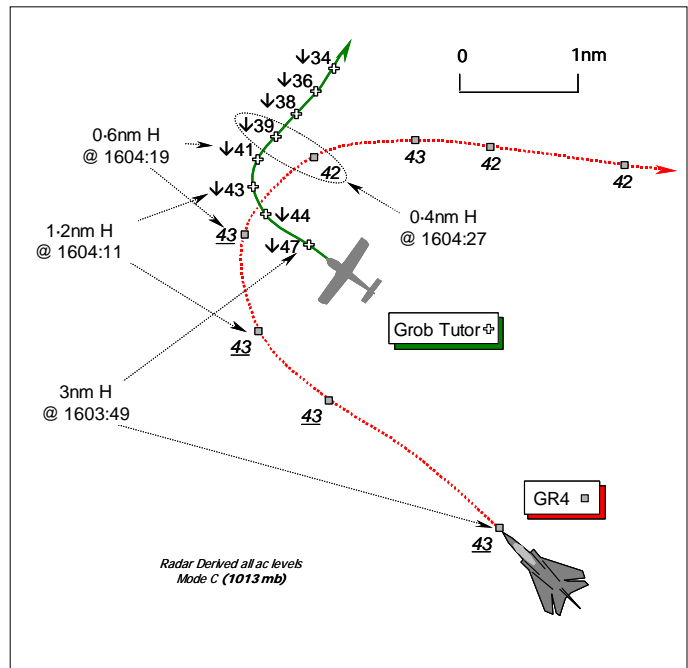
Cause: Conflict in the Lincolnshire AIAA.

SATCO Cranwell has highlighted the issues surrounding this Airprox in a recent Unit Standards Bulletin; controllers have been reminded to pay particular attention to the traffic situation during the handover of operating positions. This Command has also recommended that this scenario is incorporated into Unit training simulations.

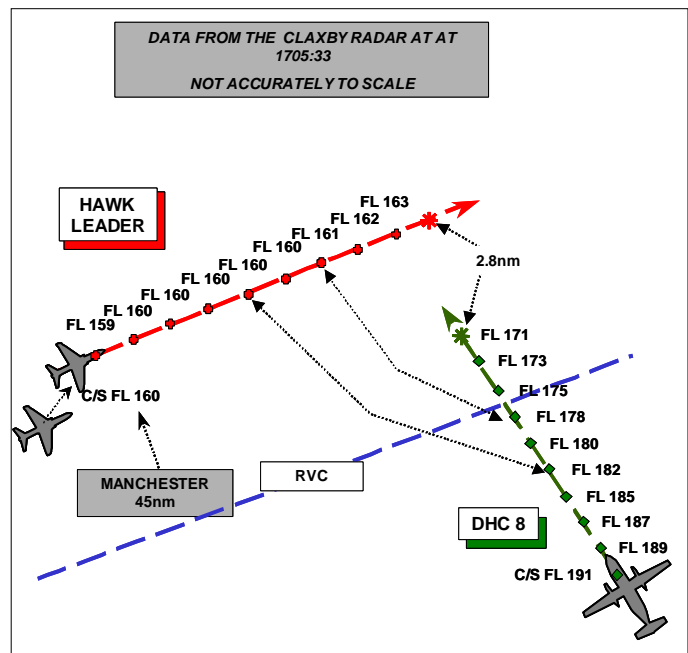
Cause: The Hawk pair climbed above their cleared level.

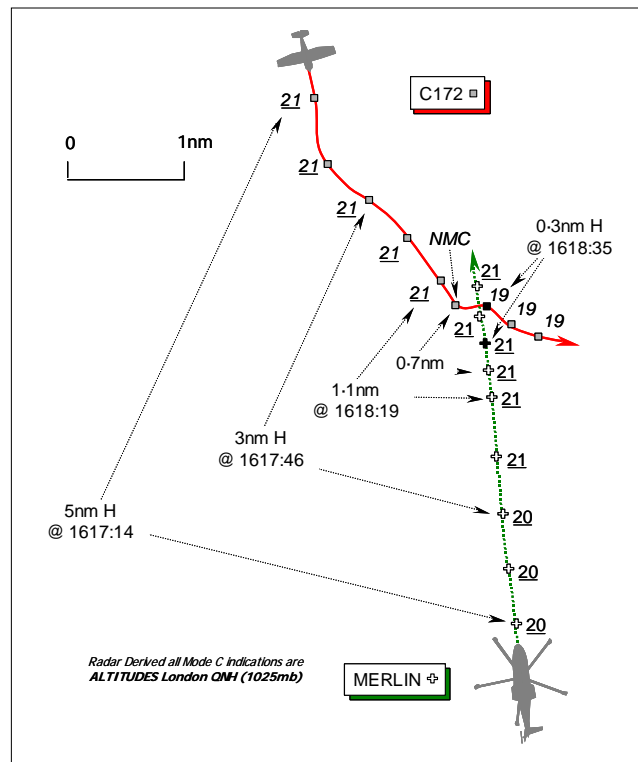
Cause: Conflict in the Oxford AIAA resolved by the C172 pilot.

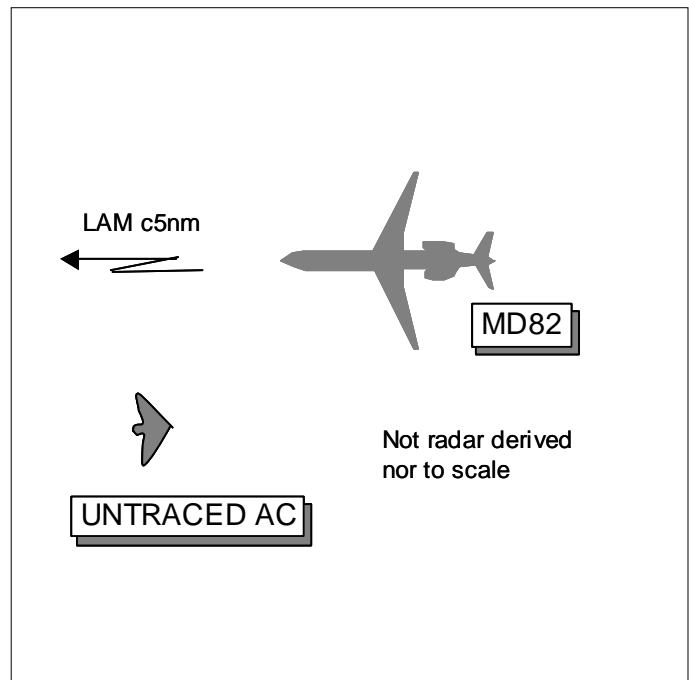
Cause: Conflict in Class A airspace with an untraced ac.

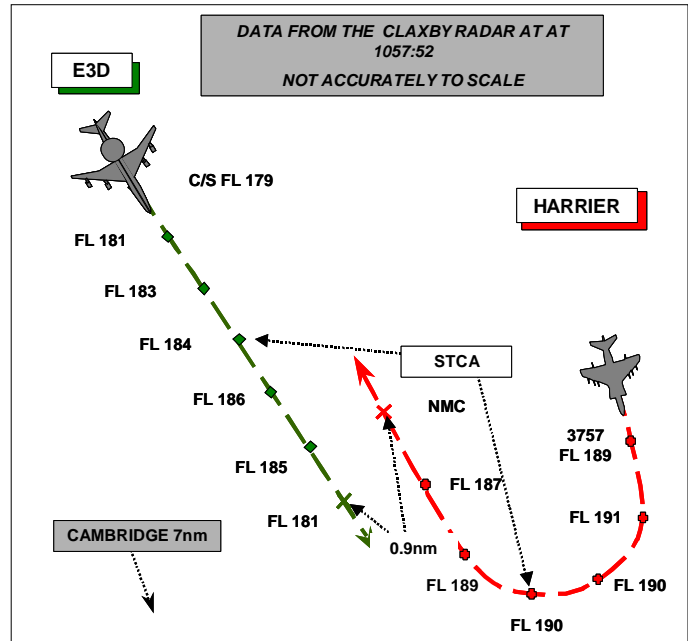
Cause: Sighting report (TCAS).

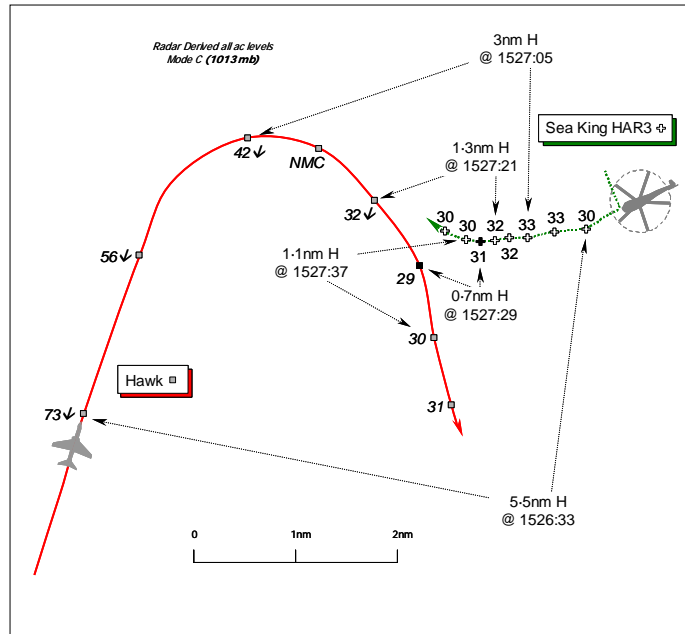
Cause: Sighting Report.
