ASSESSMENT SUMMARY SHEET FOR UKAB MEETING ON 14 SEPTEMBER 2011

AIRPROX REPORT No 2011024

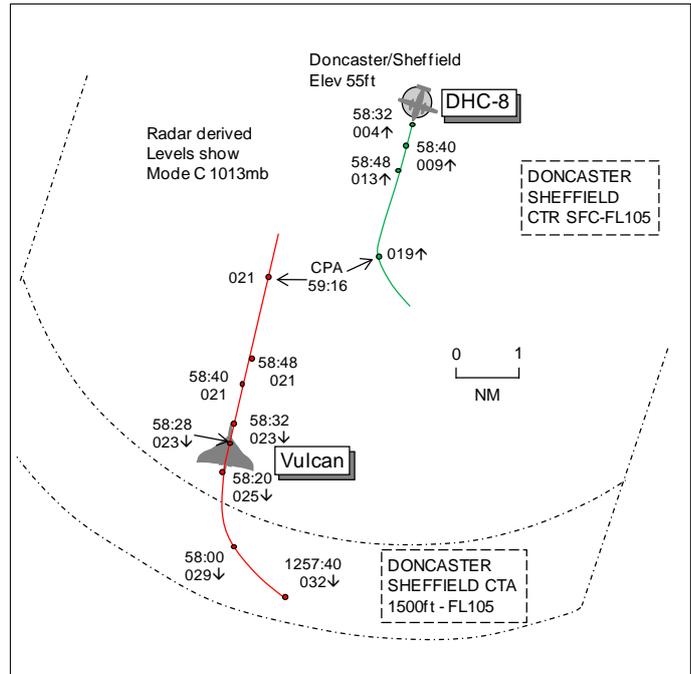
Nil V/1.9nm H

Cause: Late recognition that the Vulcan was not flying in accordance with the controller's expectations.

CAA ATSI recommends that the ATSU reminds controllers of the requirement to ensure that non-operational conversations must not be permitted to interfere with a controller's operational duties. MATS Part1, Appendix E, Page 2, paragraph 2, states:

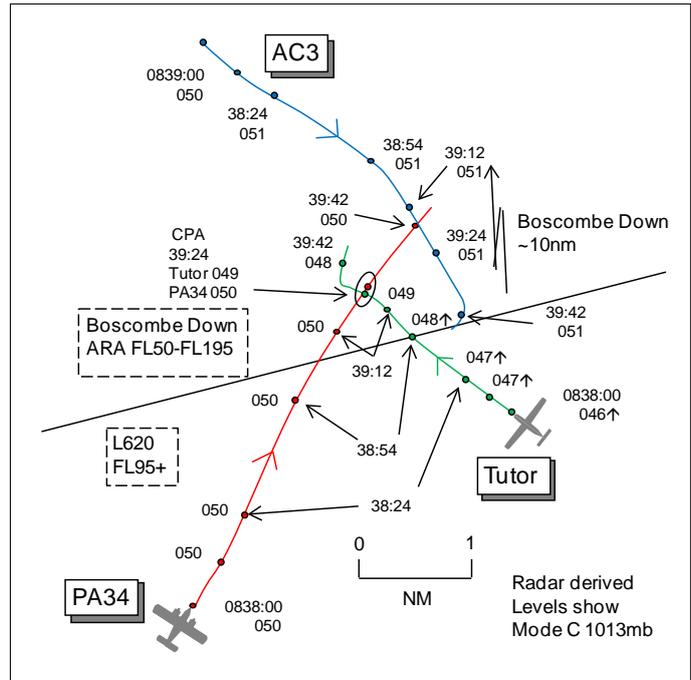
100ft V/<0.1nm H

Cause: A non-sighting by the PA34 crew and effectively a non-sighting by the Tutor pilot.

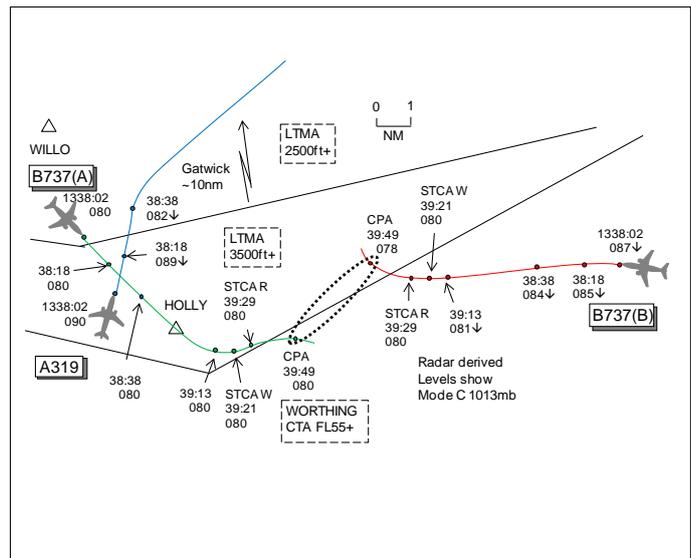
Cause: The Gatwick INT DIR vectored B737(B) into conflict with B737(A).

100ft V/0.1nm H

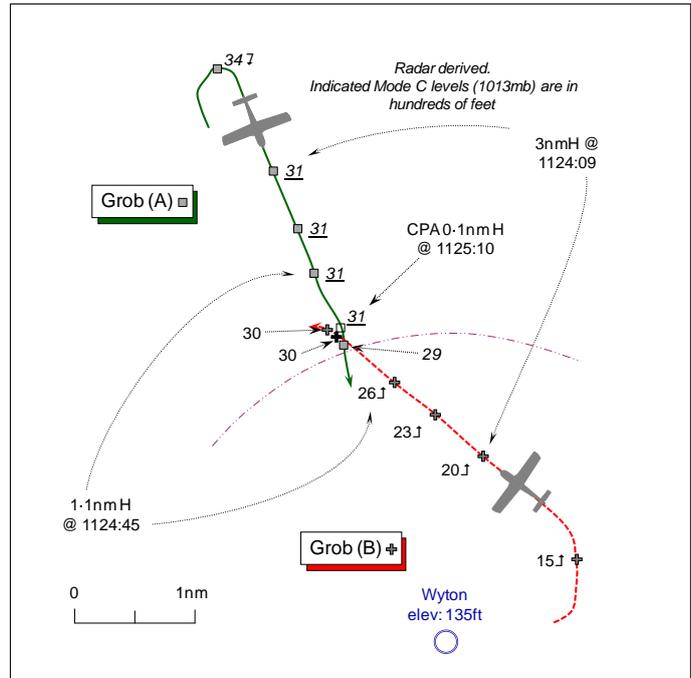
Cause: Effectively a non-sighting by Tutor (B) pilot and a late sighting by Tutor (A) crew.

0.3nm H

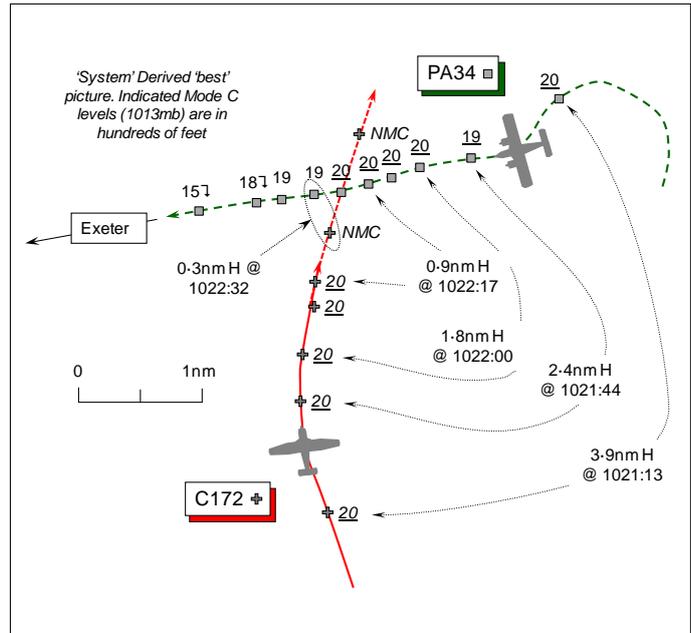
Cause: A late sighting by the C172 pilot.

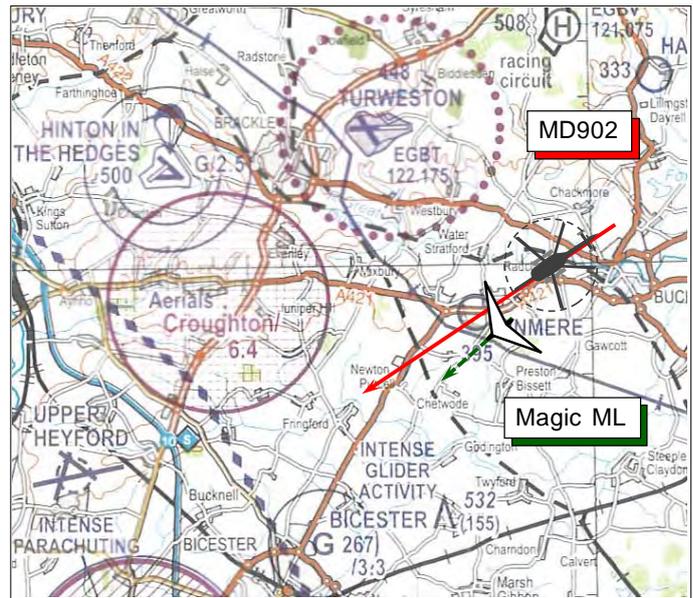
- Cause: The MD902 pilot flew close enough to cause the flexwing ML pilot concern.
- Degree of Risk: E.
- Recommendation: The Board was concerned that there have been a number of incidents in which Microlight/para gliders/hang gliders etc appear to have been affected by helicopters at unexpected distances and aspects. Director UKAB was

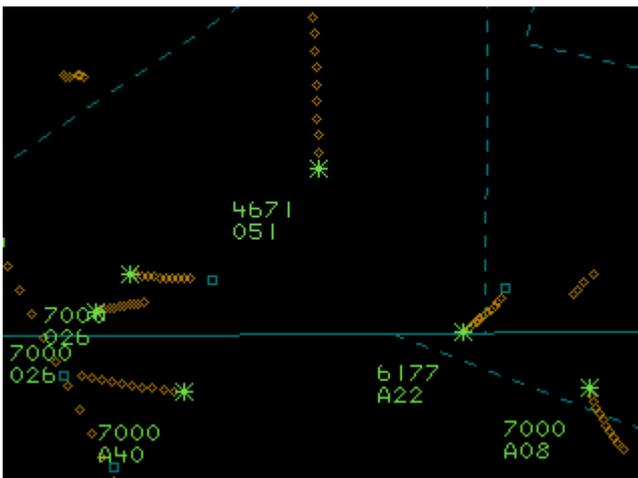
The traffic visible to Luton RADAR at this time is shown on the radar snapshot below:
