**AIRPROX REPORT No 2010005**

Date/Time: 12 Feb 1235

Position: 5114N 00201W  
(SPTA - elev 488ft)

Type: DH3 UAV Sea King

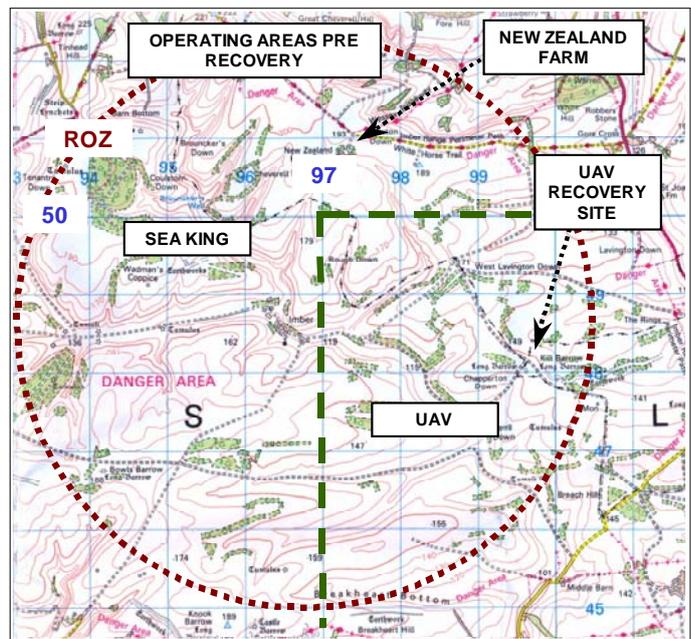
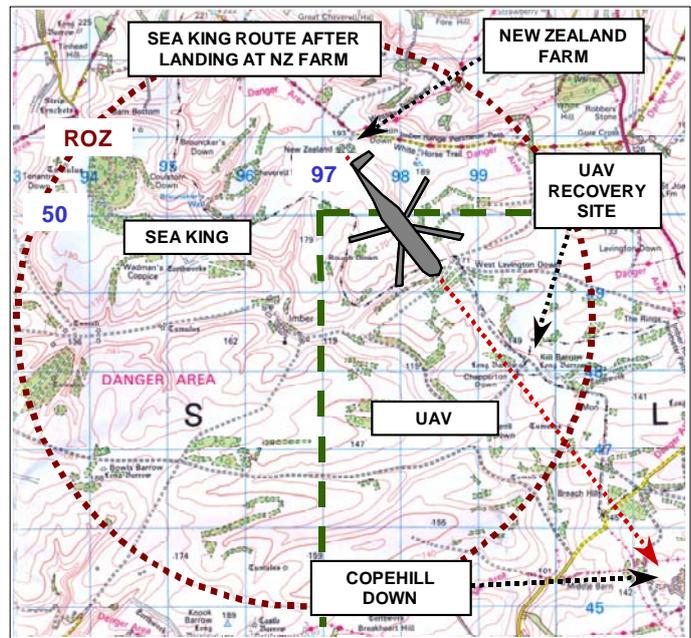
THE DH3 MUAV PILOT reports that he was operating a small, non-SSR or TCAS equipped UAV in an exercise ROZ, 2nm in radius from 0-1500ft amsl centred on 5114N 00203W (see Diagram). Meanwhile a Sea King was cleared to operate in the ROZ and was being deconflicted geographically from the UAV by the Tactical Air Control Party (TACP).

After taking off from the FOB a short time later the Sea King routed direct from the FOB to Copehill Down (2nm SSE of the landing site) at low level. This routing took them through the airspace reserved for the DH3.

At this point the DH3 was turning left and descending, 300m out in its final landing pattern, flying at 32kt, when the Flight Safety Officer (FSO) saw the Sea King approaching 700m away. He carried out the immediate action drill, sending the UAV into an emergency orbit away from the flight path of the Sea King. The helicopter came within 300m of the UAV with both ac at the same alt. This was a very close encounter and had the FSO not reacted so quickly a mid air collision could have occurred. Since the Sea King was flying so low it was not seen by the air sentries and gave the Detachment little time to react; it was also too low for RT contact with the TACP.
