AIRPROX REPORT No 2010016

Date/Time: 9 Mar 1655

Position: 5148N 00008W (1nm SE
Panshanger - elev 250ft)

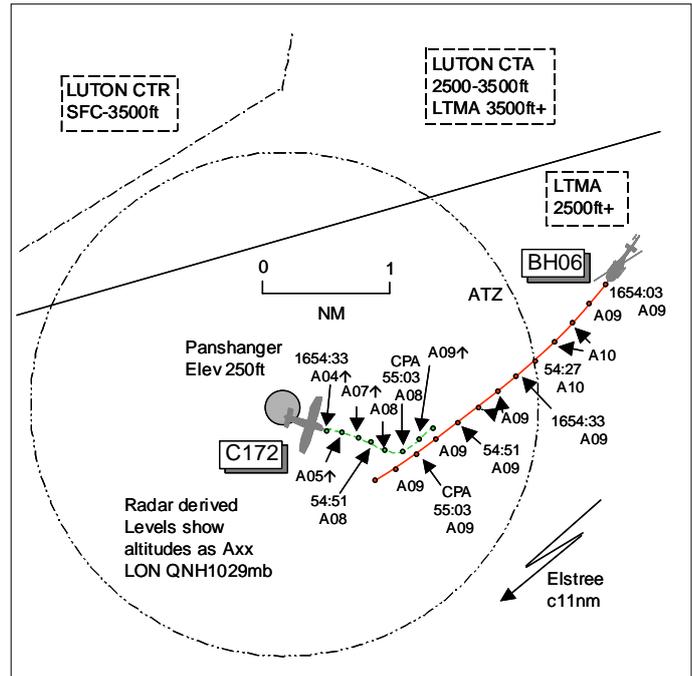
UKAB Note (5): Analysis of the Debden radar recording at 1654:03 shows a 7000 squawk, believed to be the BH06, 2.7nm ENE of Panshanger tracking SW indicating unverified altitude 1000ft LON QNH 1029mb. The BH06 continues on a steady track and is seen to enter the Panshanger ATZ at 1654:27. Six seconds later a 7000 squawk appears, believed to be the C172, 0.5nm SE of Panshanger tracking 110° and showing unverified altitude 400ft QNH with the BH06 in its 11 o'clock range 1.6nm and 500ft above. The ac continue on converging tracks, the radar showing the C172's Mode C levelling-off at altitude 800ft QNH at 1654:51 with the BH06 in its 1130 position at range 0.7nm. The next sweep 6sec later shows the C172 commencing a L turn, the subject ac separated by 0.4nm with the BH06 100ft above. The CPA occurs on the next sweep at 1655:03, the ac passing starboard to starboard, the BH06 showing 900ft QNH, 100ft above the C172 with lateral separation of 0.1nm. Thereafter the BH06 passes 0.9nm SE abeam Panshanger whilst the C172 continues its climb on a NE'ly track crosswind for RW11.
