## AIRPROX REPORT No 2010026

Date/Time: 24 Mar 1537

Position: 5120N 00131W (1nm E  
Rivar Hill G/S - elev 730ft)

Type: K8 Glider SK76

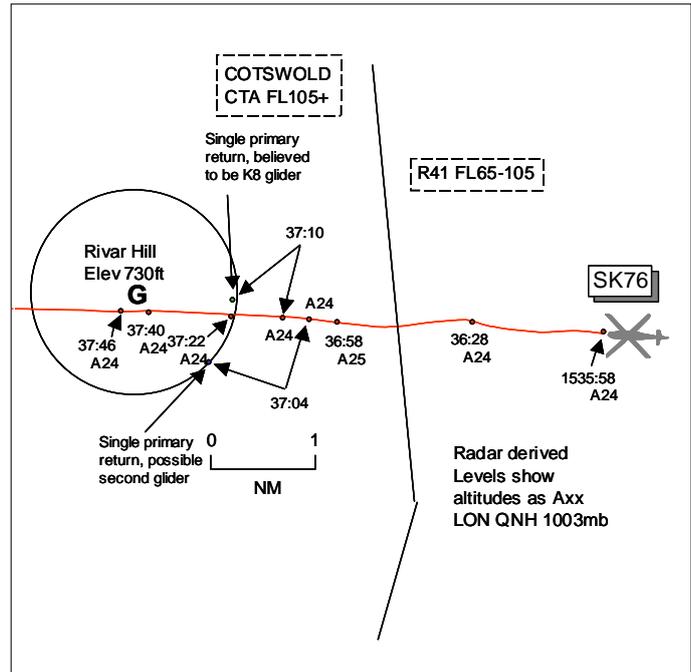
UKAB Note (3): The Airprox is not captured on recorded radar. The Pease Pottage radar recording at 1535:58 shows the SK76 4.6nm E of Rivar Hill tracking 270° indicating altitude 2400ft London QNH 1003mb. The SK76 continues on a broadly W'ly track reaching a position 1.5nm E of Rivar Hill at 1537:04 with a single pop-up primary contact, believed to be the second glider reported by the K8 pilot, in its 11 o'clock range 1nm. On the next radar sweep 6sec later at 1537:10 another single pop-up primary contact appears, believed to be the K8, in the SK76's 1230 position range 0.5nm. Thereafter, no other returns appear that could possibly be gliders close to Rivar Hill, the SK76 passing through the Rivar Hill O/H between sweeps at 1537:40 and 1537:46 at 2400ft QNH.

Whether the SK76 pilot had planned to fly directly O/H the gliding site whilst flying VFR is not known; however, the gliding site is clearly marked on the 1:250,000 and 1:500,000 topographical charts. The radar recording shows the SK76 on a steady W'ly track approaching the glider site from the E at 2400ft LON QNH before transiting directly O/H post Airprox. Members agreed that best practice was to take due regard of the airspace and its activities during the planning stages before flight and then plan and fly the route accordingly. As the incident occurred in Class G airspace both pilots were responsible for maintaining their own separation from other traffic through 'see and avoid'. Although the SK76 was under a BS from Farnborough, the controller was under no obligation to monitor the flight or pass TI. The SK76 pilot, who was flying into sun, recalled seeing a white glider out to his L but not the green K8 crossing ahead; the K8 pilot heard and then saw the helicopter, albeit late, 0.25nm away to his L. Members agreed that the non-sighting by the SK76 pilot and late sighting by the K8 pilot had been the cause of the incident.

Cause: A non-sighting by the SK76 pilot and a late sighting by the K8 pilot in the vicinity of a notified and active gliding site.

The same lesson was identified in this Airprox as that in 2010007 - when flying close to a promulgated site, an encounter with a glider is likely and therefore a wide berth should be given. The far greater potential hazard was that of an impact with the winch cable if crossing O/H the site below the promulgated maximum winch height, in this case 3000ft agl (3730ft amsl). Fortunately no launch was in progress when the SK76 pilot passed O/H Rivar Hill.
