## AIRPROX REPORT No 2010045

Date/Time: 10 May 2010 1440Z

Position: 5140N 00105W (3nm N  
Benson - elev 203ft)

Type: Puma                      Untraced Glider

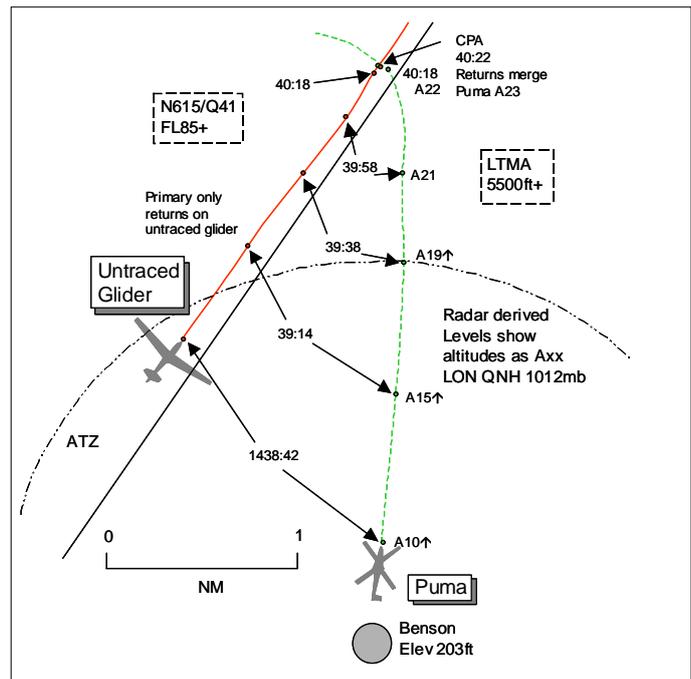
returns merge

UKAB Note (1): Analysis of the Heathrow 23cm and 10cm recorded radars, not available to Benson ATC, at 1438:42, when the Puma pilot acknowledges the trainee Director's climb, first shows the Puma 0.3nm N of Benson tracking 005° climbing though altitude 1000ft QNH 1012mb (800ft Benson QFE). At the same time a primary only return, the untraced glider, shows 2nm NW of Benson tracking 035° in the Puma's 1030 position. The subject ac continue on converging headings with separation reducing to 0.7nm at 1439:38, the time when the trainee Director passes TI to the Puma pilot on traffic to the NE. Separation reduces further to 0.4nm at 1439:58 when Director instructs the Puma flight to turn L onto heading 310°. As the Puma pilot's transmission starts, reporting his sighting of the glider, the ac as separated by <0.1nm before they merge 4sec later at 1440:22, the Puma indicating a climb of 100ft to altitude 2300ft QNH, in accord with the pilot's reported avoiding action.
