## AIRPROX REPORT No 2010094

Date/Time: 10 Jul 2010 1105Z (Saturday)

Position: 5159N 00120W (9nm N  
Oxford - elev 270ft)

Airspace: Oxford AIAA (Class: G)

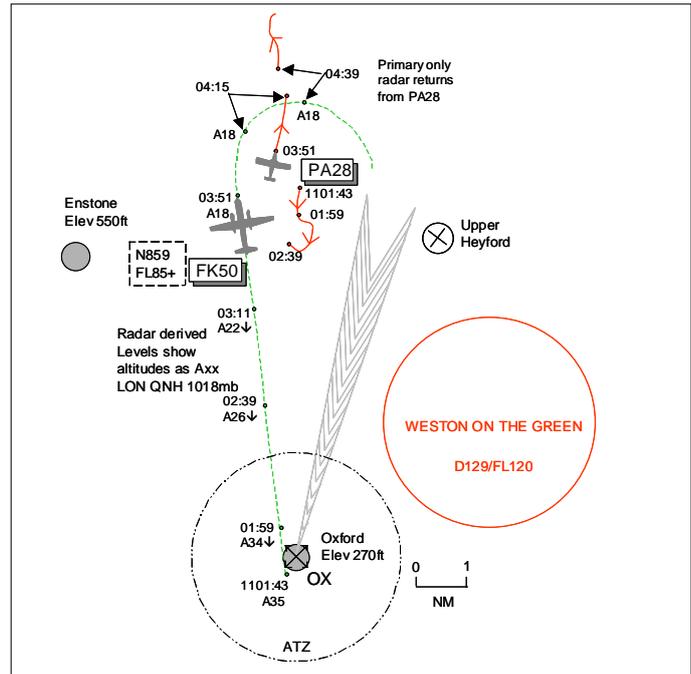
[UKAB Note (1): The radar recording between 1101:43 and 1102:39 shows an intermittent primary contact, believed to be the PA28, manoeuvring 6-7nm N of Oxford airport and 3nm WNW of Upper Heyford, close to the instrument let down area. The primary only return fades after the sweep at 1102:39, when it is 3nm N of the FK50 and turning through a NW'ly heading.]

[UKAB Note (2): The PA28 reappears on radar at 1103:51 7.5nm N of Oxford tracking 010° in the FK50's 0130 position range 1.1nm, the FK50 level at 1800ft QNH 1018mb.]

[UKAB Note (3): At 1104:15 the radar recording shows the FK50 in a R turn with the PA28 crossing through its 12 o'clock range 1nm tracking N; the PA28 then fades from radar. The PA28 reappears 24sec later at 1104:39 tracking N 0.8nm NW of the FK50, which is turning though an E'ly heading. The CPA is not captured but it is estimated to be <0.5nm]
