AIRPROX REPORT No 2010110

Date/Time: 19 Aug 2010 1507Z

Position: 5239N 00008W (12nm
E RAF WITTERING)

Type: HARRIER T12 PA28

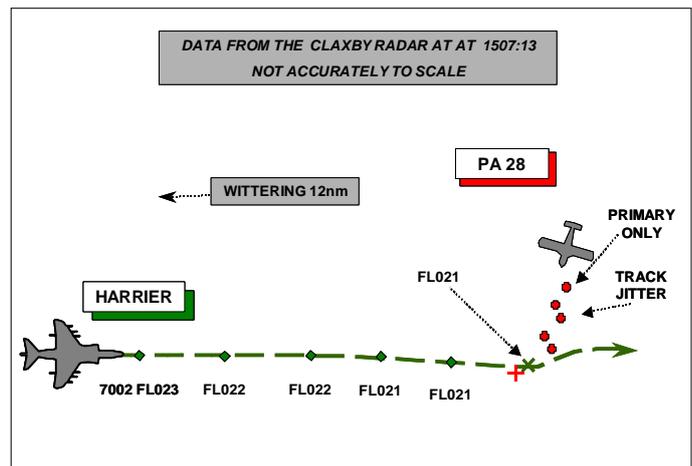
NR V/ 0.1nm H (subject to severe track jitter)

UKAB Note (2): The recording of the Claxby Radar shows the incident. The Harrier can be seen getting airborne from Wittering at about 1504, squawking 3743 with Mode C. At that time a primary only contact, presumed to be the PA28, can be seen just to the SW of Fenland tracking about 220°. After TO the Harrier rolls out on a track of 065° before turning right onto 090° at FL021, changing Squawk to 7002 and tracking directly towards the PA28. The CPA is at 1507:13 when the PA28 is in the Harrier's 11 o'clock at 0.1nm but it suffers from significant track jitter; the Harrier is at FL021 but the PA28 is not squawking. On the next 2 sweeps the Harrier can be seen to have turned hard left and climbing to FL025 before reversing back onto track and descending.
