## AIRPROX REPORT No 2010145

Date/Time: 16 Sep 2010 2255Z (night)

Position: 5314N 00430W (Final  
RW31 Valley - elev 36ft)

Type: Hawk Lynx

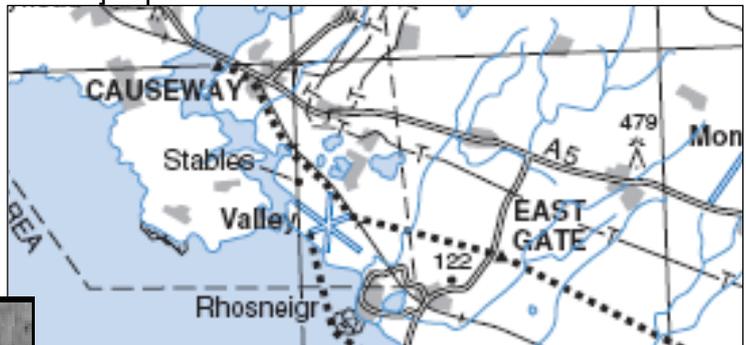
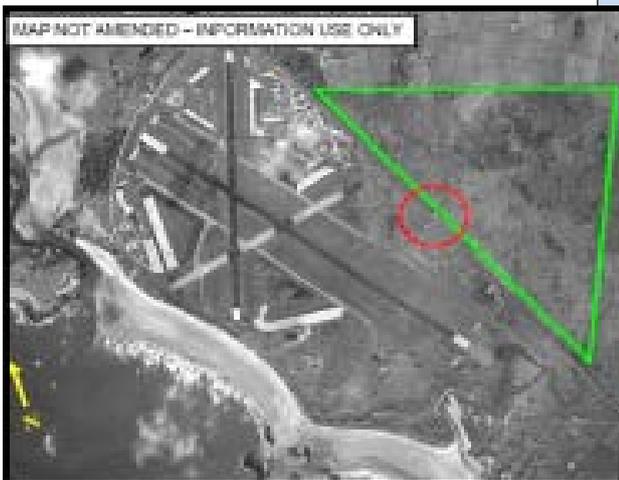
The following diagrams show East Gate and the railway line in relation to the airfield, and the area known as the ‘Golf Course’ which is bounded by the NE fence of the railway line, then the two fence lines running E-W and N-S forming the other 2 sides of the green triangle marked on the photograph.

Without a radar replay it is not possible to be certain, but from the descriptions given it is probable that the Lynx was routeing through the South-Eastern corner of the Golf Course, which is roughly the same position as late-downwind or early finals for the Hawk.

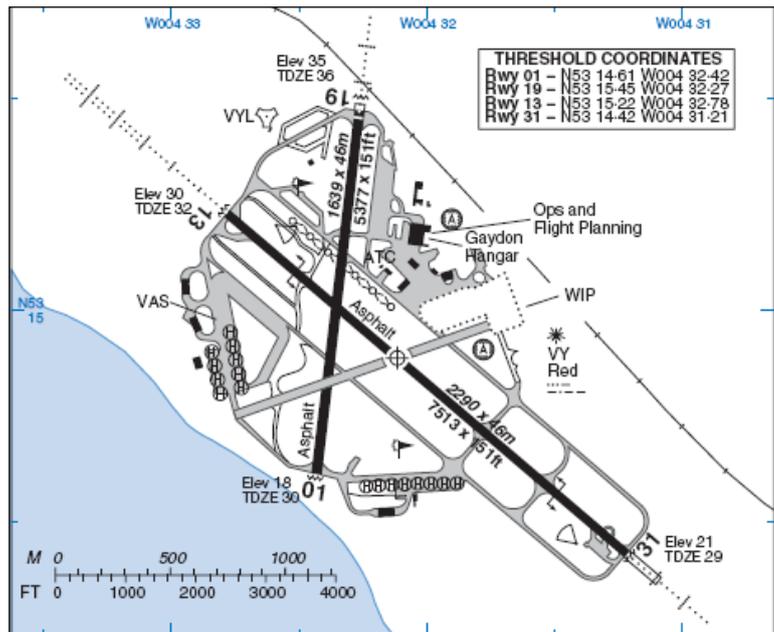
Although the ADC did not reiterate the height at which that the Lynx was required to operate, given that the Lynx crew had received an ATC brief and that they were considered to be familiar with the airfield, the ADC reasonably assumed that the crew would fly in accordance with the locally published procedures. Although it is impossible to be certain, it is possible that the Lynx was flying higher than stated in the published procedure.
