AIRPROX REPORT No 2010156

Date/Time: 12 Oct 2010 1254Z

Position: 5154N 00016E (1.75nm
NE Stansted - elev 348ft)

Type: A319 C152

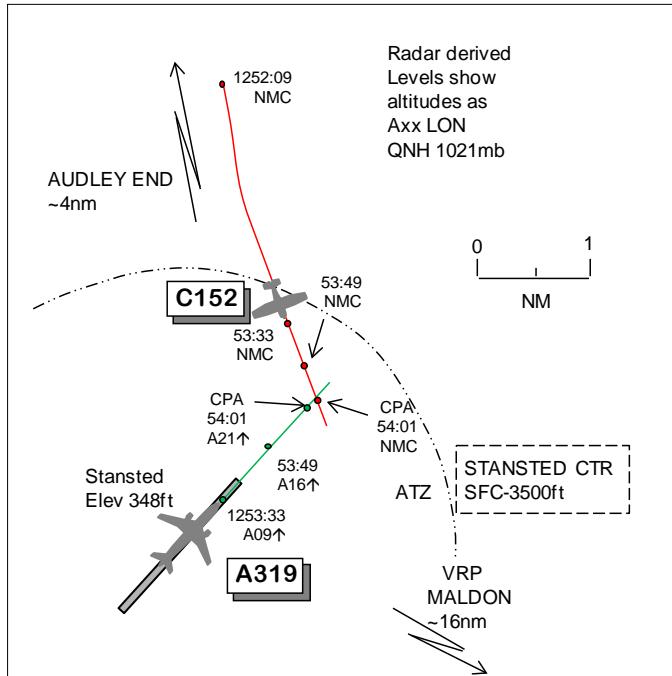
Reported Separation:

700ft V/Nil H NB

Recorded Separation:

<0.1nm H

[UKAB Note (1): The CPA occurs at 1254:01; the C152 is now in the A319's 1230 position range 0·1nm, the A319 now climbing through altitude 2100ft.]
