AIRPROX REPORT No 2010167

Date/Time: 3 Nov 2010 1716Z NIGHT

Position: 5117N 00034W (4nm S Fairoaks)

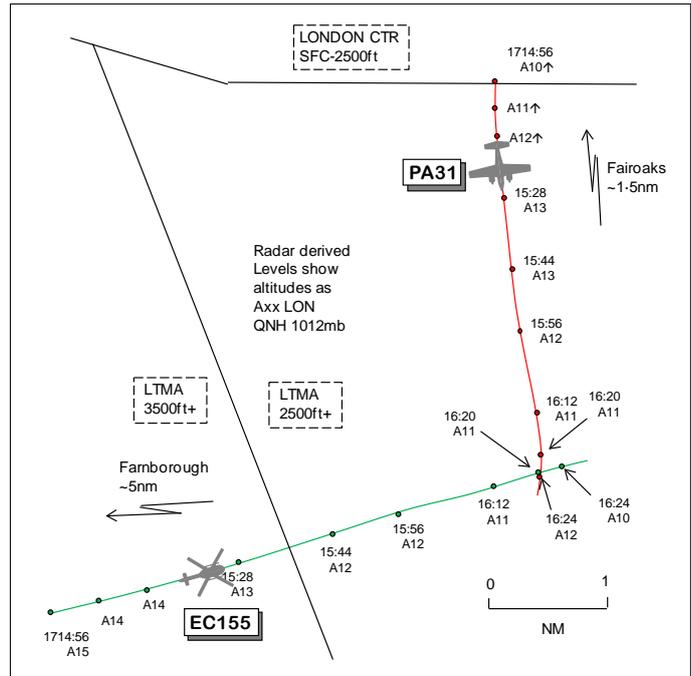
At 1716:20, the radar recording shows the 2 ac, 0.1nm apart, and converging. The EC155 was tracking ENE and the PA31 was tracking SSE. Both ac were indicating an altitude of 1100ft. The PA31 was in the EC155's 10 o'clock position, at a range of 0.1nm and crossing from L to R.

[UKAB Note (1): The next radar sweep at 1716:24 shows the ac having passed. The PA31 is now tracking 190° indicating altitude 1200ft, having turned R 20° and climbed 100ft, in the EC155's 6 o'clock range 0.2nm, the EC155 now indicating altitude 1000ft, having descended 100ft. The CPA is estimated to be <100ft and <0.1nm.]

Cause: Effectively a non-sighting by the EC155B crew and a late sighting by the PA31 pilot.
