AIRPROX REPORT No 2010004

Date/Time: 12 Feb 0940

Position: 5113N 00200W
(SPTA - elev 488ft)

Type: DH3 UAV AH64

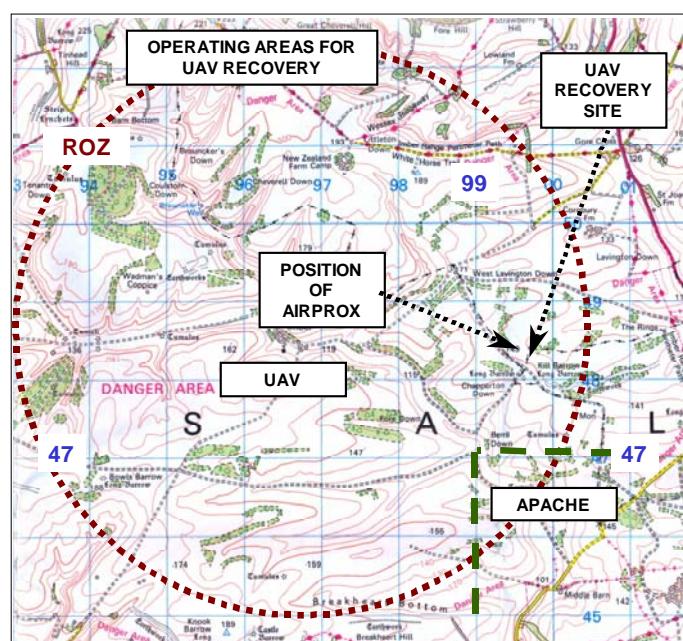
THE DH3 UAV PILOT reports that he was operating a small, non-SSR or TCAS equipped UAV in an exercise ROZ [Restricted Operating Zone], 2nm in radius from 0-1500ft amsl centred on 5114N 00203W (see diagram). Meanwhile an Apache was cleared to operate in the ROZ and was being deconflicted geographically by the Tactical Air Control Party (TACP). He understood that the Apache was cleared to operate W of the 98E 'line' and his UAV was to operate to the E.

The Tactical Commander (TAC) informed the TACP that the DH3 needed to recover due to low battery endurance, and it was planned to recover to a point at ST 997481 (see diagram); he also informed the TACP that a new de-confliction plan would have to be implemented. They agreed that the Apache would have to operate E of the 99E and S of the 47N and informed its pilot. The TACP asked the Apache pilot to confirm when he was S of the 47N deconfliction line; he replied that he was already to the S and they passed this on to the DH3 TAC.

The Apache then moved to the N and the DH3 FSO (Flight Safety Officer) reported to TAC that it was breaching the deconfliction line. The TACP again asked the Apache pilot to confirm that he was S of the 47N, and he verified that he was. At this point the Apache was identified by the DH3 FSO to be at Grid ST 995479 [just under 1km N of the line and very close to the DH3 recovery point] at about 300ft agl (radar verified with Salisbury Air Ops). At this time the DH3 was in its landing pattern at 300ft agl, 300m from the Apache and on a collision course with it. The DH3 FSO instructed the UAV operator to initiate an immediate orbit to prevent collision and it was then commanded to fly to the NW, away from the Apache.
