AIRPROX REPORT No 2010017

Date/Time: 25 Feb 2010 1521Z

Position: 5212N 00010E (4nm NE of Cambridge A/D - elev 47ft)

Airspace: London FIR (Class: G)

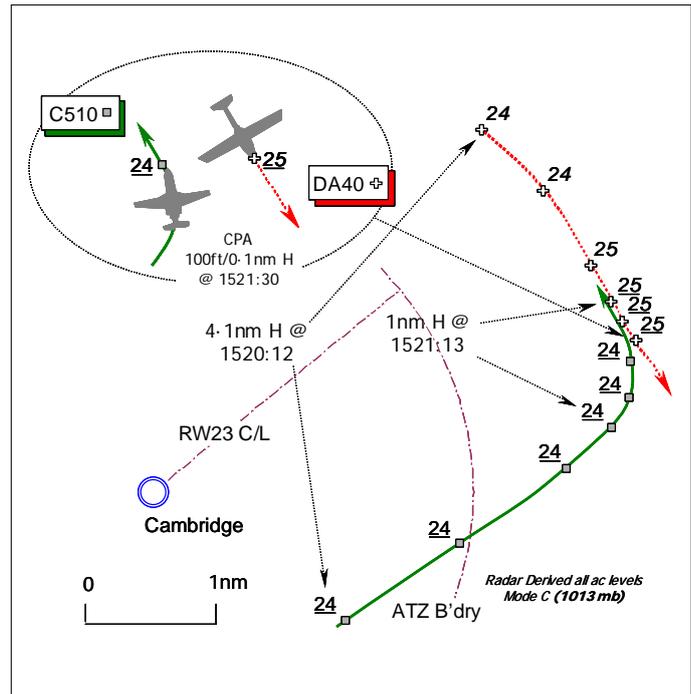
100ft V/0.1nm H (200yd H)

The radar recordings at 1521:30, show the C510 3-9nm E of the aerodrome in a L turn onto base leg, indicating FL024 [about 1560ft QNH (985mb)], with the DA40 100ft above it on a reciprocal track passing 0.1nm [200yd] to starboard, indicating FL025 [about 1660ft QNH (985mb)]. Neither controller was aware of the close proximity of the 2 ac. The C510 continued within the cct and landed at 1524 with no further mention of the incident. The pilot of the DA40 did not mention on RT another ac being in close proximity and at 1527:45, the DA40 pilot switched en-route - "Cambridge RADAR [C/S]..well clear of your Zone now request..frequency change to Earls Colne 1-2-2 decimal 2-5", which was approved without further comment.

Cause: A non-sighting by the DA40 pilot and a late sighting by the C510 pilots.

Degree of Risk: B.
