AIRPROX REPORT No 2010049

Date/Time: 13 May 2010 (Thursday) 1718Z

Position: 5307N 00005W (3nm
ENE Coningsby - elev
24ft)

Type: Typhoon Untraced Glider

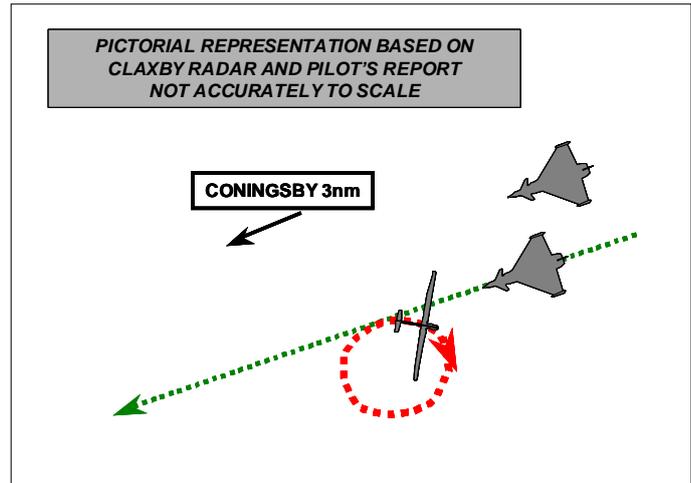
THE TYPHOON PILOT reports flying dual, leading a pair of Typhoons recovering visually to Coningsby RW27 (L) in echelon formation, from a routine training sortie in contact with Coningsby TWR squawking as directed with Mode C. As the formation approached initials [070°/3nm@2000ft QFE] the No2 pilot called 'Bunt, Bunt, Bunt' in order avoid a [white] glider [which he saw 0.25nm away]. The lead Typhoon bunted aggressively and the No2 subsequently called that the collision risk had been averted. The lead Typhoon pilot did not see the glider at any stage.

Subsequent analysis of the mission recording system revealed that the glider was on the extended centreline at 3nm and 2000ft, well within the MATZ.

UKAB Note (2): The recording of the Claxby Radar shows the Typhoons on the approach to Coningsby but they drop out in the left turn onto the centreline, reappearing 2 sweeps later with NMC. There is a primary-only return for 1 sweep only at 2.2nm on the approach, which might be the glider, coincident with Typhoon Leader. There is another intermittent primary contact 2min later, 2nm S of the position of the original primary contact but it again disappears and cannot be tracked. The Cromer and Debden radars only show the Typhoons intermittently with no primary contacts in the area.
