## **AIRPROX REPORT No 2010079**

Date/Time: 22 June 2010 (Tuesday) 1310Z

Position: 5043N 00247W  
(BRIDPORT)

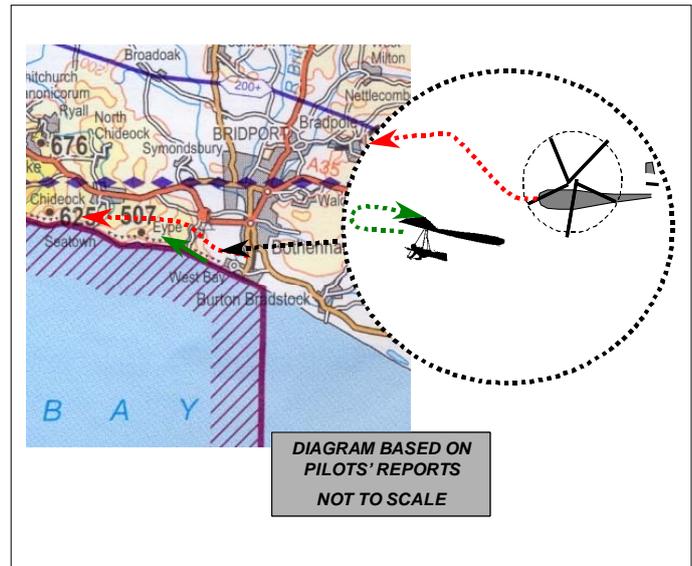
**THE PARAGLIDER PILOT** reports flying a brightly coloured paraglider with no lights, radio or SSR, cliff-soaring along the S Dorset Coast near Bridport at about 400ft amsl and at 20kt. There were other paragliders in the area. A dark coloured helicopter appeared from his blind area, behind and above. The helicopter may well have judged his rotor downwash would pass well inland of these paragliders but that day the wind strength he experienced above Thornecombe Beacon some 15min earlier was weak and only just significant enough to allow him to reach a maximum height of 600ft (around 70ft above the beacon). The helicopter pilot took some avoiding action but then climbed above several other paragliders and continued in a Westerly direction immediately above the paragliders. He assessed the risk as being Medium and provided a photograph of the event.

UKAB Note (2): The photographs provided show the weather to be CAVOK and the Merlin to be an estimated 250m N of the cliff-line.

He considers that pilots should be advised to avoid paragliders a wide margin downwind and not fly above them where they cannot be seen.
