AIRPROX REPORT No 2010088

Date/Time: 14 Jul 2010 (Wednesday) 0953Z

Position: 5250N 00028W (12nm SSE Cranwell)

Type: Tutor Tutor

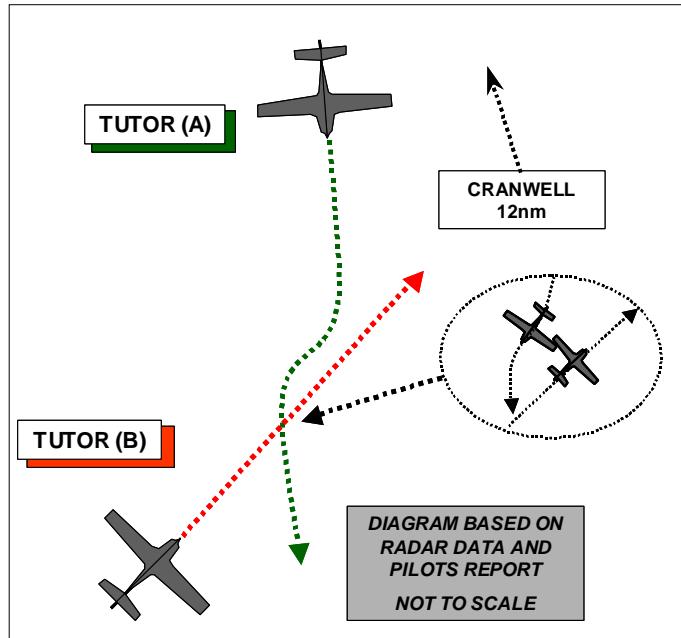
UKAB Note (2): The recording of the Claxby radar shows the incident clearly. In the lead up to the CPA at 0952:30, Tutor (A) can be seen climbing through FL062 in a Southerly direction and Tutor (B) is in its 2 o'clock, tracking 040° and level at FL065 (i.e. Tutor (A) is in Tutor (B)'s 1130, 1.6nm away and 300ft below it). The ac continue to close on unaltered headings until 0952:53 when Tutor (A) at FL064 commences a descending right to pass behind Tutor (B), which has descended by 200ft. The CPA with the separation of 100ft V/0.1nm H is at 0952:59, with Tutor (A) passing above and behind Tutor (B).
