AIRPROX REPORT No 2010104

Date/Time: 10 Aug 0954Z

Position: 5047N 00158W
(5nm W of Bournemouth
Airport elev: 38ft)

Airspace: Solent CTA (Class: D)

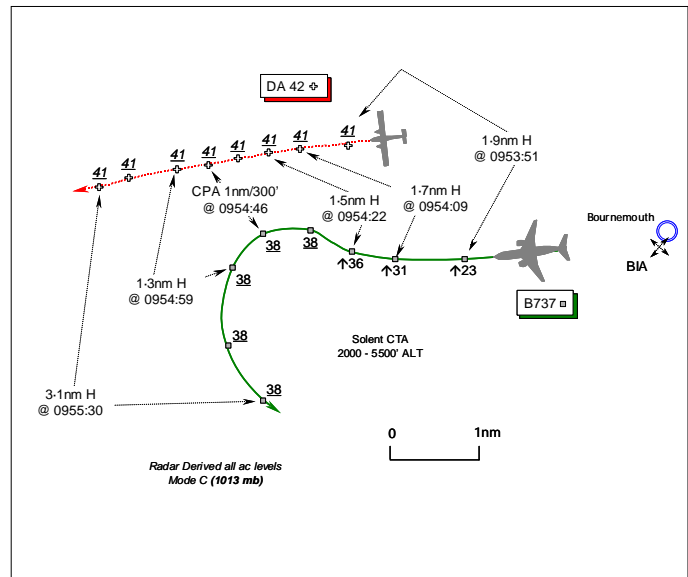
300ft V/1nm H

Cause: TOWER did not pass the altitude restriction to the B737 crew resulting in a conflict with the DA42.

Degree of Risk: C.
