AIRPROX REPORT No 2010124

Date/Time: 3 Sep 2010 1228Z

Position: 5300N 00034W (10nm SbyW of Waddington elev: 231ft)

Airspace: Lincolnshire AIAA (Class: G)

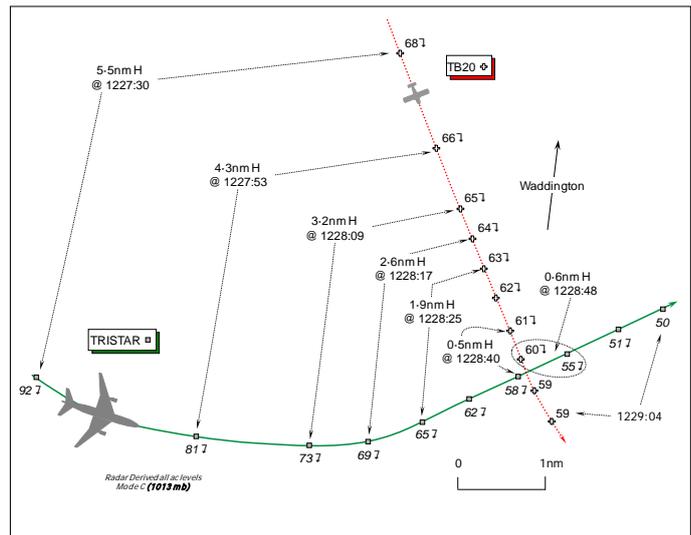
Recorded Separation:

Nil V @ 1.2nm H

0.5nm Min H @ 300ft V

With the Tristar descending through FL73, APP turned it L onto N at 1228:08, when it was 3.2nm SW of the TB20. CAP 774 states that:

The Supervisor reports that at some point between the time that the instructions to turn onto N and to stop descent at FL75 were issued, ZONE pointed out the TB20 to APP. At 1228:15, APP instructed the Tristar crew to, "*..stop descent flight level 7-5, traffic north east 4 miles, tracking south, at flight level 6-5.*" The TB20 is 2.6nm NE of the Tristar, the latter indicating FL69. The Tristar crew replied that they were, "*just passing 7-0 this time*" and APP instructed them to, "*stop descent 7-0*" at 1228:25. At this point the Tristar is shown descending through FL65, 1.9nm SSW of the TB20; the Tristar crew read back this instruction also advising that they were, "*rolling out [on heading] 0-7-0.*" At 1228:37, the Tristar pilot reported a TCAS RA, [which APP acknowledged] and just after this the point of minimum horizontal separation is shown at 1228:40 as 0.5nm, the Tristar passing FL58 having descended 300ft below the TB20 indicating FL61 Mode C. [The Tristar pilot reported "*..clear of conflict*" at 1229:03.]

APP would have been aware of the regulation regarding taking into account traffic in the immediate vicinity prior to issuing a vector to ac under their control. The ATSU has stated that the taskload on APP should not have been a problem for the controller, considering her ability and experience. However, it is clear that the taskload and complexity were significant factors in this occurrence. Specifically that APP was operating in the band-boxed APP-DIR position. The taskload and complexity faced by APP caused attentional tunnelling, which in turn meant that APP was unable to perceive the presence of the TB20, hence the Tristar was unknowingly turned into conflict with the TB20.

Operation of the band-boxed APP-DIR position and the associated increase in taskload that this generated was a causal factor in this Airprox.

SATCO Waddington has reviewed lunchtime manning arrangements to ensure that staff are available for DIR when appropriate.
