AIRPROX REPORT No 2010139

Date/Time: 7 Sep 2010 1301Z

Position: 5047N 00148W (1.5nm FIN APP
RW26 Bournemouth - elev 38ft)

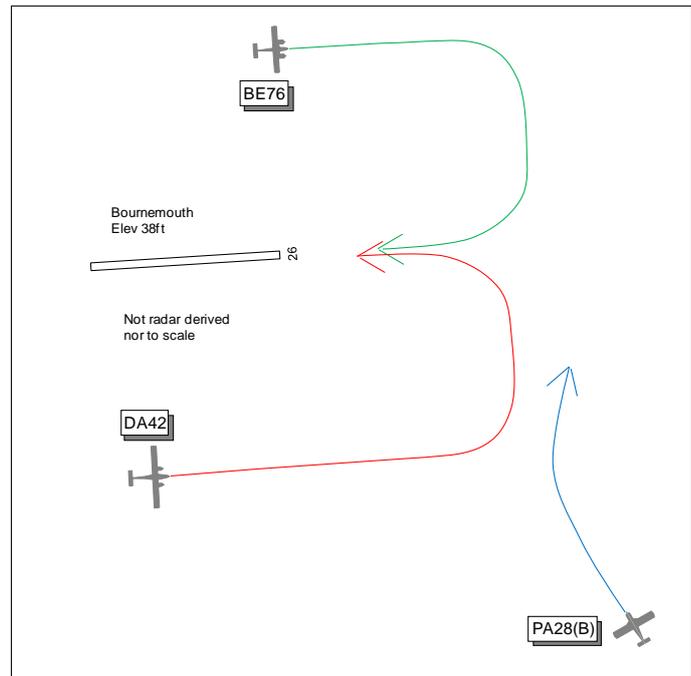
The unit radar replay showed that as the DA42 turned onto L base the ac SSR label fades, leaving only an intermittent primary return. PA28(B) continues towards L base 1nm E of the DA42. The track of the DA42 on base leg, brings the DA42 into close proximity with the BE76 as both ac turn onto final approach.

After the DA42 pilot reported final and was told to continue approach, the BE76 pilot reported 'going around' owing to the DA42 having passed just beneath. The ac passed each other unsighted to both crews whilst descending on final approach. That the ac missed each other was purely fortuitous and, with neither crew nor ATC having taken any action to resolve the conflict, the Board were in no doubt that a definite risk of collision existed during this encounter.

1. Lack of positive control by ATC.
2. Having taken avoiding action against joining traffic (PA28(B)), the Twin Star pilot did not position No2 on final to the BE76 as instructed by the ADC.
