AIRPROX REPORT No 2010149

Date/Time: 4 Oct 2010 1640Z

Position: 5559N 00315W
(4nm Final RW24
Edinburgh - elev 136ft)

Airspace: Edinburgh CTZ (Class: D)

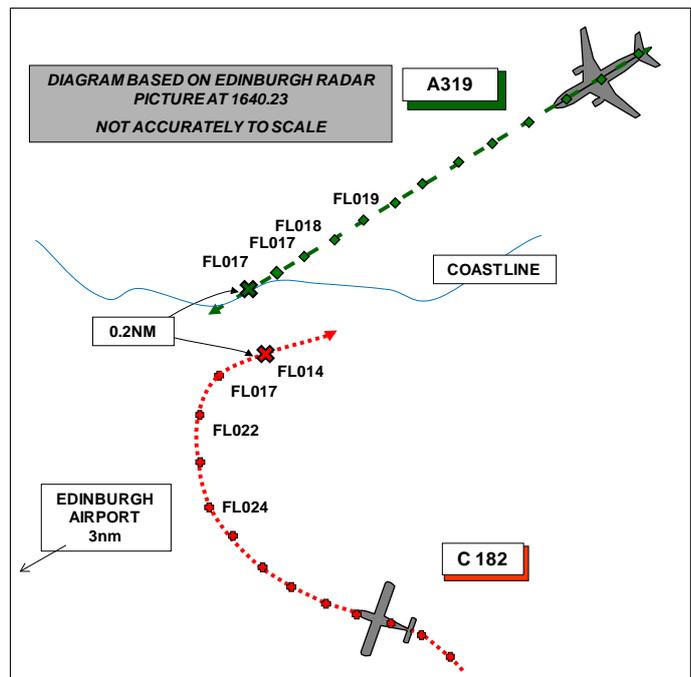
~300ft V/0.2nm H

AIR noted both visually and on the ATM, that the C182 entered a left hand orbit. At 1638:43, the radar recording showed the C182 in a left hand orbit 2.75nm E of the airfield, indicating an alt of 1800ft and the A319 established on final approach at 7nm; RAD had informed the A319 crew about the C182 holding to the S. At 1639:28 the radar recording showed the C182 taking up a N'y track indicating an alt of 1900ft. AIR reported that he saw this, but shortly afterwards he was reassured when he saw the C182 commence a left turn, still at 1800ft, as though it was continuing in the left-hand orbit. At the same time, 1639:37, the A319 pilot contacted AIR, *"Tower (A319)c/s with you descending on the ILS"*; immediately after this call AIR reported that he saw the C182 make a sharp right turn towards the final approach. The radar recording shows the C182 turn right at 1639:57 indicating an alt of 1700ft.

The controller reported that he immediately recognised that the ac were in conflict and at 1639:58 transmitted to the C182 pilot, “(C182)c/s just confirm you’re visual with the er traffic on two four”, but at 1640:05, the A319 pilot reported, “(A319)c/s is visual with the er traffic on two four”. The radar recording shows the A319 at 3.5nm on the final approach, indicating an alt of 1200ft, with the C182 in its 11 o’clock position at 1.2nm crossing from left to right, indicating 1700ft. AIR responded to the A319’s call, “(A319)c/s roger there is VFR traffic I believe just about to cross you left to right are you visual with that”. At 1640:14 the radar recording showed the C182 descending and passing 1600ft, in a right turn towards the A319, indicating 1100ft. At 1640:19, the A319 pilot replied, “Er Yeah it’s erm a bit close”.

At that point radar the recording shows both ac indicating an alt of 1100ft, 0.5nm apart with the C182 then continuing its right turn and descending to 700ft. AIR reported seeing the C182 make a rapid descent and right turn and pass down the left hand side of the A319 and was concerned regarding the safety of the C182.
